GENERAL ASSESSMENT & REHABILITATION PLAN

2 BULL STREET

CHARLESTON ~ SOUTH CAROLINA

This Paper was written by  
Katherine Hillock  
for the 2007 Spring Semester of the  
Historic Preservation Studio Course  
taught by Professor James L. Ward

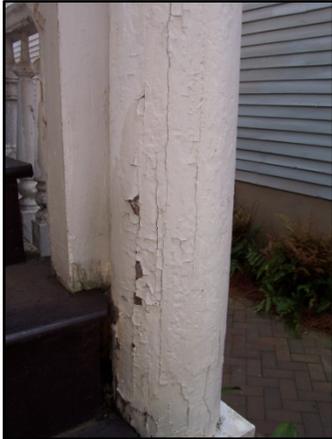
An architectural Inventory of the house was taken in 1973 and the condition was recorded as 'good'; this essentially holds true today. There is minor decay on the porches that appears to be moisture driven and not from termites. On the interior there is also indication of a moisture problem in the ceiling below the second floor shower, at the front of the building. These issues will be addresses prior to work commencing. Other than the conditions mentioned, the house is structurally sound and has modern utilities and mechanical systems.

moisture damage on rear piazza column

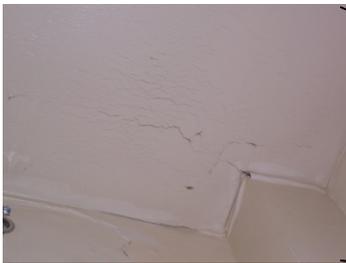
moisture in ceiling under front shower

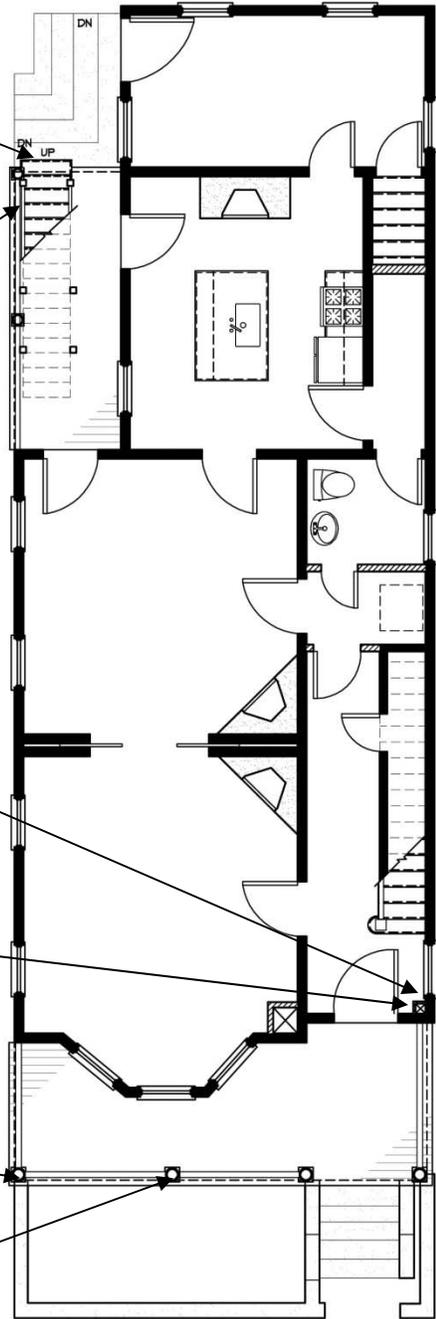
1 EXISTING PLAN & CONDITIONS  
SCALE: 1/8"=1'-0"  
FIRST FLOOR  
1100 SQ. FT.

moisture damage to deck boards on front porch
