HISTORIC AMERICAN BUILDING SURVEY
NEW TABERNACLE FOURTH BAPTIST CHURCH
HABS #SC-535

Documentary Drawings for New Tabernacle Fourth Baptist Church (Old St. Luke's Episcopal Church)

Prepared by the College of Charleston Historic Preservation
and Community Planning Program
HPCP 299 - Spring 2013
James L. Ward, Assistant Professor

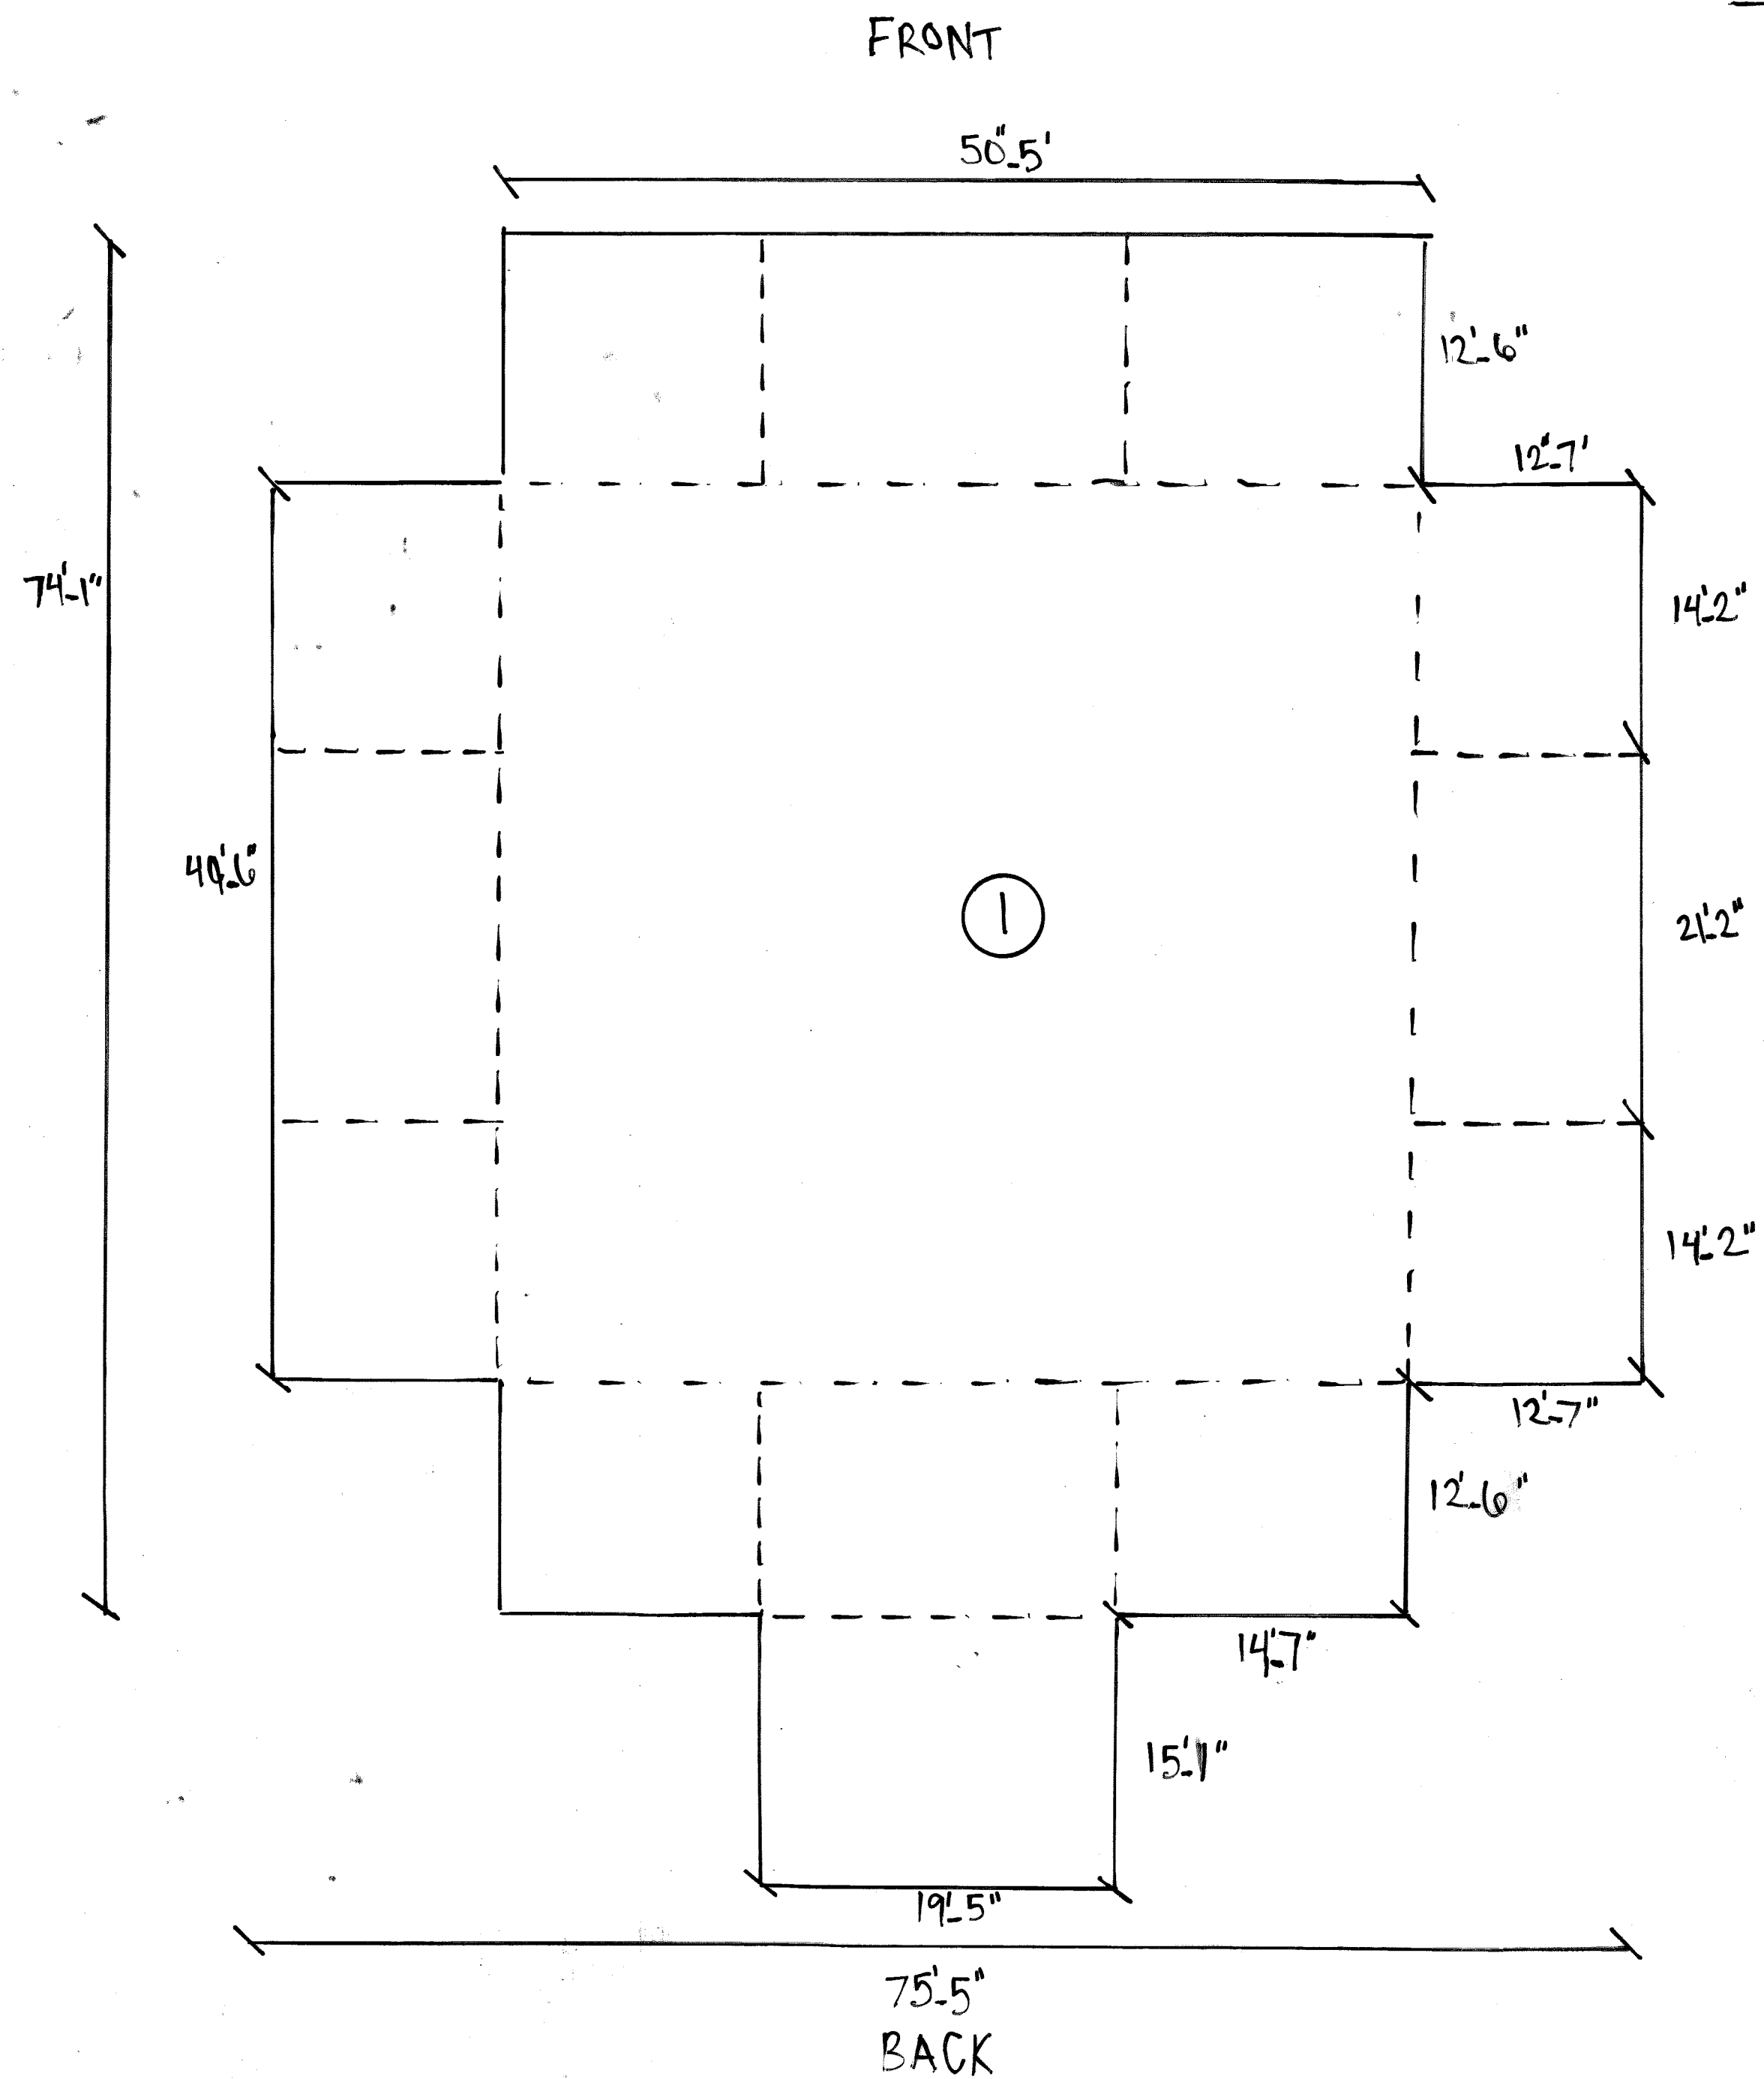
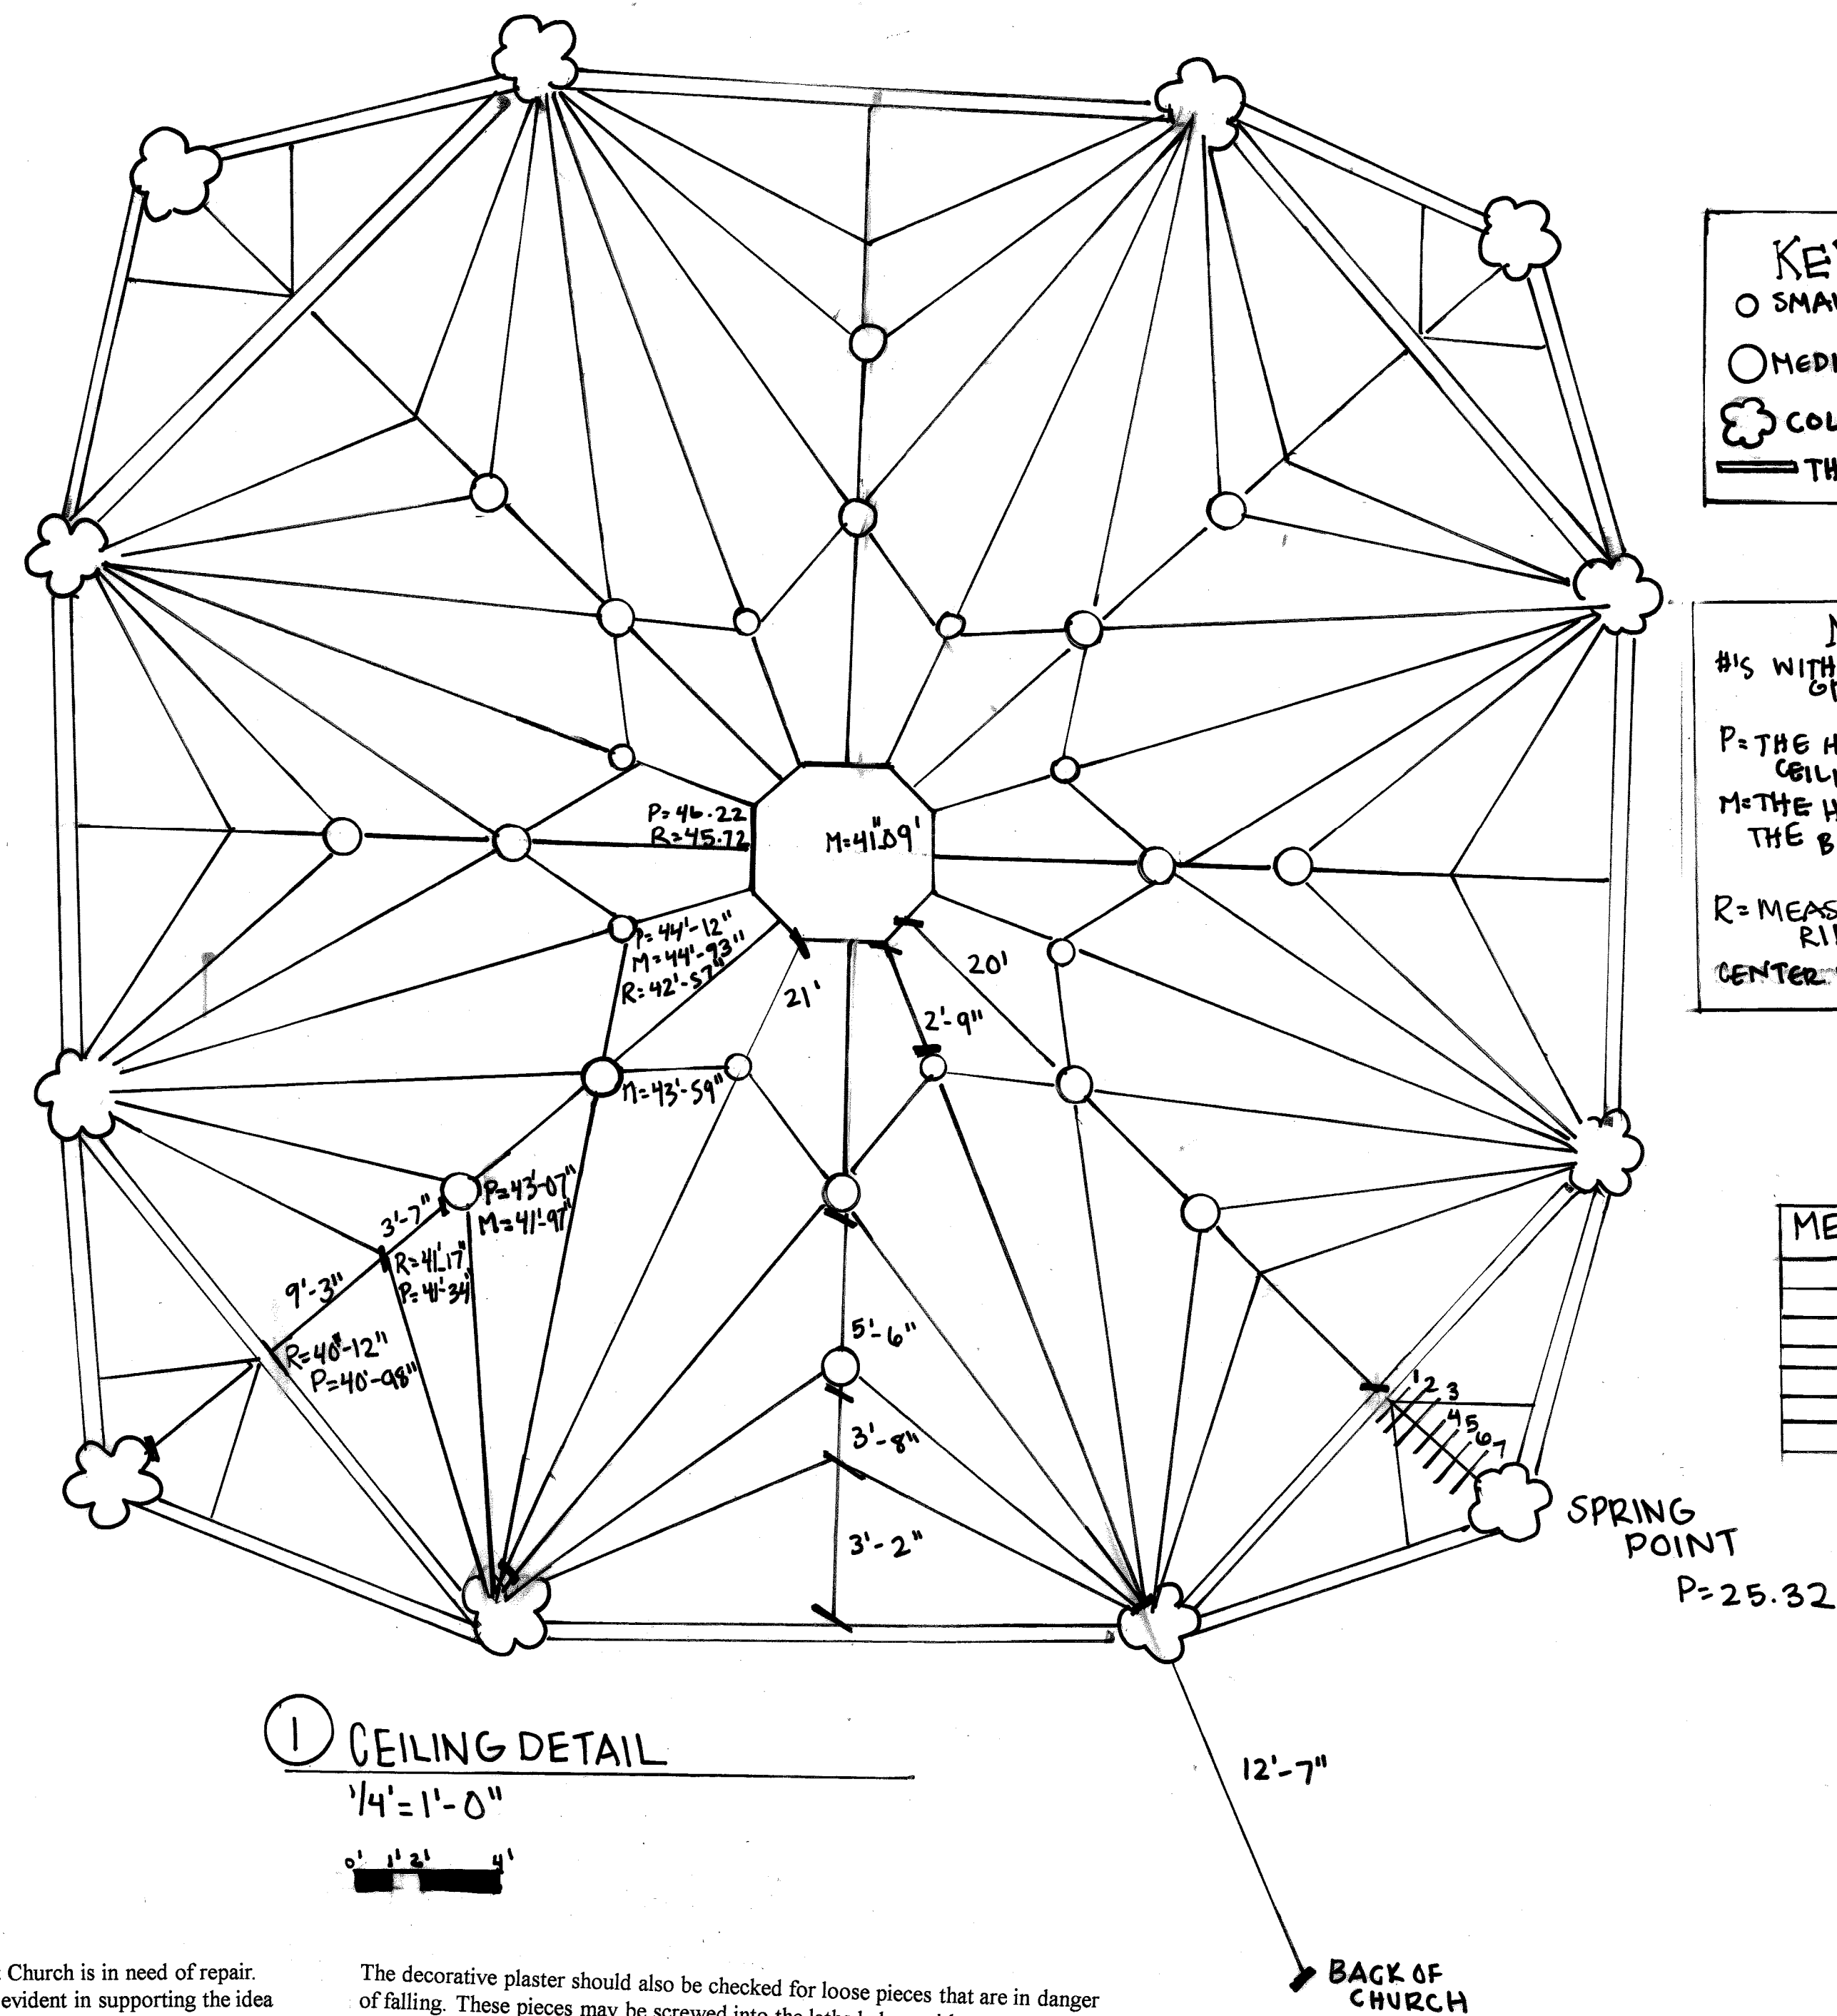
CEILING DETAIL PLAN

The plaster in the New Tabernacle Fourth Baptist Church is in need of repair. The discoloration, cracking, and missing plaster are evident in supporting the idea that the plaster is in bad condition. Since the church was built in the late 1800's, the plaster that is inside is lime plaster and that the rehab of the plaster will be time consuming and expensive. Even with the expense, it is important that the plaster is in good condition so it will not be a hazard if the church is used in an adaptive reuse project.

The way to move forward would be to attempt to repair the lime plaster in a way so that it looks like the original. This means using lime plaster and repairing the spots that need to be fixed without destroying the rest of the walls. If the plaster is lime and gypsum mix is used, the plaster is extra susceptible to water damage. Since there is discoloration in the plaster there is water that is leaking through the roof, flashing, and brick.² The missing pieces of plaster and cracking may also be because of water damage. In order to repair the water damage a new roof as well as mortar must be added to the church before any work is done on the inside of the church.² The mortar must be flexible so the building breathes letting the moisture out so that it does not stay inside of the walls.²

First, the person must evaluate the situation and look to see which spots need repair. Next, the person should remove the plaster that has been damaged to the laths underneath to see what condition they are in. If the laths are in bad shape, use metal laths with small holes to create keys in the laths that will hold the plaster into place. Then new lime plaster should be properly mixed and applied to the spots that are in need of repair. The plaster will need three coats, a scratch coat, a brown coat, and a finish coat. After completing the "match test" on the plaster, attempt to match the paint colour with the rest of the wall². If the plaster is not damaged try not to remove it².

The decorative plaster should also be checked for loose pieces that are in danger of falling. These pieces may be screwed into the laths below with screws to prevent them from falling². The plaster may also be held to the ceiling with plaster that is inserted with syringes into the ceiling in small holes that fill the keys above³. This way of application is slow and expensive⁴.

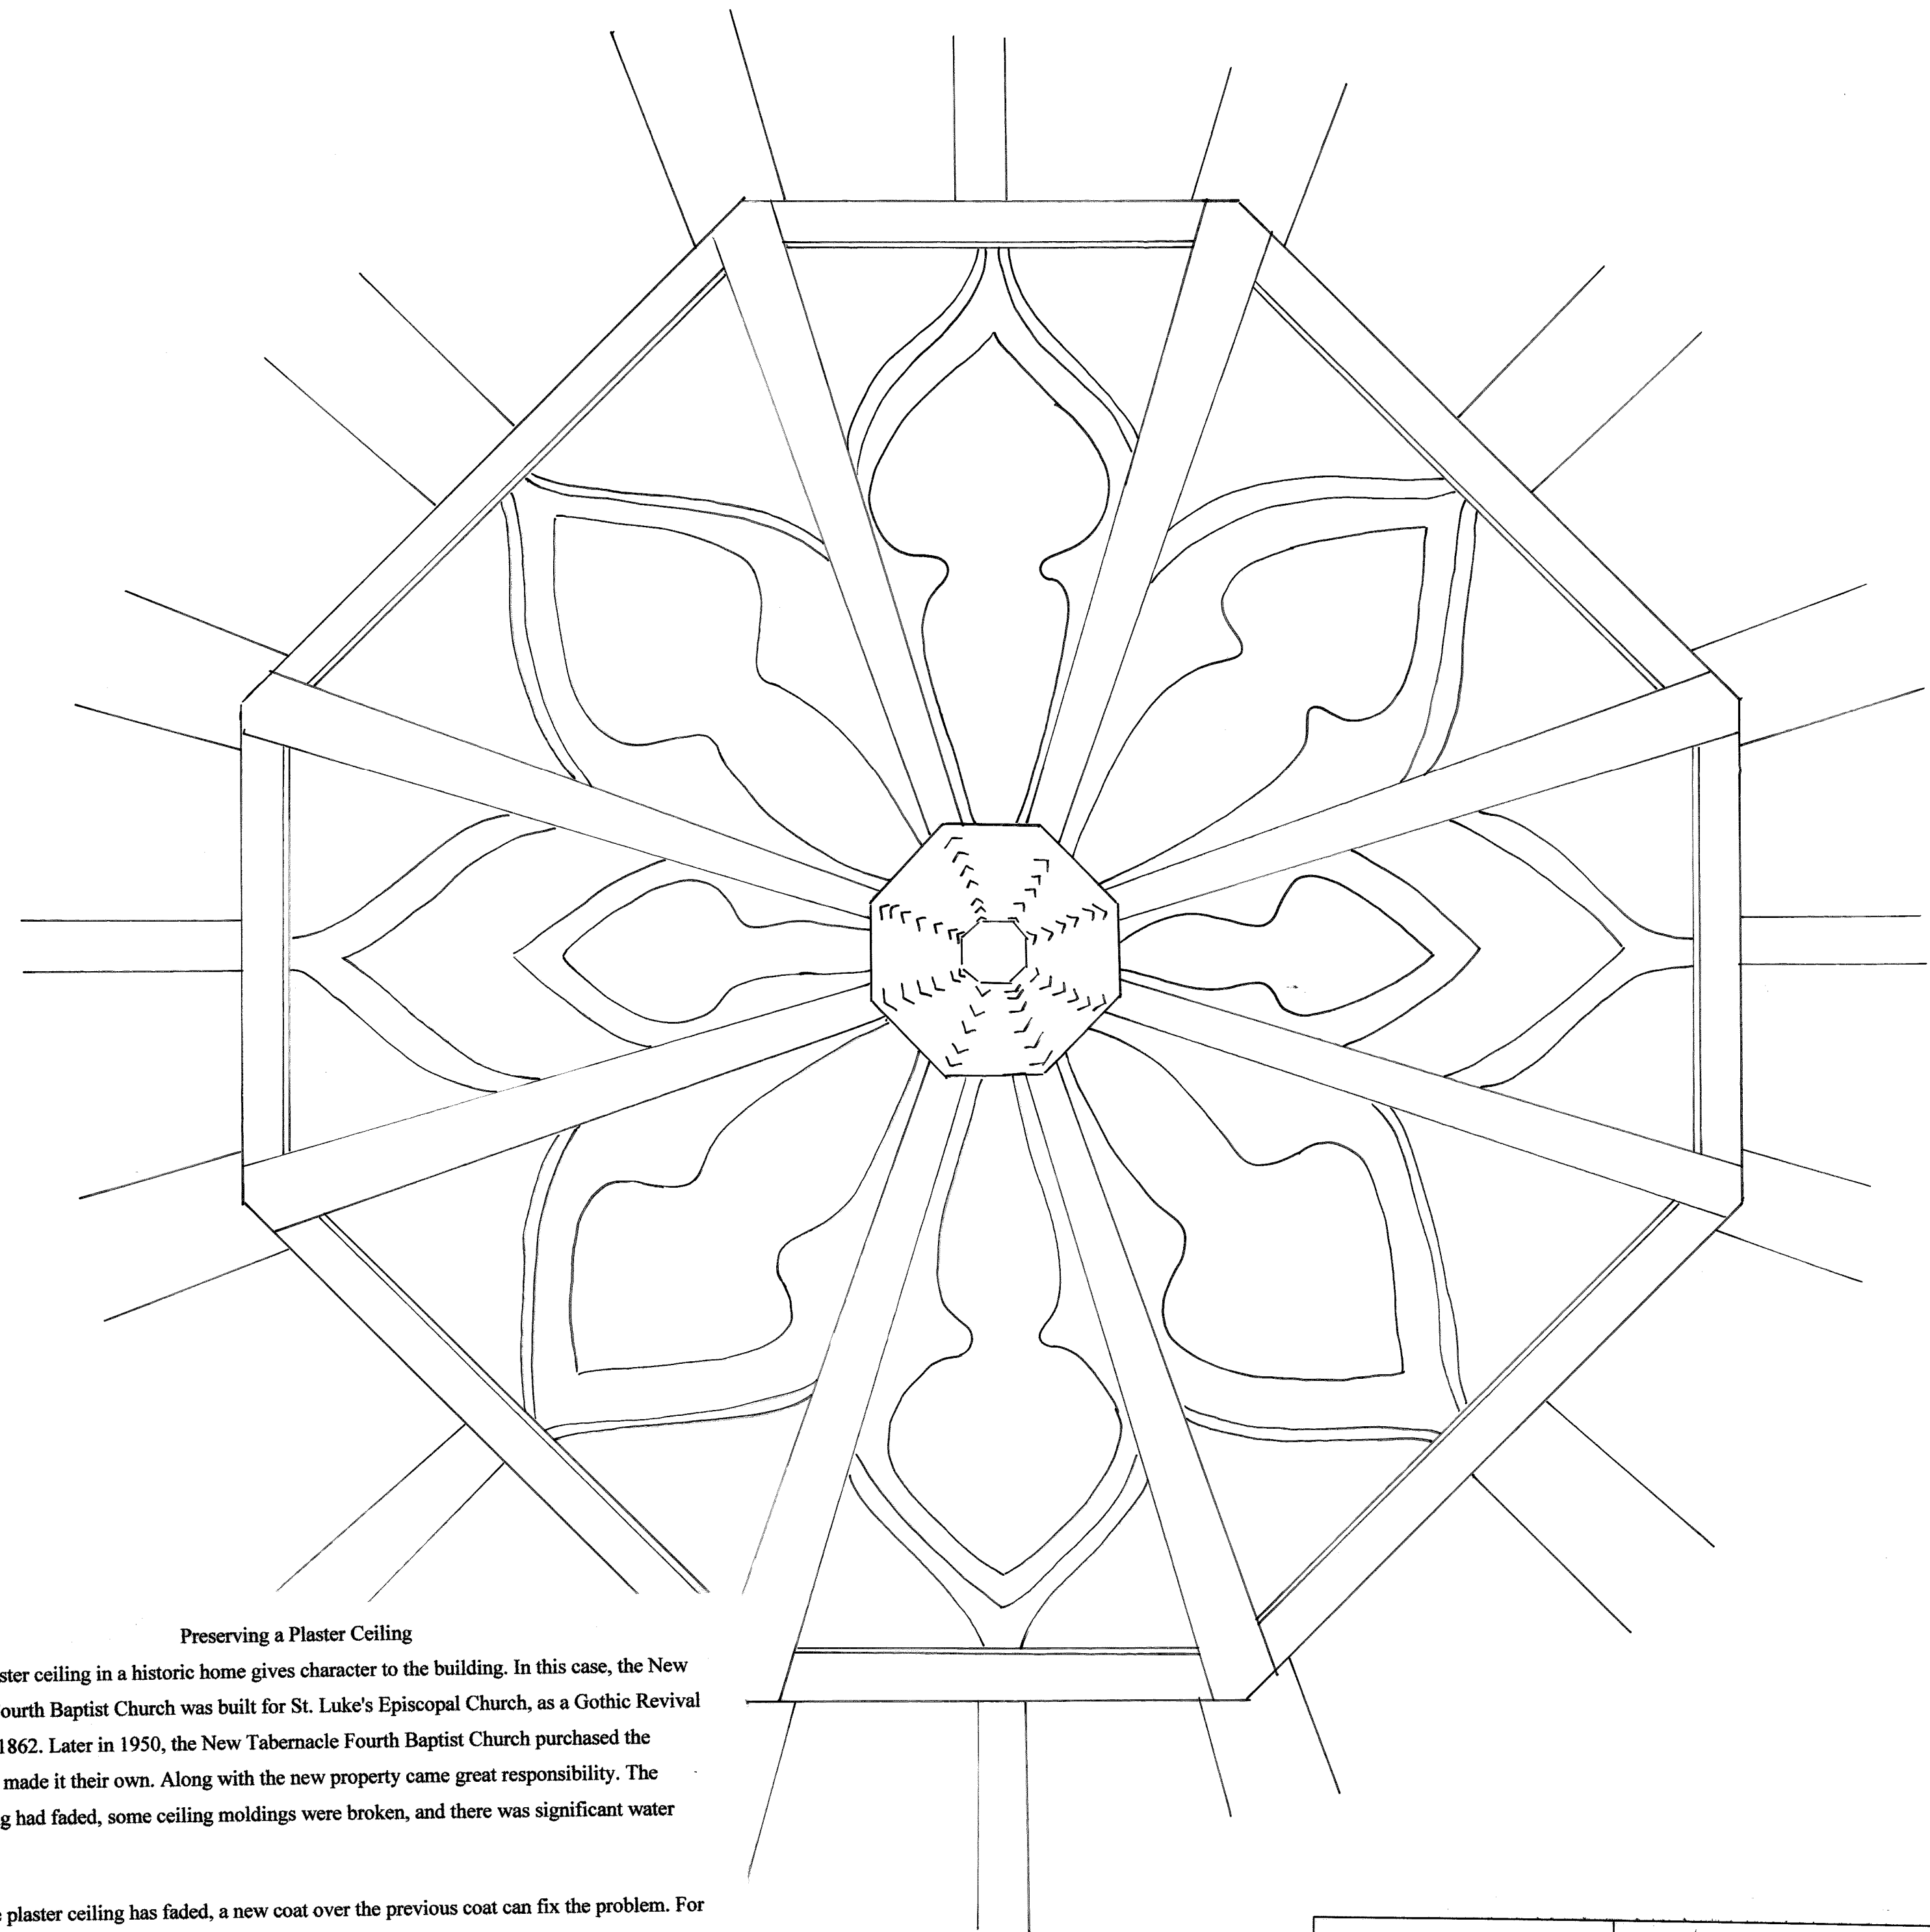
A plaster ceiling in a historic home gives character to the building. In this case, the New Tabernacle Fourth Baptist Church was built for St. Luke's Episcopal Church, as a Gothic Revival structure, in 1862. Later in 1950, the New Tabernacle Fourth Baptist Church purchased the property and made it their own. Along with the new property came great responsibility. The plaster ceiling had faded, some ceiling moldings were broken, and there was significant water damage.

If the plaster ceiling has faded, a new coat over the previous coat can fix the problem. For the ceiling medallions, some have been broken off completely, so using research to find the specific details for how the plaster medallions was originally designed should be used in restoring the medallions of New Tabernacle. According to Preservation Brief 23, historic ornamental plaster is made of gypsum and lime which are stable and durable materials. An extremely versatile material, plaster can be modeled, cast, incised, colored, stamped, or stenciled. However, as an integral part of the building system it is subject to the typical problems of water intrusion, structural movement, vibration and insensitive alterations, and pieces that are deteriorated or damaged beyond plain patching must be removed and replaced with new pieces that exactly match the existing historic plaster. There are multiple sources of water damage in the Church, occurring from the walls, windows, drainage, and roof leaks. Preservation Brief 21 explains that with roof leaks causing ceiling damage, coatings applied to the interior are not effective in the long run. The moisture problem must be stopped on the outside of the wall.

The ceiling at New Tabernacle Fourth Baptist Church needs to undergo major repairs to stop the historic ceiling from deteriorating, and to stop water damage from influencing the deterioration.

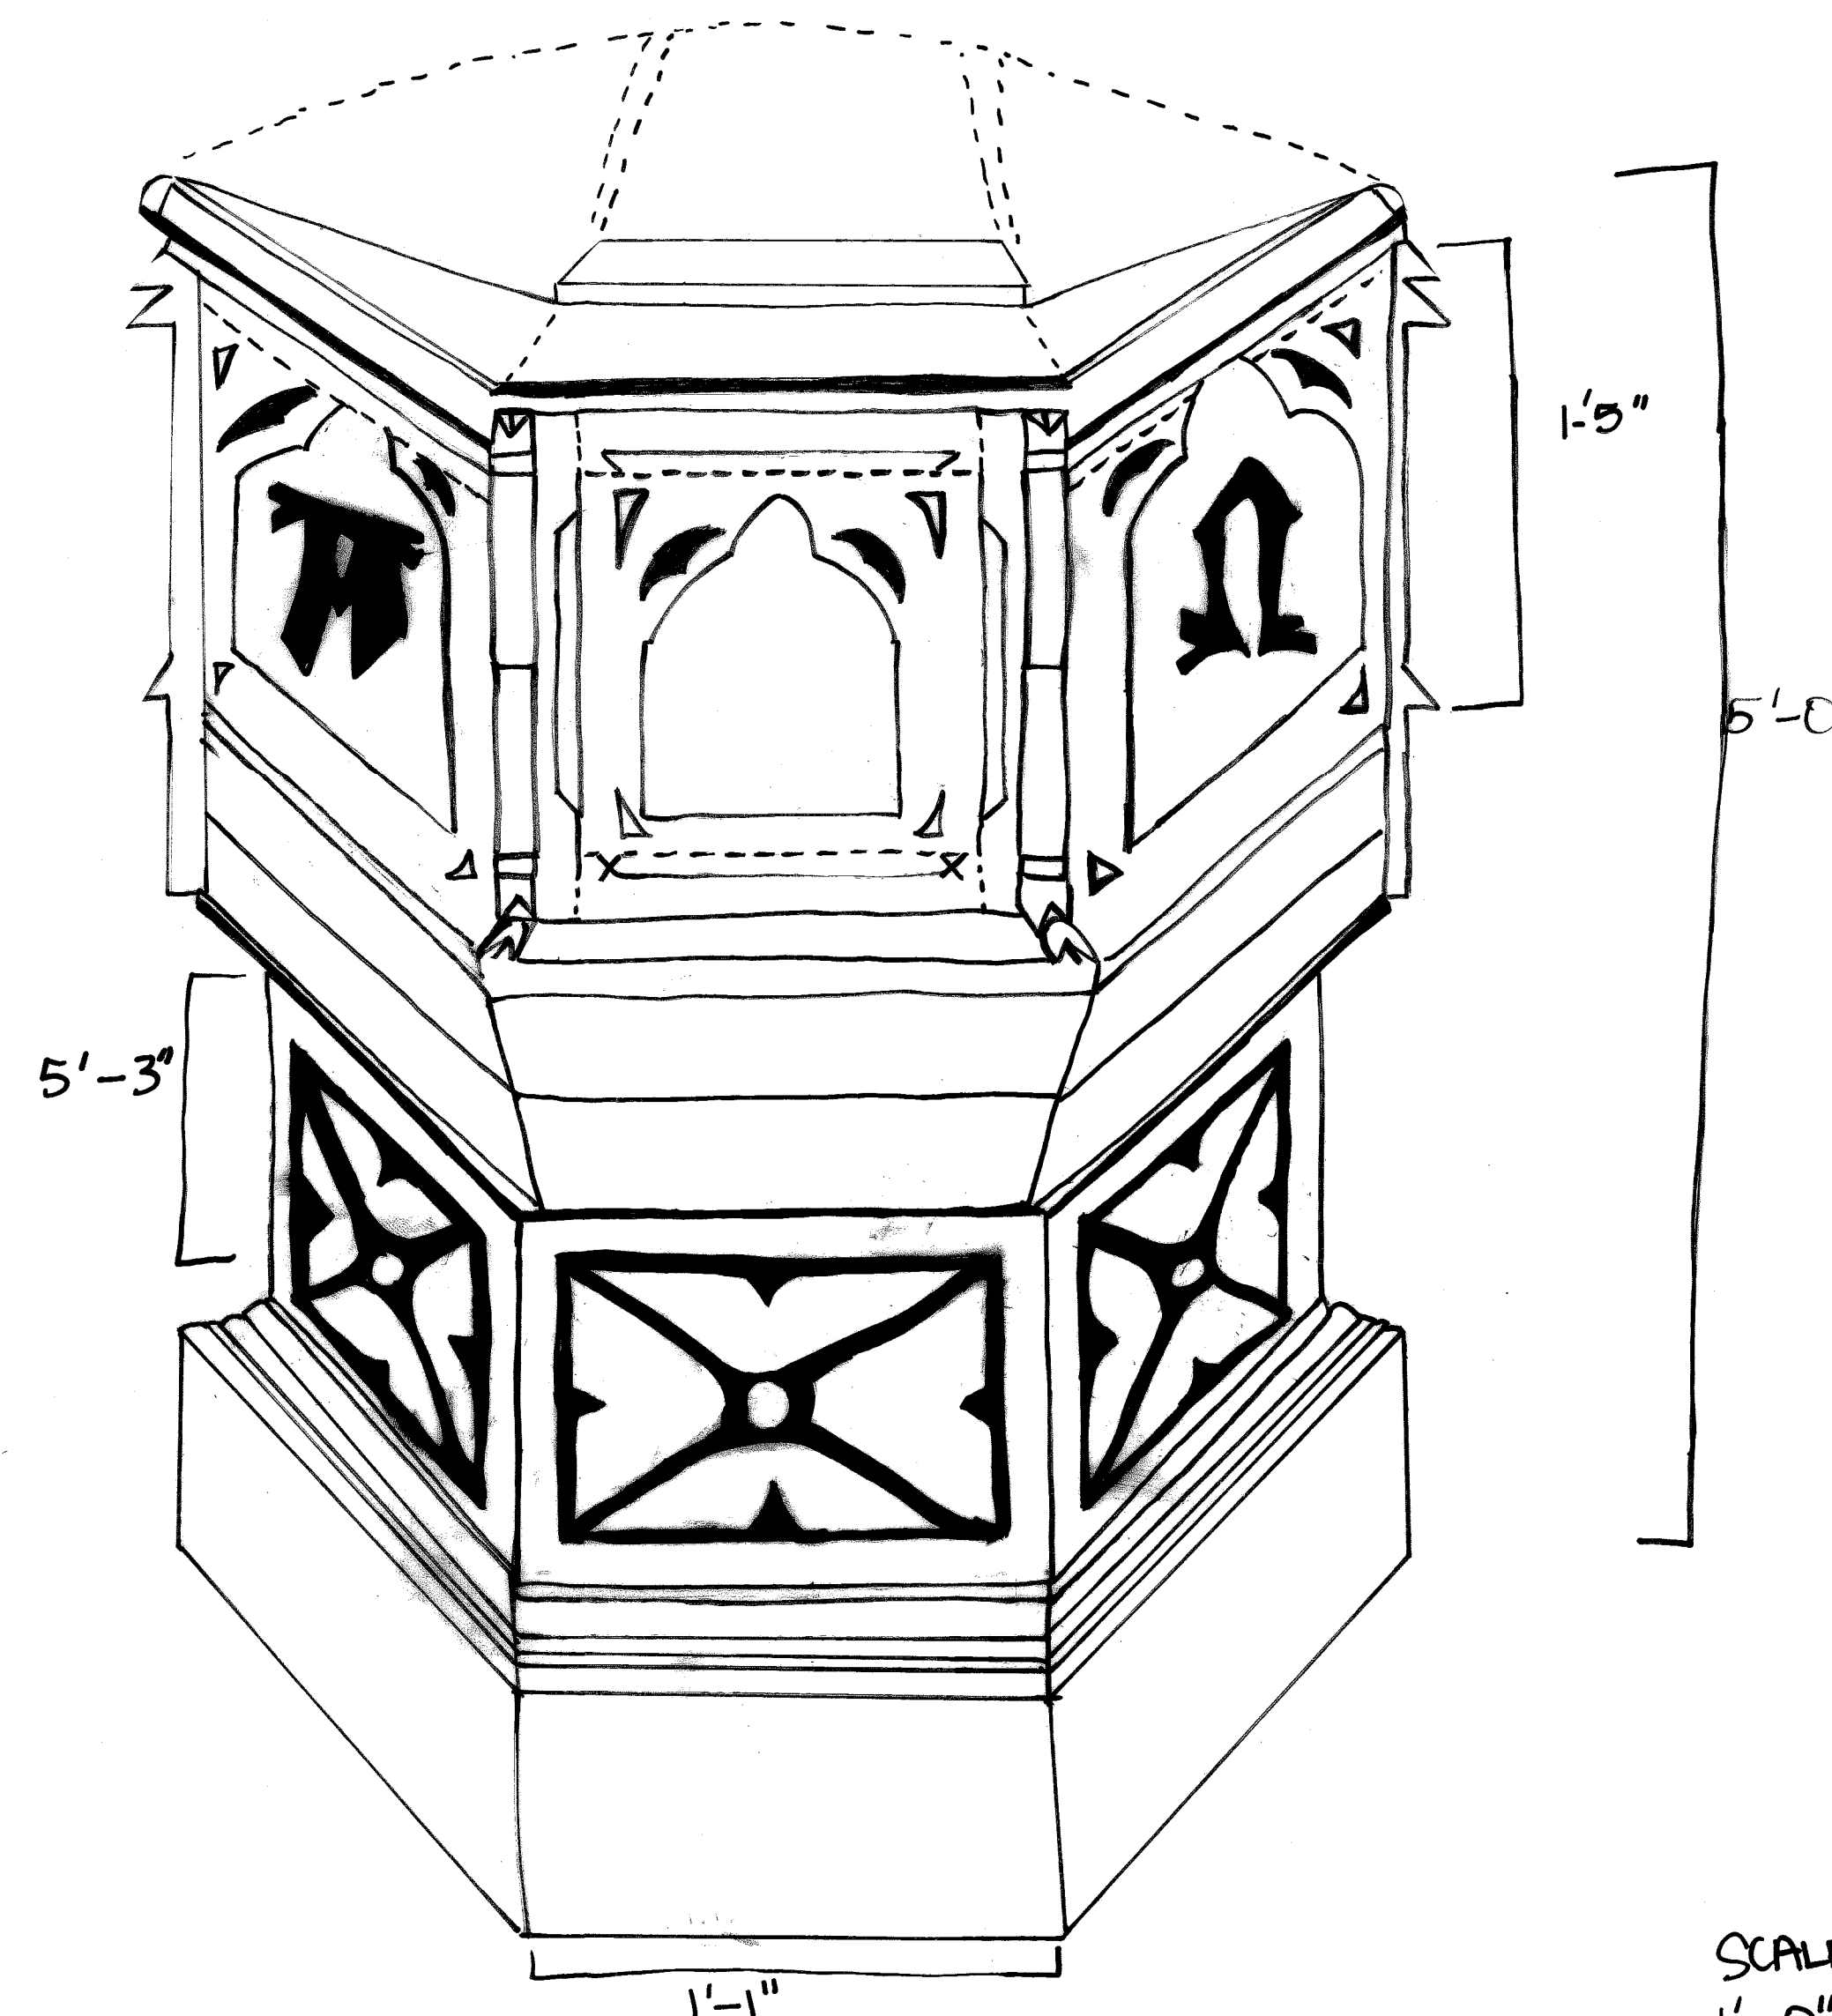
THE PULPIT:
AN AXIOMETRIC DRAWING

This deep rich mahogany pulpit has an overall structure in good condition. The preservation of mahogany wood only requires some basic cleaning with no abrasive solutions and polishing. A soft damp cloth will easily remove any dirt or grime. Heavy heat, sunlight and water can easily damage a piece of this magnitude.
