HISTORIC AMERICAN BUILDING SURVEY
NEW TABERNACLE FOURTH BAPTIST CHURCH
HABS #SC-535

Documentary Drawings for New Tabernacle Fourth Baptist Church (Old St. Luke's Episcopal Church)

Prepared by the College of Charleston Historic Preservation
and Community Planning Program
HPCP 299 - Spring 2013
James L. Ward, Assistant Professor

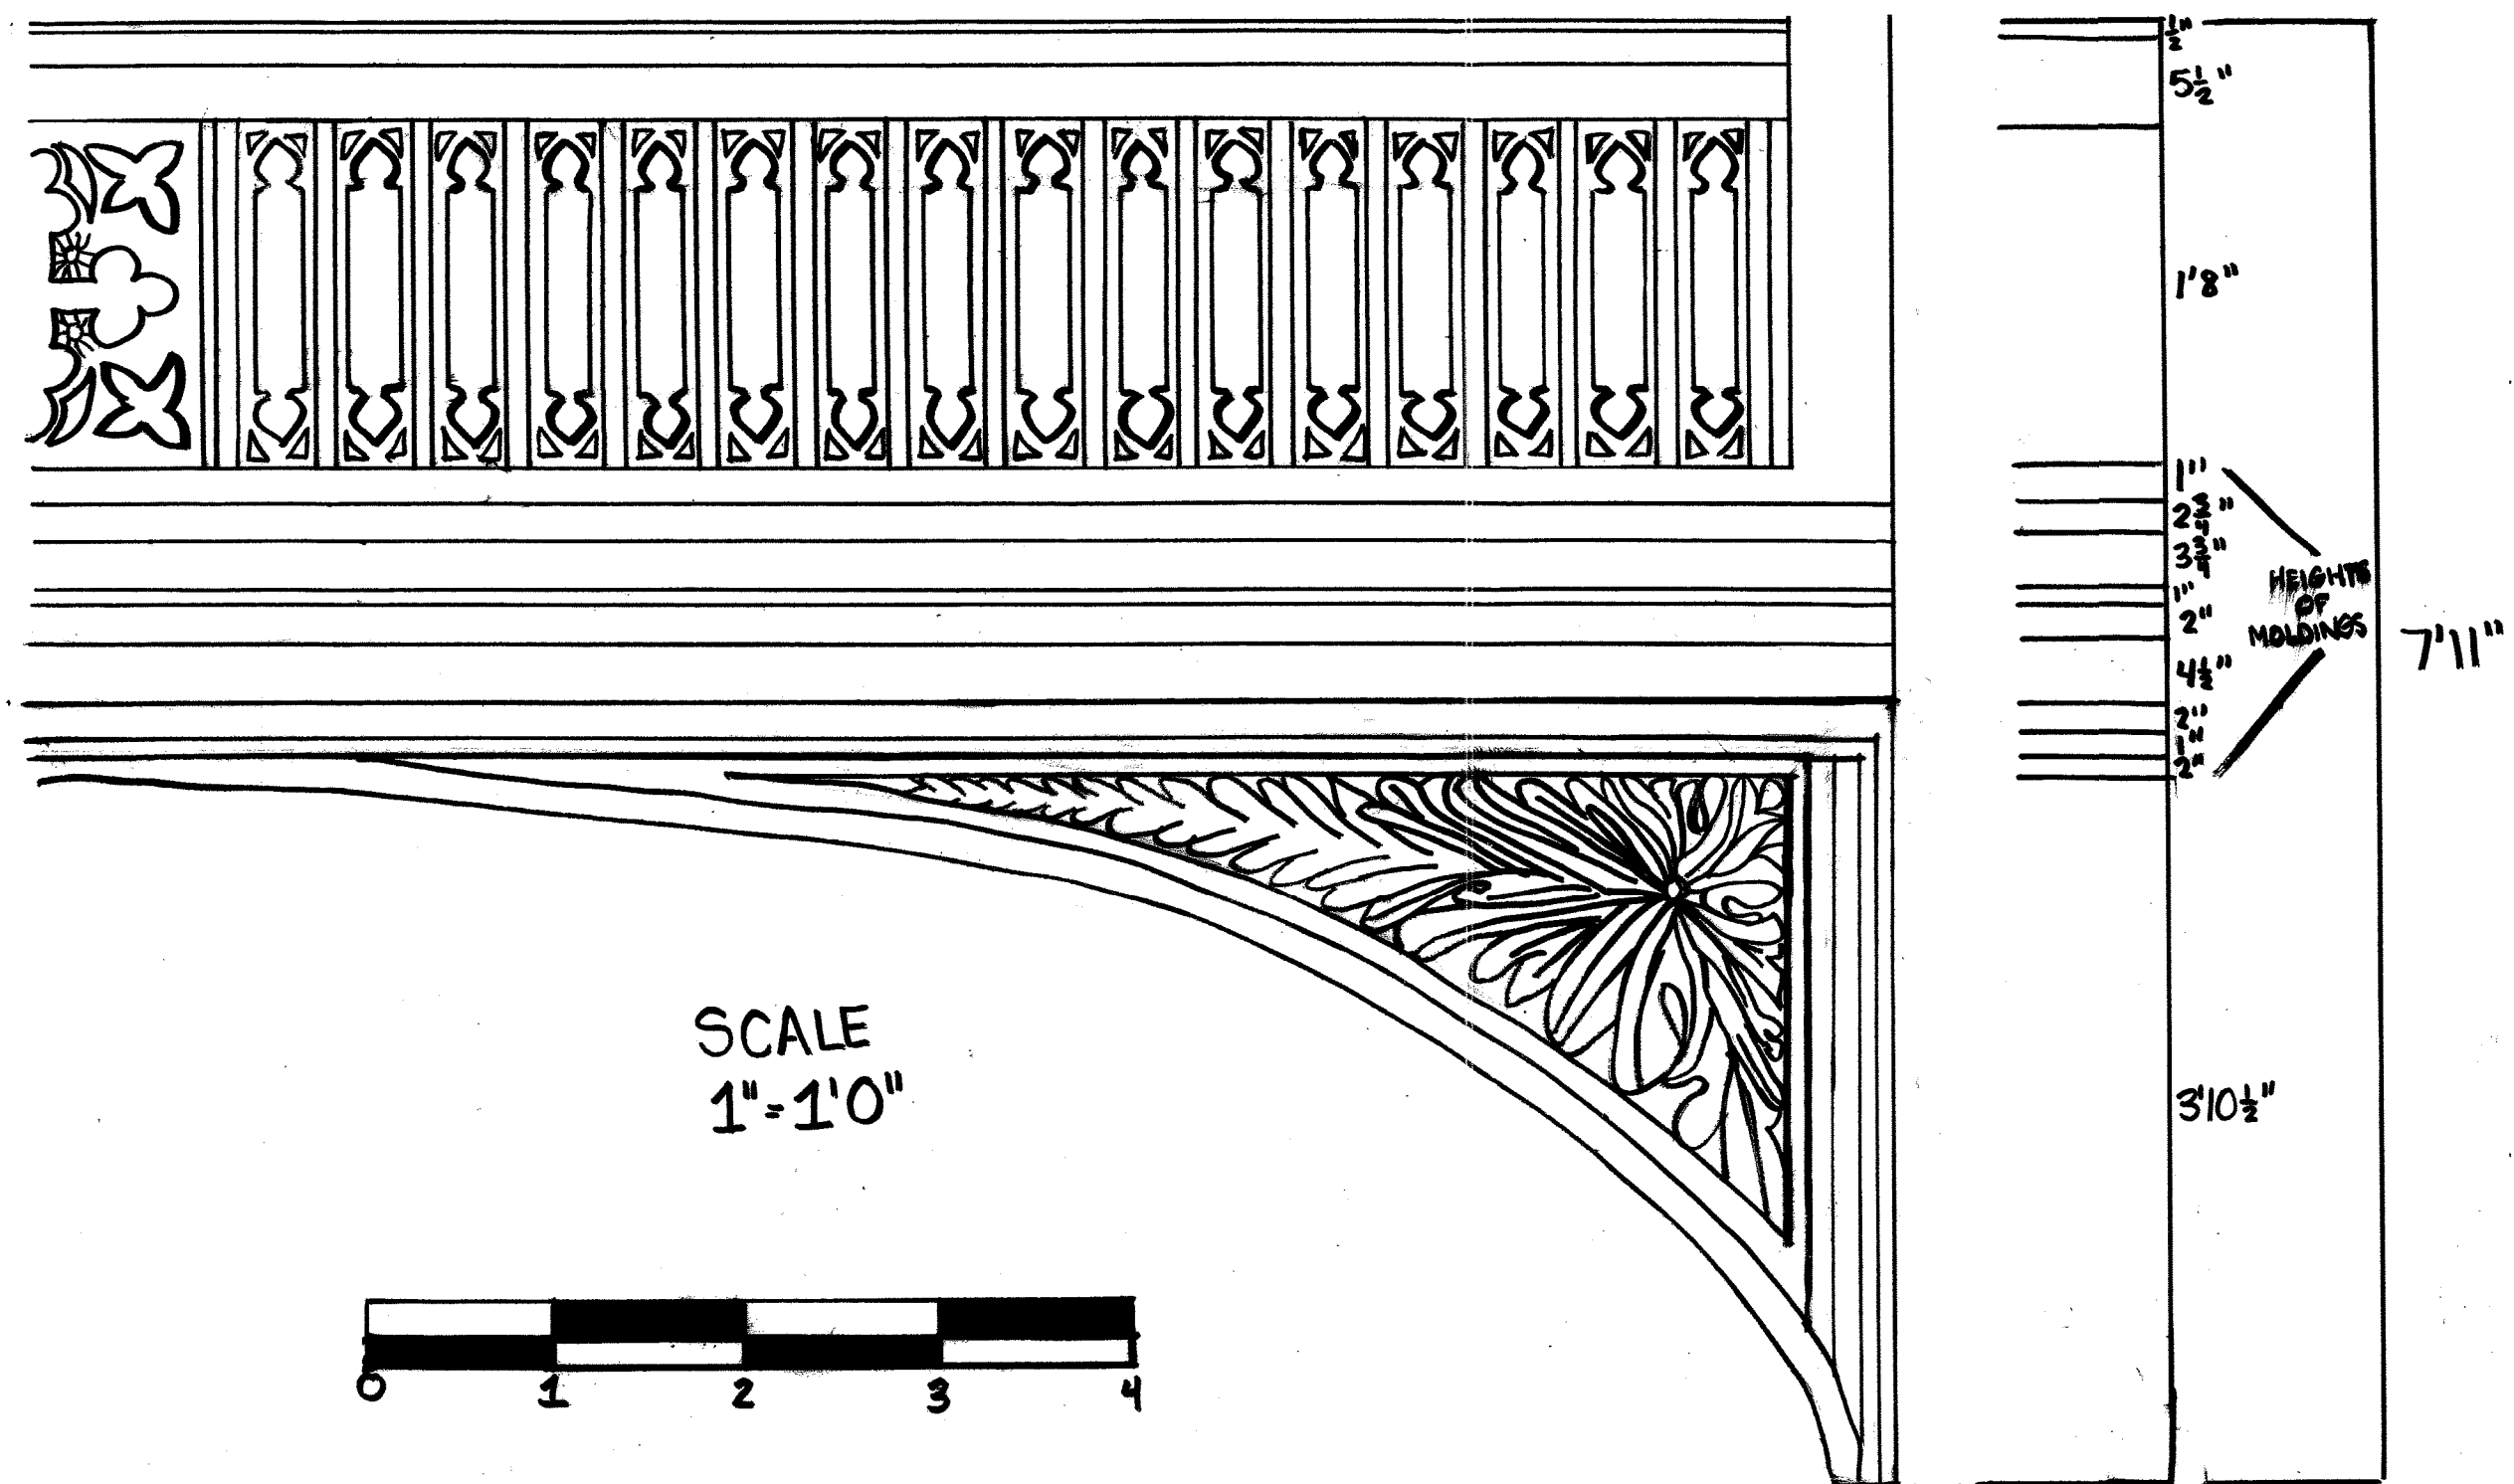
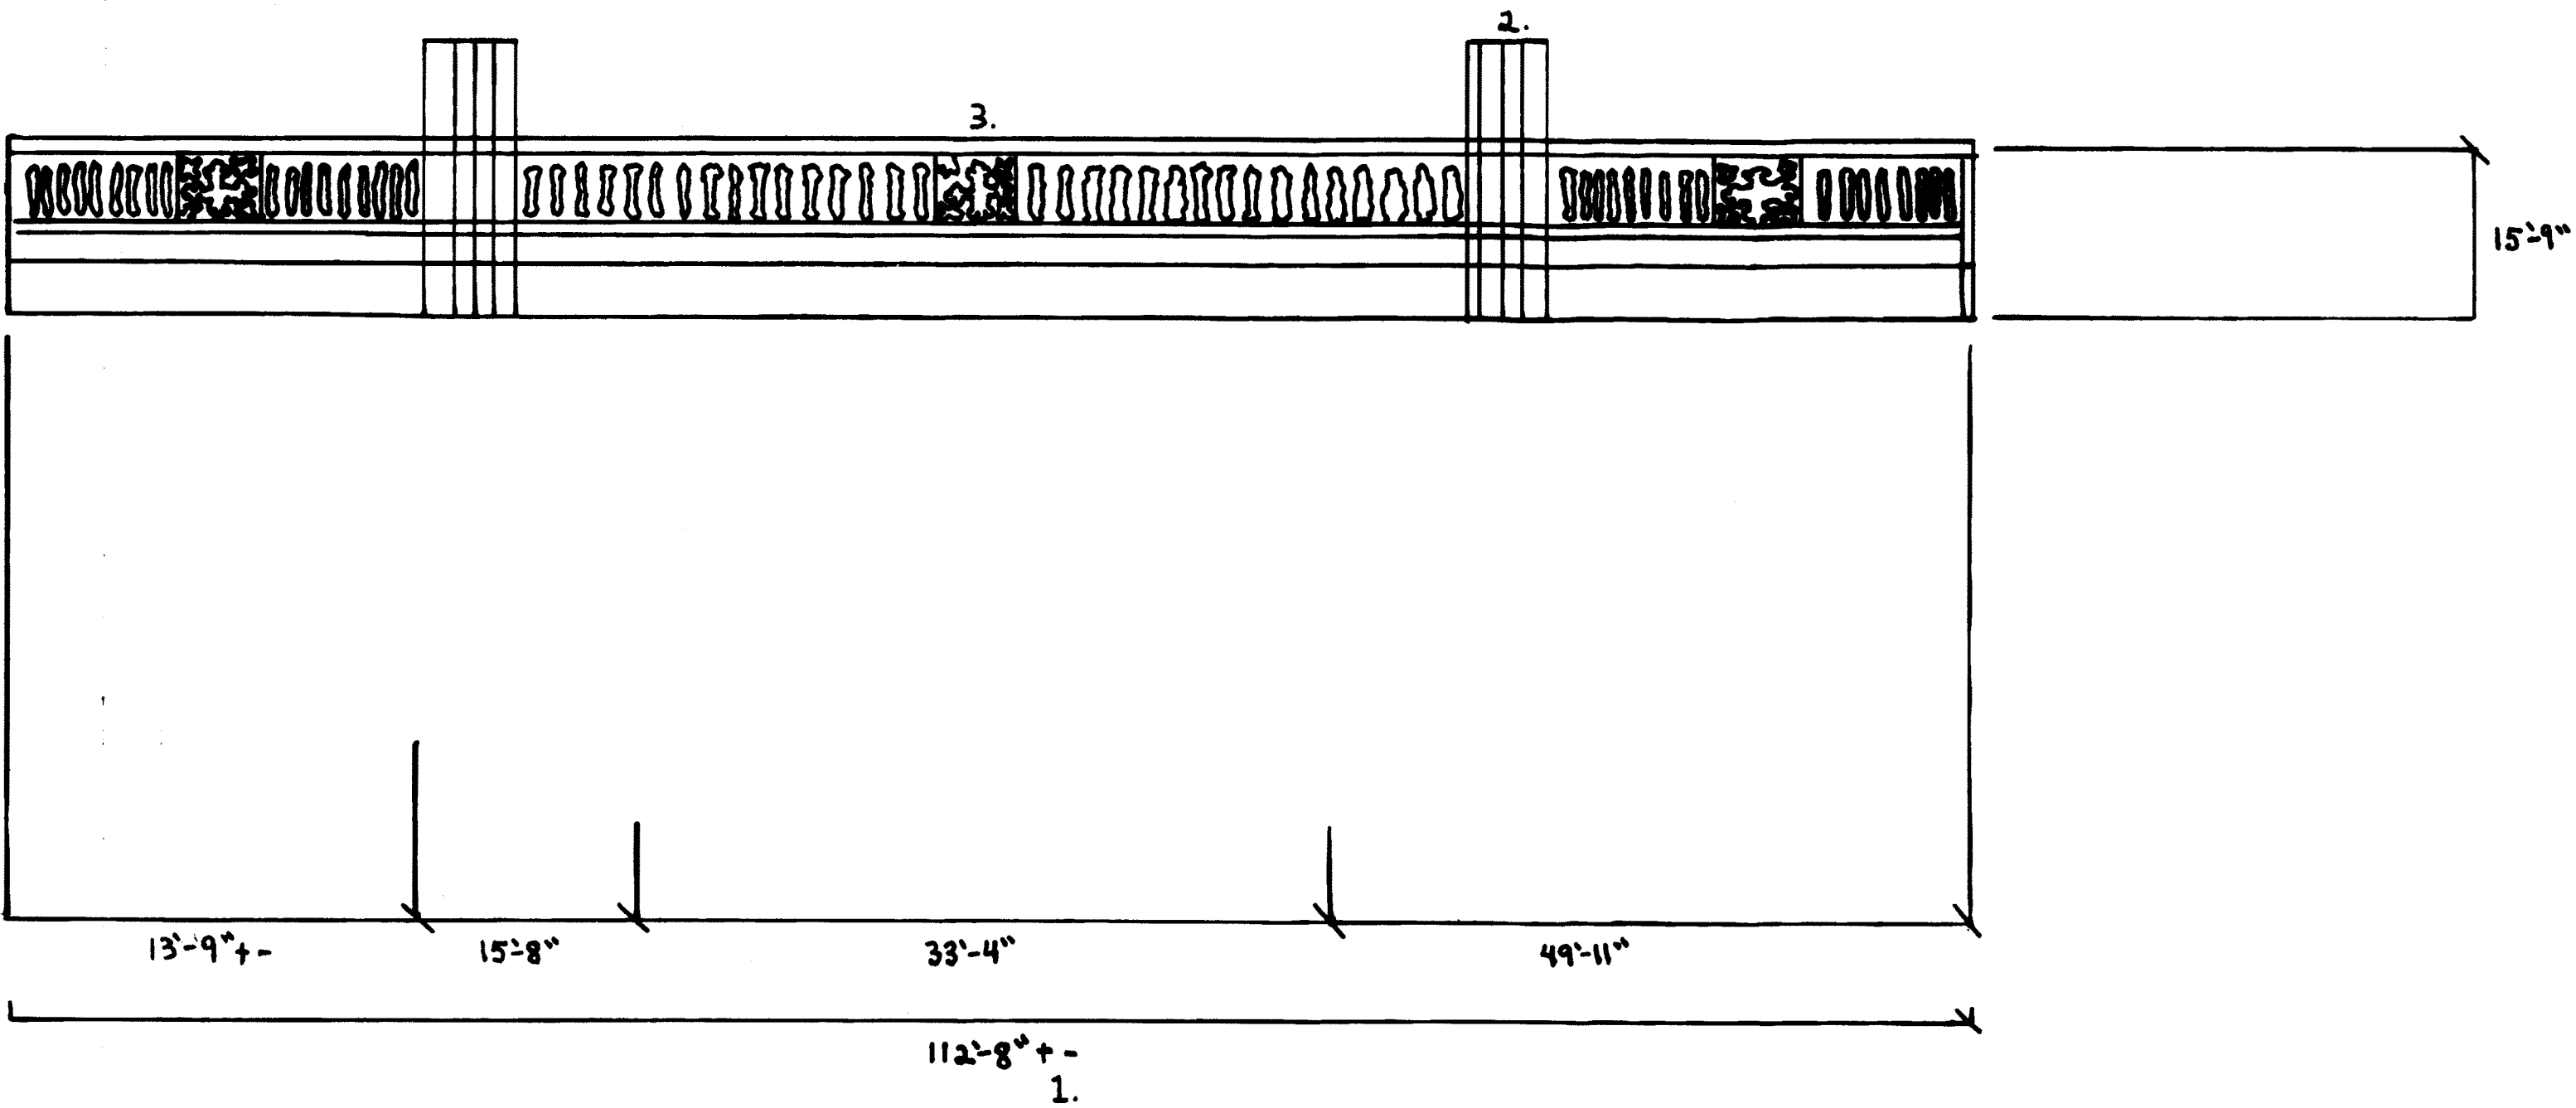
BALCONY RAILING AND SPANDREL

The impact of the detail featured in the drawing is to remain as historic as possible in its original state if possible. The condition needs proper care and changes need to be made in order to maintain the function of the balcony as well as its historic features and design. In order to preserve the balcony and its features, one needs to take into consideration the materials that were used in the initial construction, as well as to make sure that all necessary alterations and fixes are done in the proper manner to preserve its character.

As a preservationist, I would suggest using the West Systems to repair any affected areas on the balcony and surrounding detail, mainly because it appears to be the most affective. Sanding down the balcony for repainting also needs to be done in order to restore the entire finish of the wood. Proper paint needs to be matched as closely to the original paint as possible in order to keep as much historic character as possible. Any support that needs to be done for the entire structure also needs to be considered during repair. Always consider proper safety measures for the structure, and furthermore for whoever may be making the repairs to protect themselves from exposure to paint and other harmful agents.

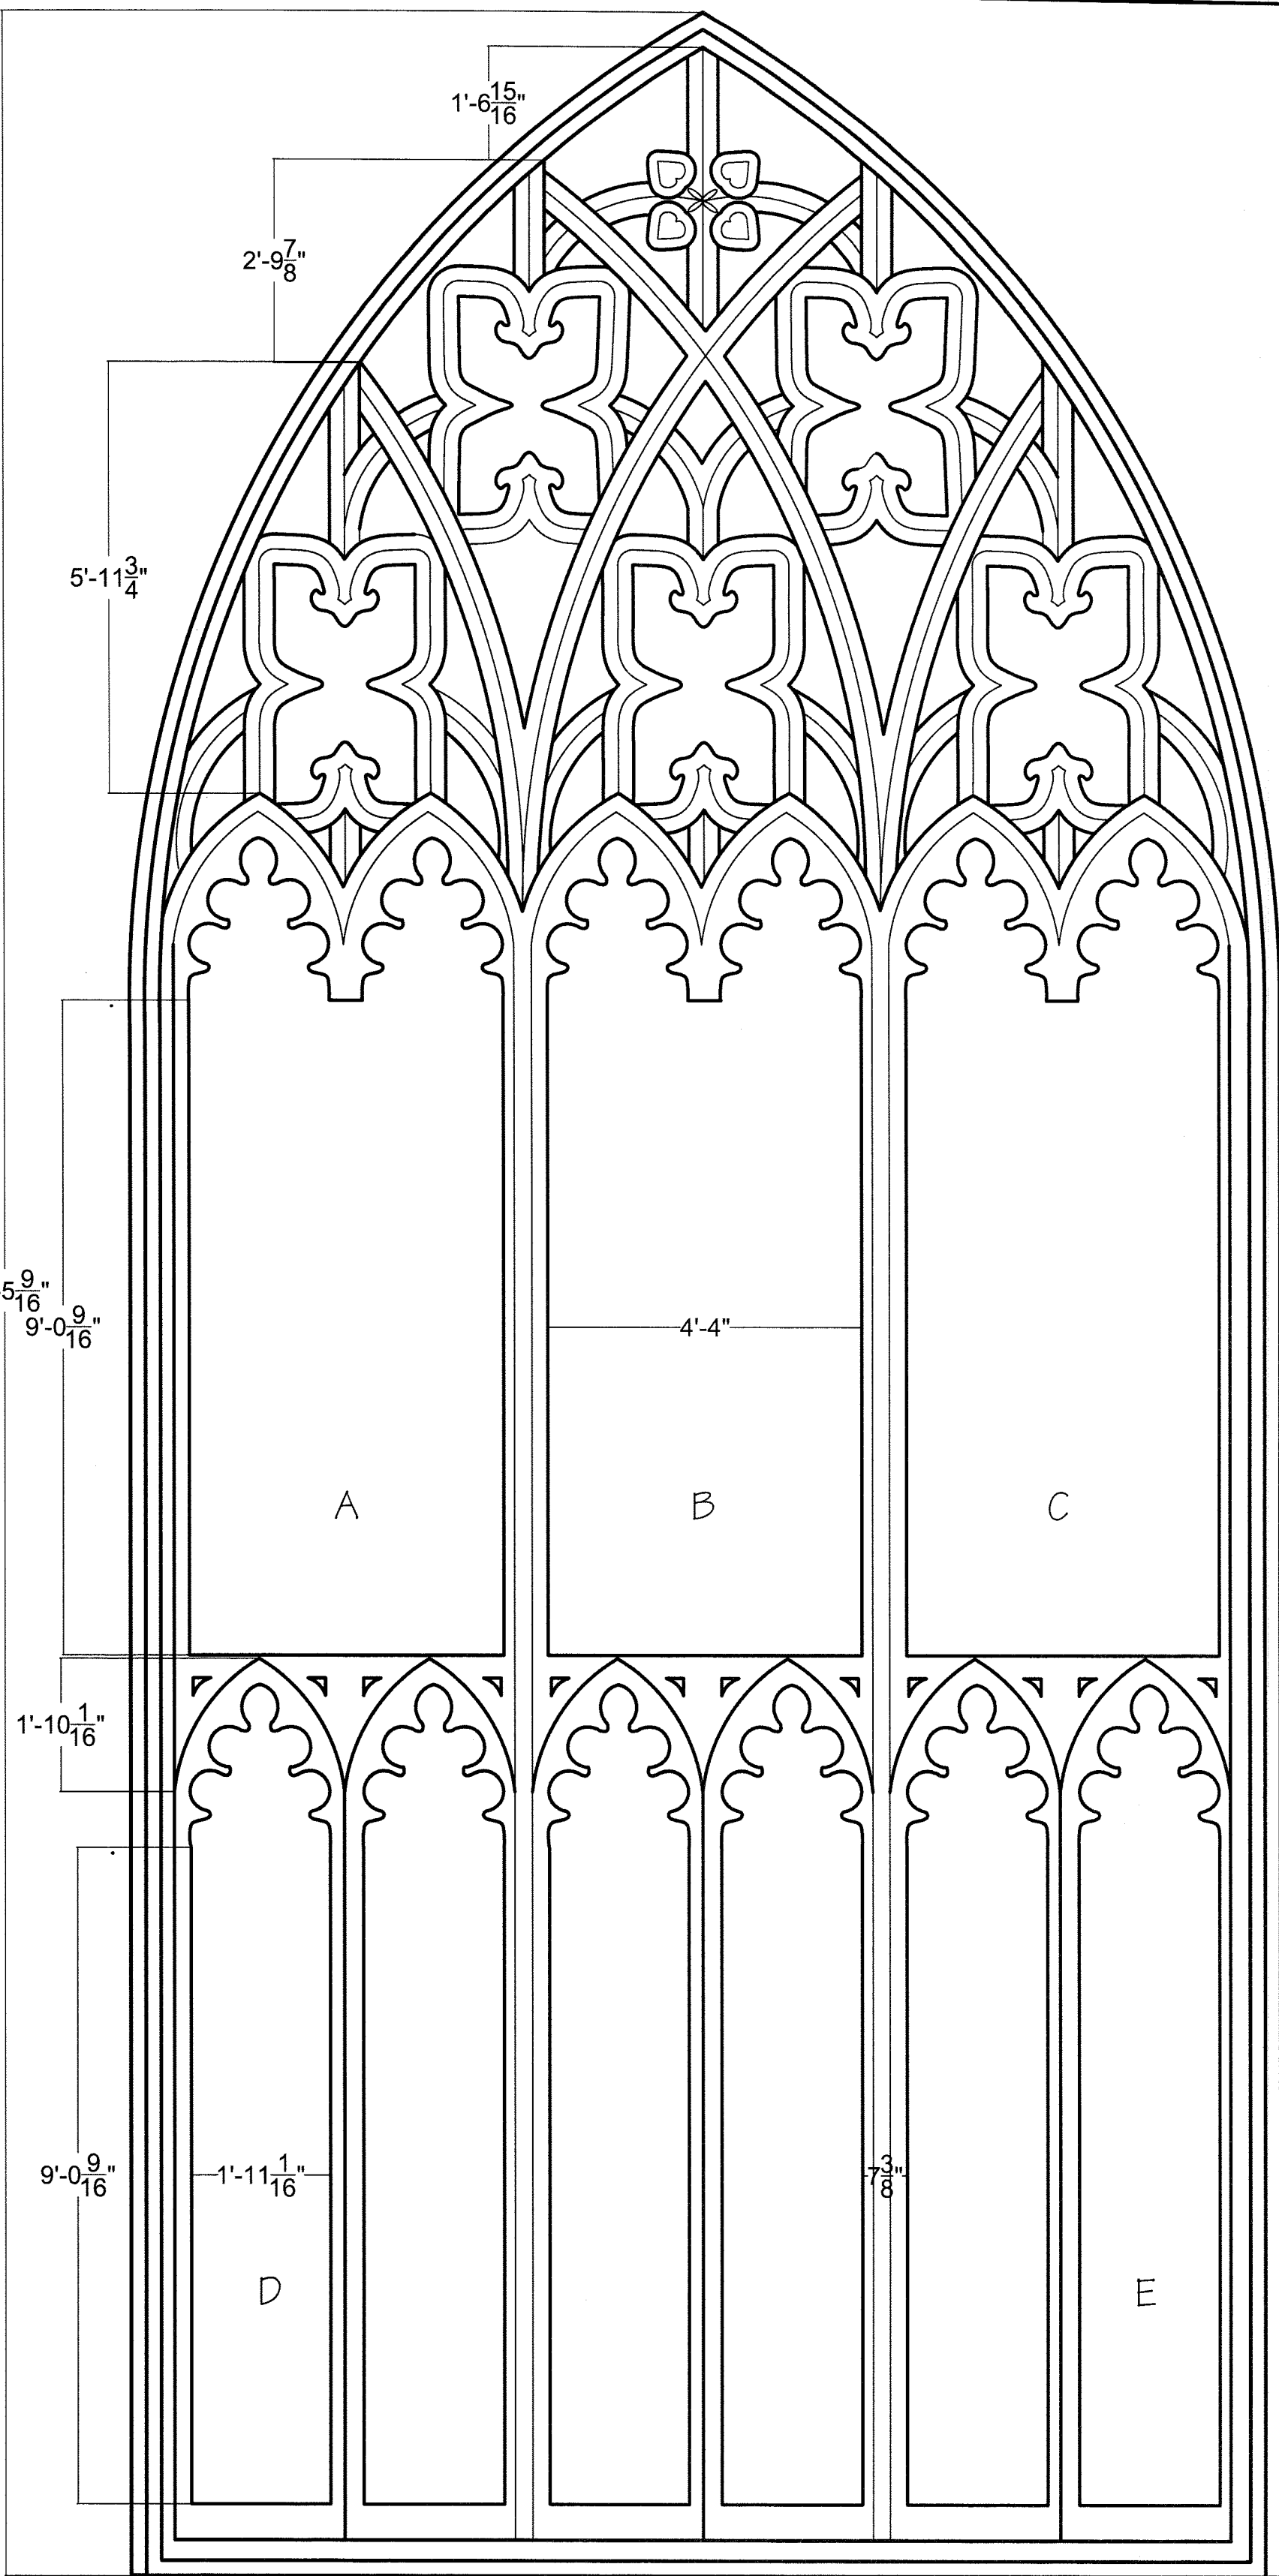
THE GREATEST THREAT TO THE WINDOW MATERIALS THEMSELVES IS PHYSICAL IMPACT. THIS IS ESPECIALLY TRUE AT NEW TABERNACLE WHERE THE WINDOWS TAKE UP SUCH A LARGE SURFACE AREA OF THE FACADES AND THE BUILDING IS LOCATED ON SUCH A PROMINENT STREET CORNER, UPPING ITS EXPOSURE TO FLYING ROCKS AND OTHER THREATS. GLASS CAN ALSO CRACK WHEN EXPOSED TO TOO MUCH PRESSURE OR VIBRATION FROM NOISE AND TRAFFIC. THE PAINTING ON STAINED GLASS IS ALSO AN IMPORTANT CONSIDERATION, AS THE WINDOWS SIGNIFICANCE IS REFLECTED IN THE SCENE IT PORTRAYS. IMPROPERLY FIRED GLASS CAN LEAD TO PAINT DETERIORATION AND FLAKING. THIS WINDOW IS MADE OF PAINTED GLASS AND THEREFORE MUST BE CLEANED VERY GENTLY.

THE WINDOWS AT NEW TABERNACLE ARE FRAMED IN WOOD WHICH LEADS TO SEVER- AL ISSUES. MOISTURE INTRUSION IS PARTICULARLY EVIDENT AT WINDOW OPENINGS AND AS THE WOOD ROTS IT BECOMES A THREAT TO THE INTEGRITY OF THE ENTIRE STRUCTURE.

THE WINDOWS SHOULD BE GENTLY CLEANED AND THE PROPER PRECAUTIONS SHOULD BE USED TO REINFORCE THE WATERPROOFING AROUND AND WITHIN THE WOODEN FRAME. THIS MAY REQUIRE RECAULKING OF THE STRUCTURE AND A RE- POINTING OF THE SURROUNDING MASONRY. THE GLAZING WHICH ADHERES THE LEAD CAME TO THE GLASS SHOULD ALSO BE CHECKED FOR CONDITION AND THE PROPER REPAIRS SHOULD BE MADE.

SOME STEPS HAVE BEEN TAKEN TO PROTECT THE GLASS AT NEW TABERNACLE. LEX- AN WINDOW COVERS WERE PLACED ON THE EXTERIOR OF THE WINDOWS TO PROTECT THEM FROM FLYING DEBRIS, BUT THE RESULT, ALTHOUGH IN LINE WITH NATIONAL STANDARDS, DOES LITTLE TO SHOWCASE THE BEAUTY OF THE BUILDING. ALTERNA- TIVE METHODS OF PROTECTION SHOULD BE EXPLORED AND STEPS SHOULD BE TAK- EN TO ALLOW PASSERBY TO REDISCOVER THE BEAUTY OF NEW TABERNACLE. THERE ARE OTHER TYPES OF PLASTIC AND GLASS COVERINGS THAT WILL MORE READILY SHOWCASE THE STAINED GLASS. METHODS AS SIMPLISTIC AS GUARDING THE WIN- DOWS WITH CHICKEN WIRE OFFER AN INEXPENSIVE AND NON OBTRUSIVE MEANS TO SHIELDING THE WINDOWS FROM FURTHER HARM.

IMPROPERLY CARED FOR GLASS AND LEAD CAME ARE MUCH MORE LIKELY TO DE- TERIORATE. YET, IT IS IMPORTANT TO MAINTAIN THAT THE WINDOWS ARE CARED FOR IN THE GENTLEST MEANS POSSIBLE, AS HARSH CHEMICAL SUBSTANCES CAN RE- MOVE PAINT AND LEAD TO FURTHER LEAD CAME CORROSION. THE WINDOWS NOW, HAVE NOT BEEN PROPERLY CLEANED AND THE DIRT AND DEBRIS IS LEADING TO A MORE RAPID BREAKDOWN OF THE PAINTED SCENES. MAINTENANCE, PROTECTION AND PRESERVATION SHOULD START BY CONTACTING A CERTIFIED STAINED GLASS STUDIO TO EVALUATE THE WINDOWS. AFTER THE INITIAL EVALUATION A PRESER- VATION AND MAINTENANCE PLAN SHOULD BE MADE SPECIFIED TO THE WINDOWS. THE SPECIALIST CAN ALSO COME UP WITH A CLEANING PLAN FOR THE CONGREGATION. IT IS RECOMMENDED THAT THE SPECIALIST CHECK UP ON THE WINDOWS EVERY FIVE YEARS

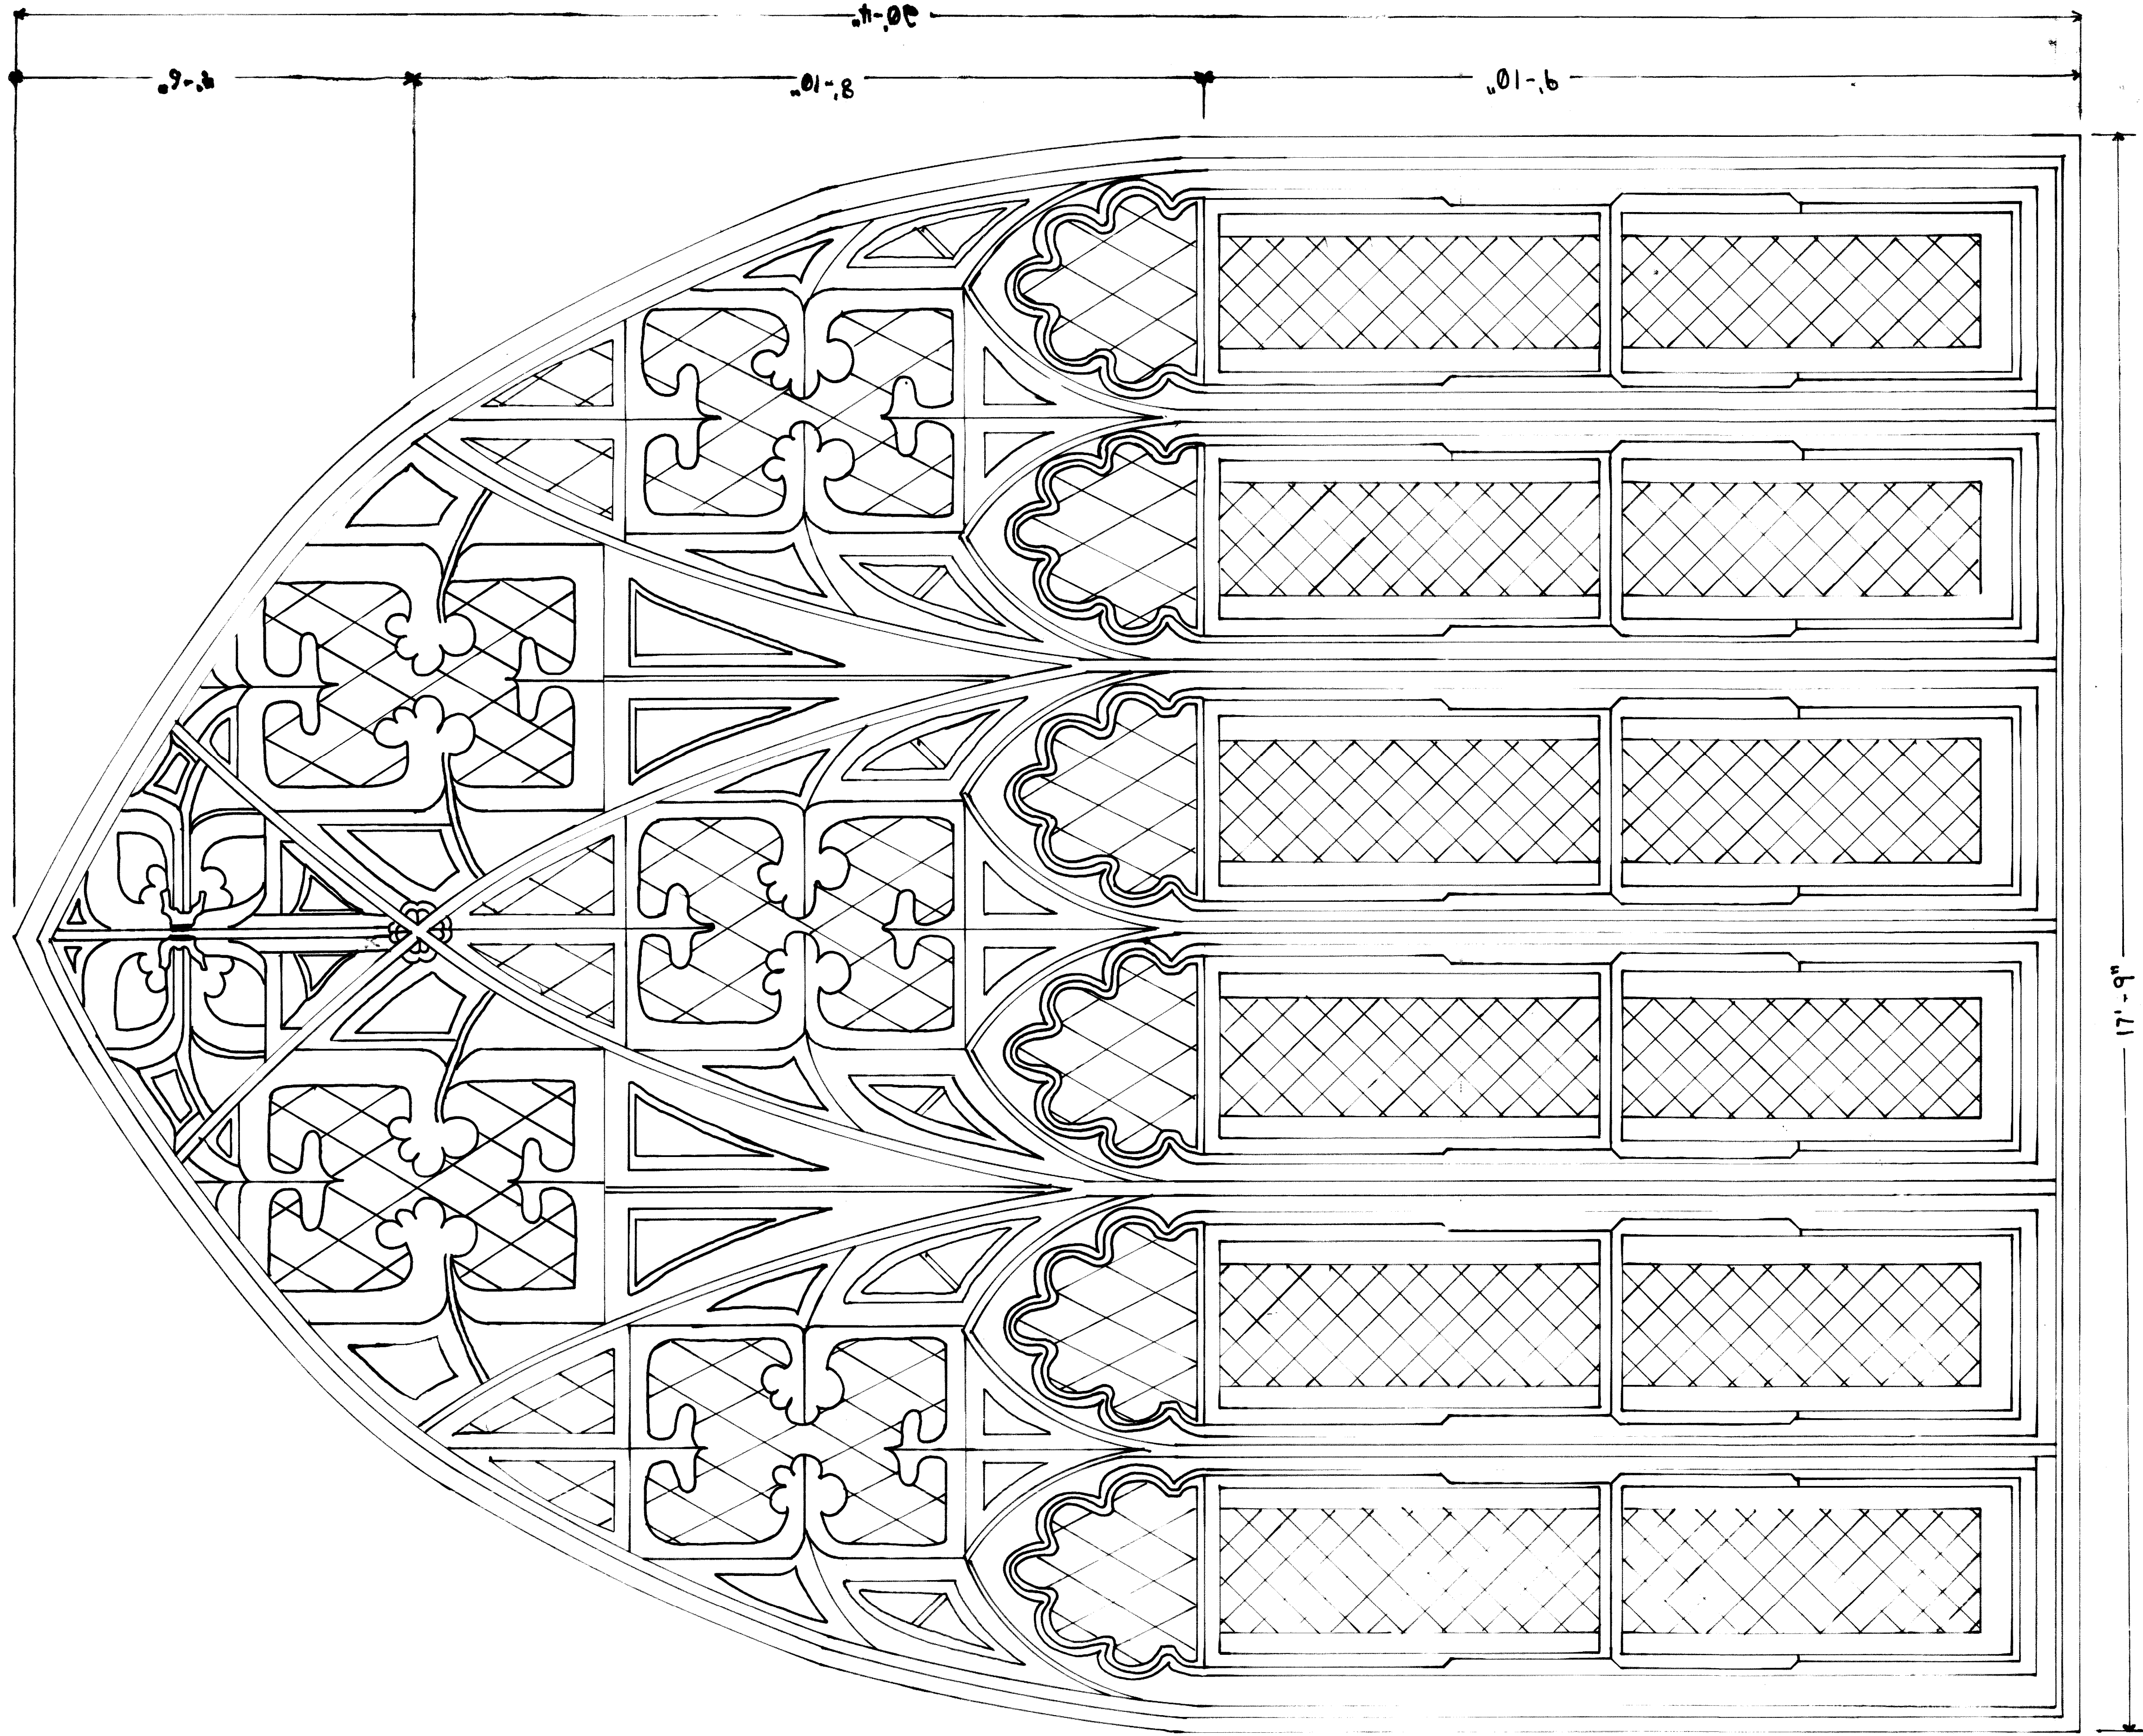
DETAILED ELEVATIONAL
STAINED GLASS WINDOW

- THIS STAINED GLASS WINDOW, LIKE MOST, HAS A SECONDARY LAYER OF PROTECTIVE GLAZING ON THE EXTERIOR KNOWN AS LEXAN.
- LEXAN GLAZING WAS PROMOTED AS AN EFFECTIVE MEANS TO PROTECT AGAINST VANDALISM, WEATHERING, AND IMPROVING THERMAL PERFORMANCE.
- LEXAN HAS BEEN FOUND THROUGH RECENT STUDIES TO HINDER PROTECTION BECAUSE IT'S BLOCKS THE AIR FLOW, ALLOWS MORE CONDENSATION AND HEAT BUILD UP IN THE AIR SPACE, AND PREVENTS MAINTENANCE.
- TO RESOLVE THIS, IT'S RECOMMENDED THAT PROTECTIVE GLAZING NOT BE USED, AND IF NEEDED WHEN POSSIBLE TO VENT THE AIRSPACE AND ALLOW EXTERIOR CIRCULATION, ALLOWING THE EXTERIOR PORTIONS OF THE WINDOW TO BREATHE.

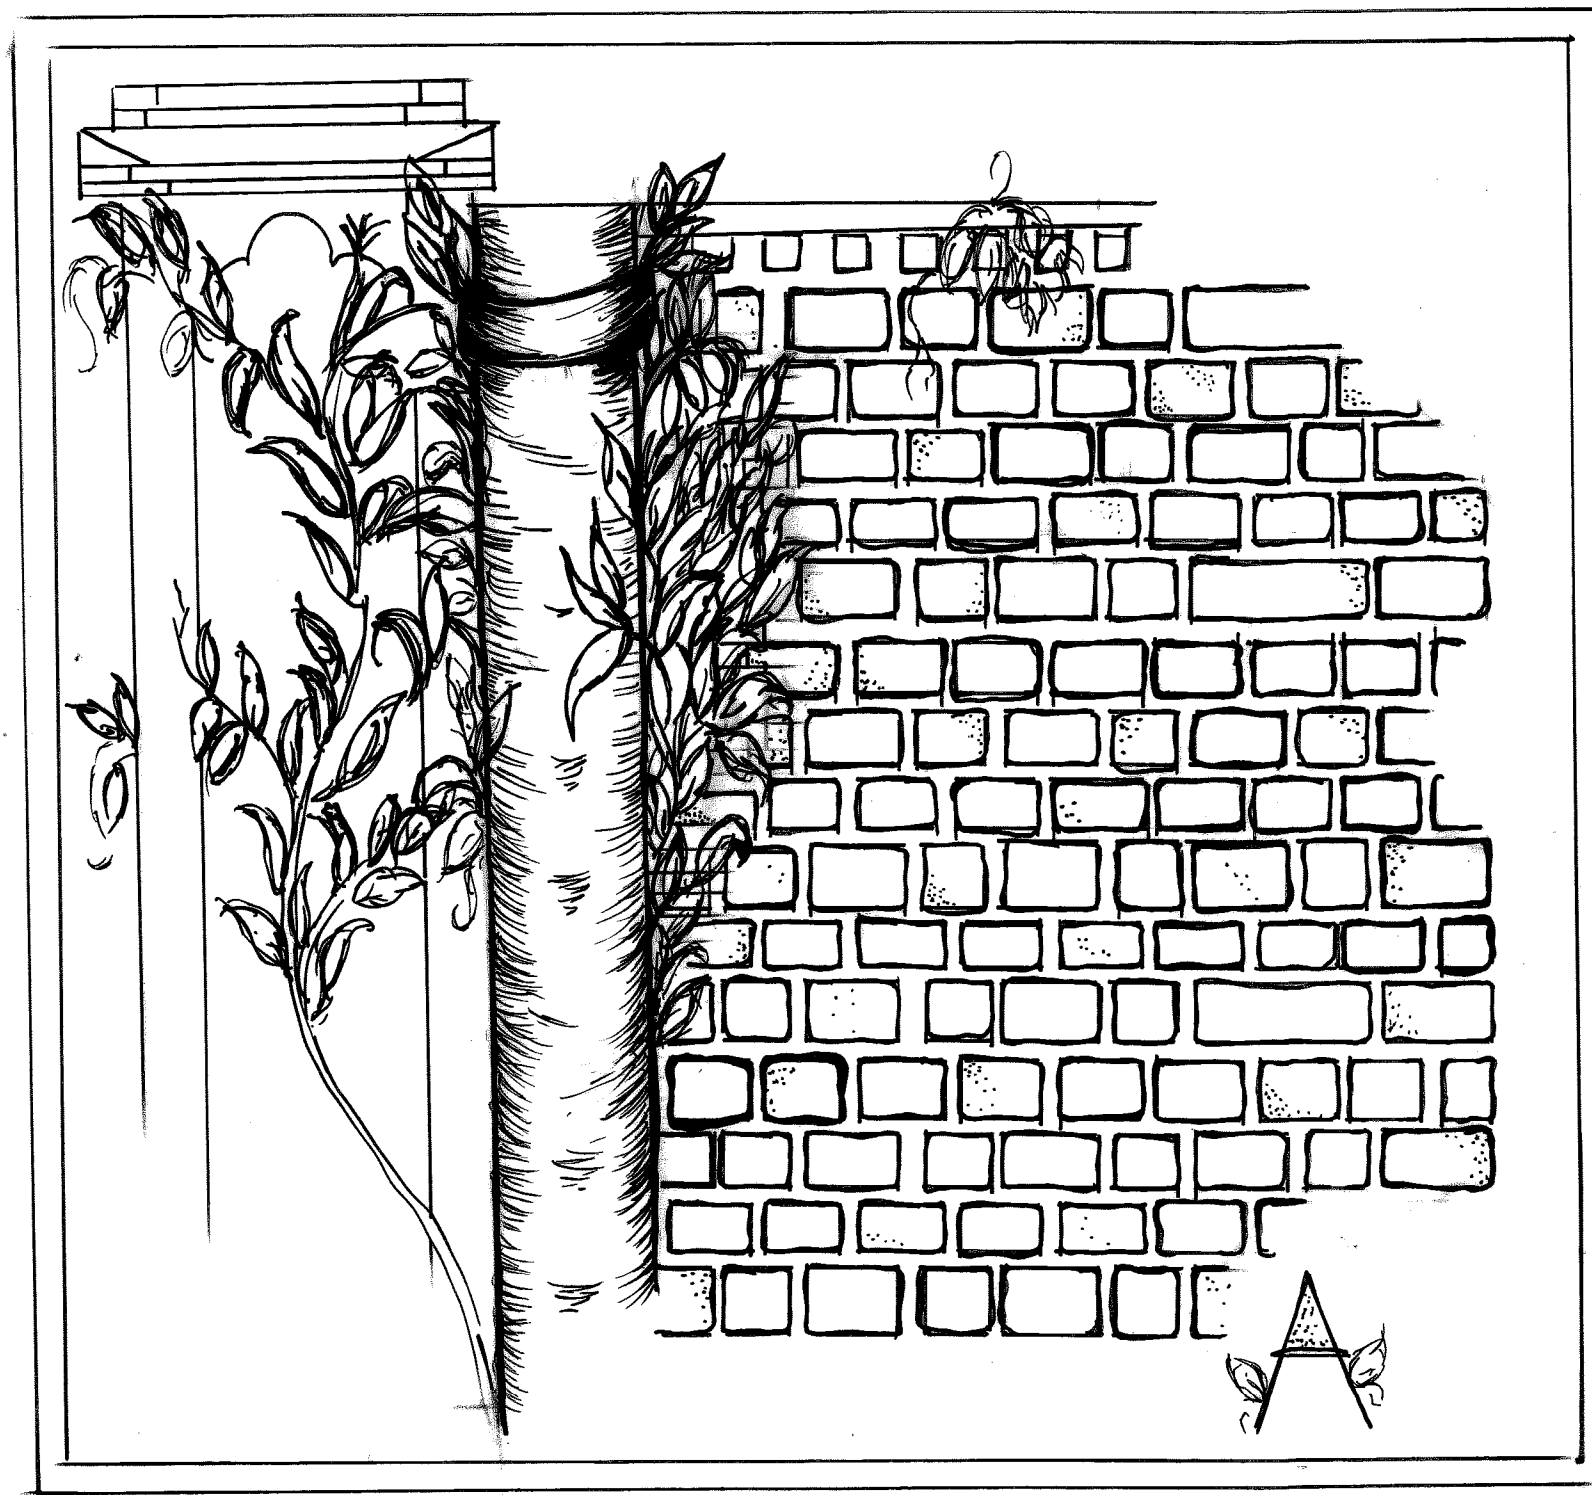
BY COMBINING BOTH WATER DAMAGE AND RISING DAMP TOGETHER THE CHURCH WILL CONTINUE TO SEE PLANT GROWTH ISSUES. AS SEEN IN BOTH DETAILS, THE CHURCH ACTUALLY HAS VINES AND OTHER GROWTH WITHIN THE STRUCTURE (BRICKS, WALLS, FOUNDATION). THIS CAN BE DETRIMENTAL TO THE CHURCH'S FURTHER USE AND WELL BEING.

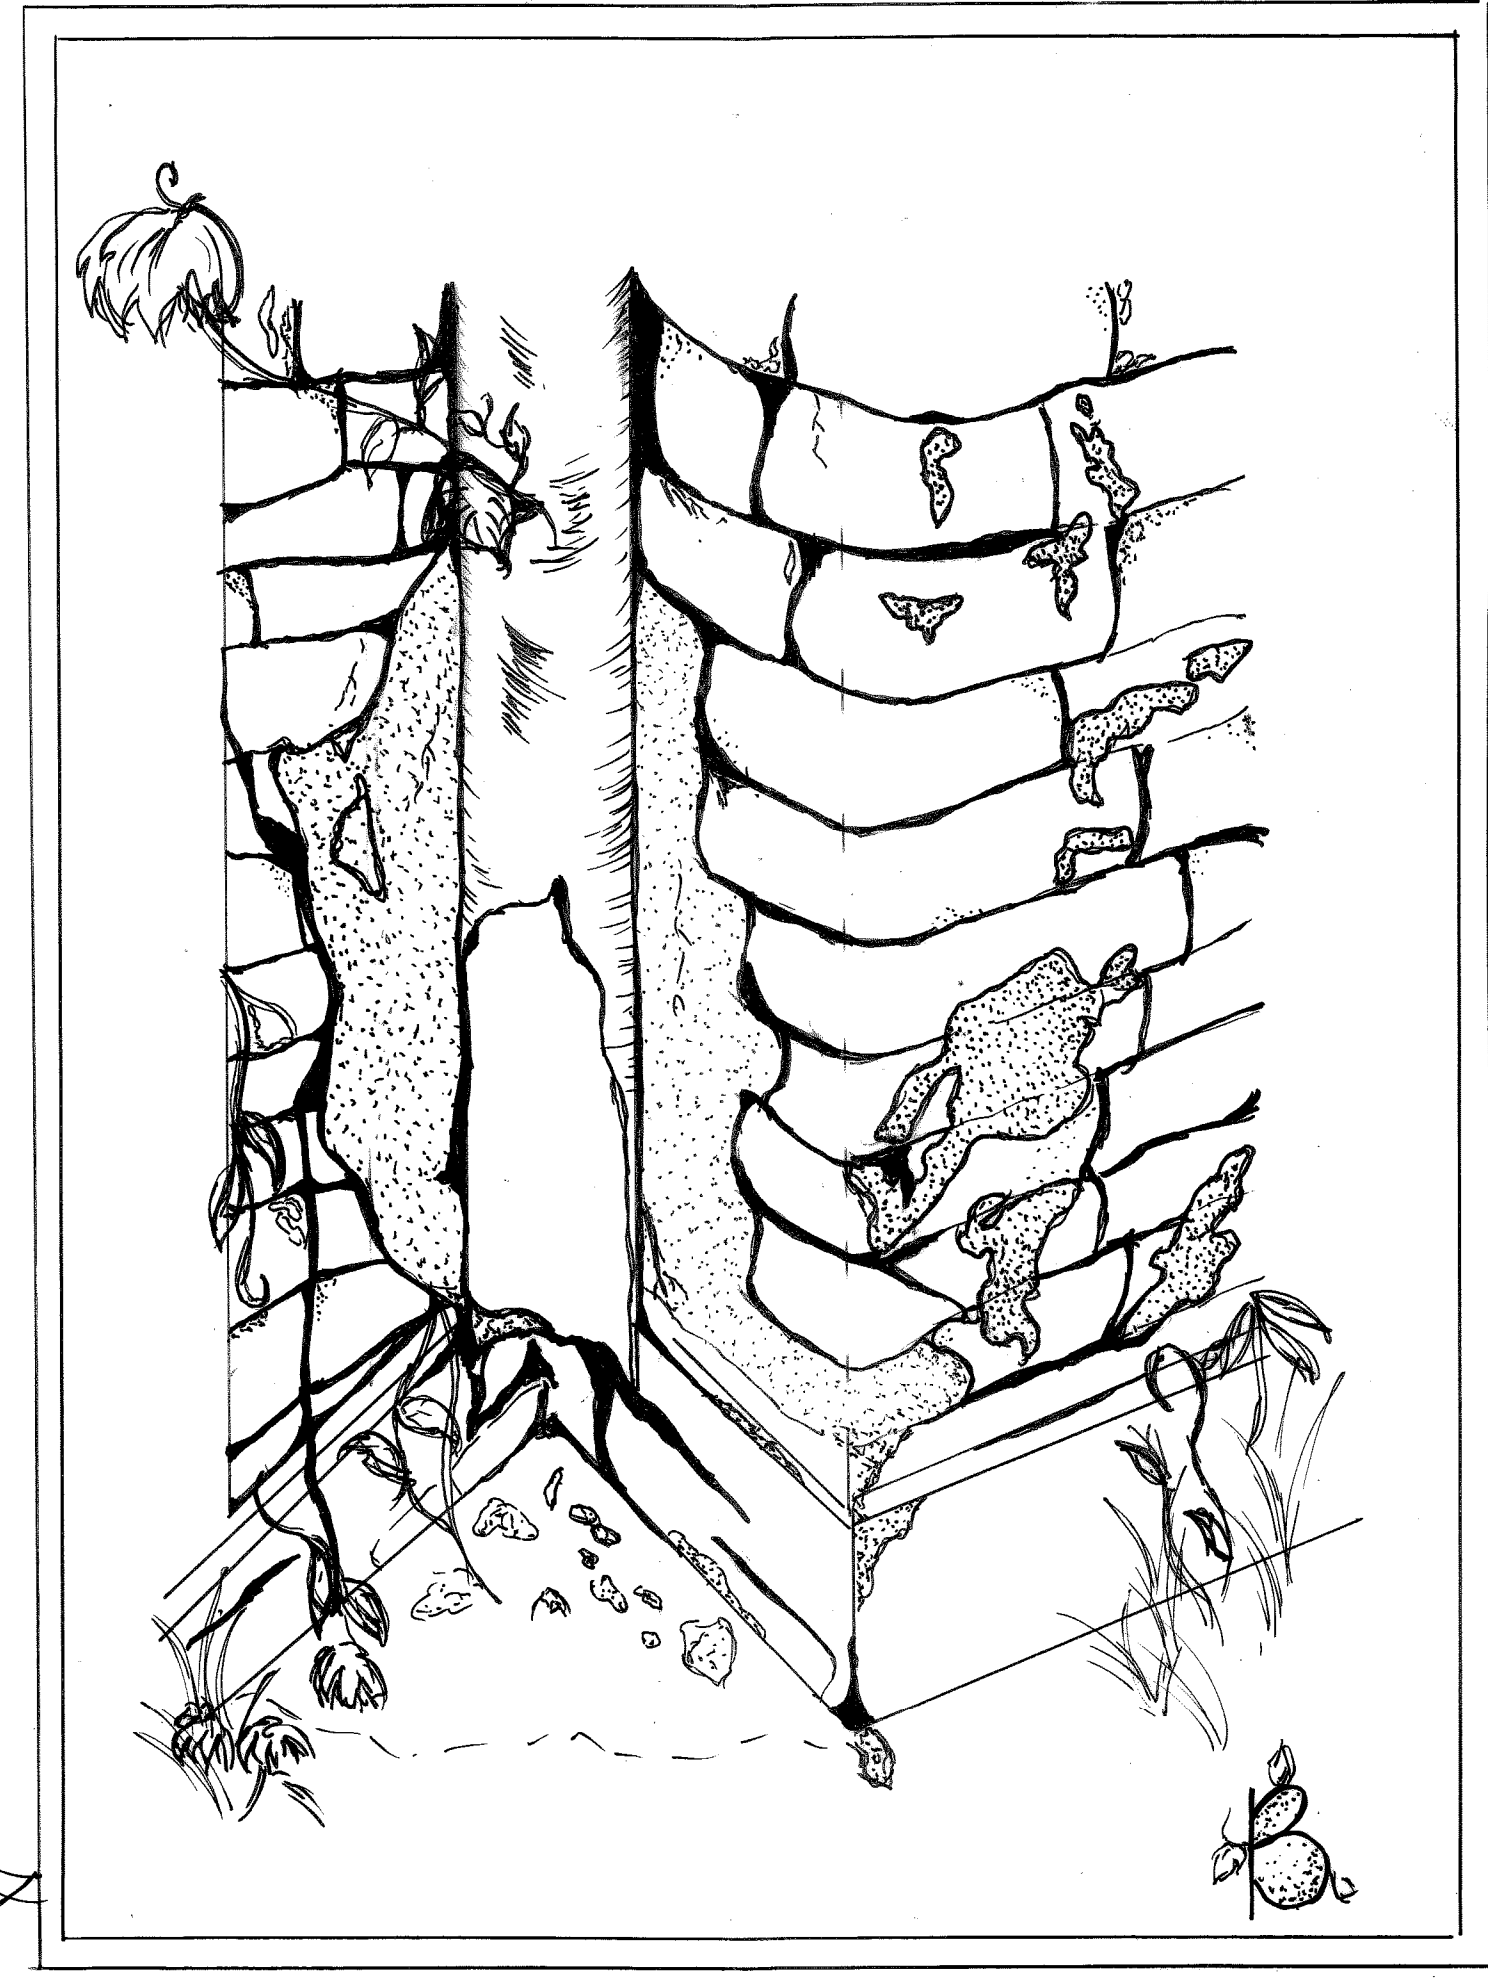
WATER DAMAGE

IMPROPER DRAINAGE SYSTEMS, SEEN IN BOTH DETAIL DRAWING, HAVE CAUSED DETERIORATION OF THE BRICK AND FOUNDATION. BY LEAVING GUTTERS AND OTHER FORMS OF DRAINAGE IN DISREPAIR THE CHURCH WILL CONTINUE TO DETERIORATE.
