HISTORIC AMERICAN BUILDING SURVEY
NEW TABERNACLE FOURTH BAPTIST CHURCH
HABS #SC-535

Documentary Drawings for New Tabernacle Fourth Baptist Church (Old St. Luke's Episcopal Church)

Prepared by the College of Charleston Historic Preservation
and Community Planning Program
HPCP 299 - Spring 2013
James L. Ward, Assistant Professor

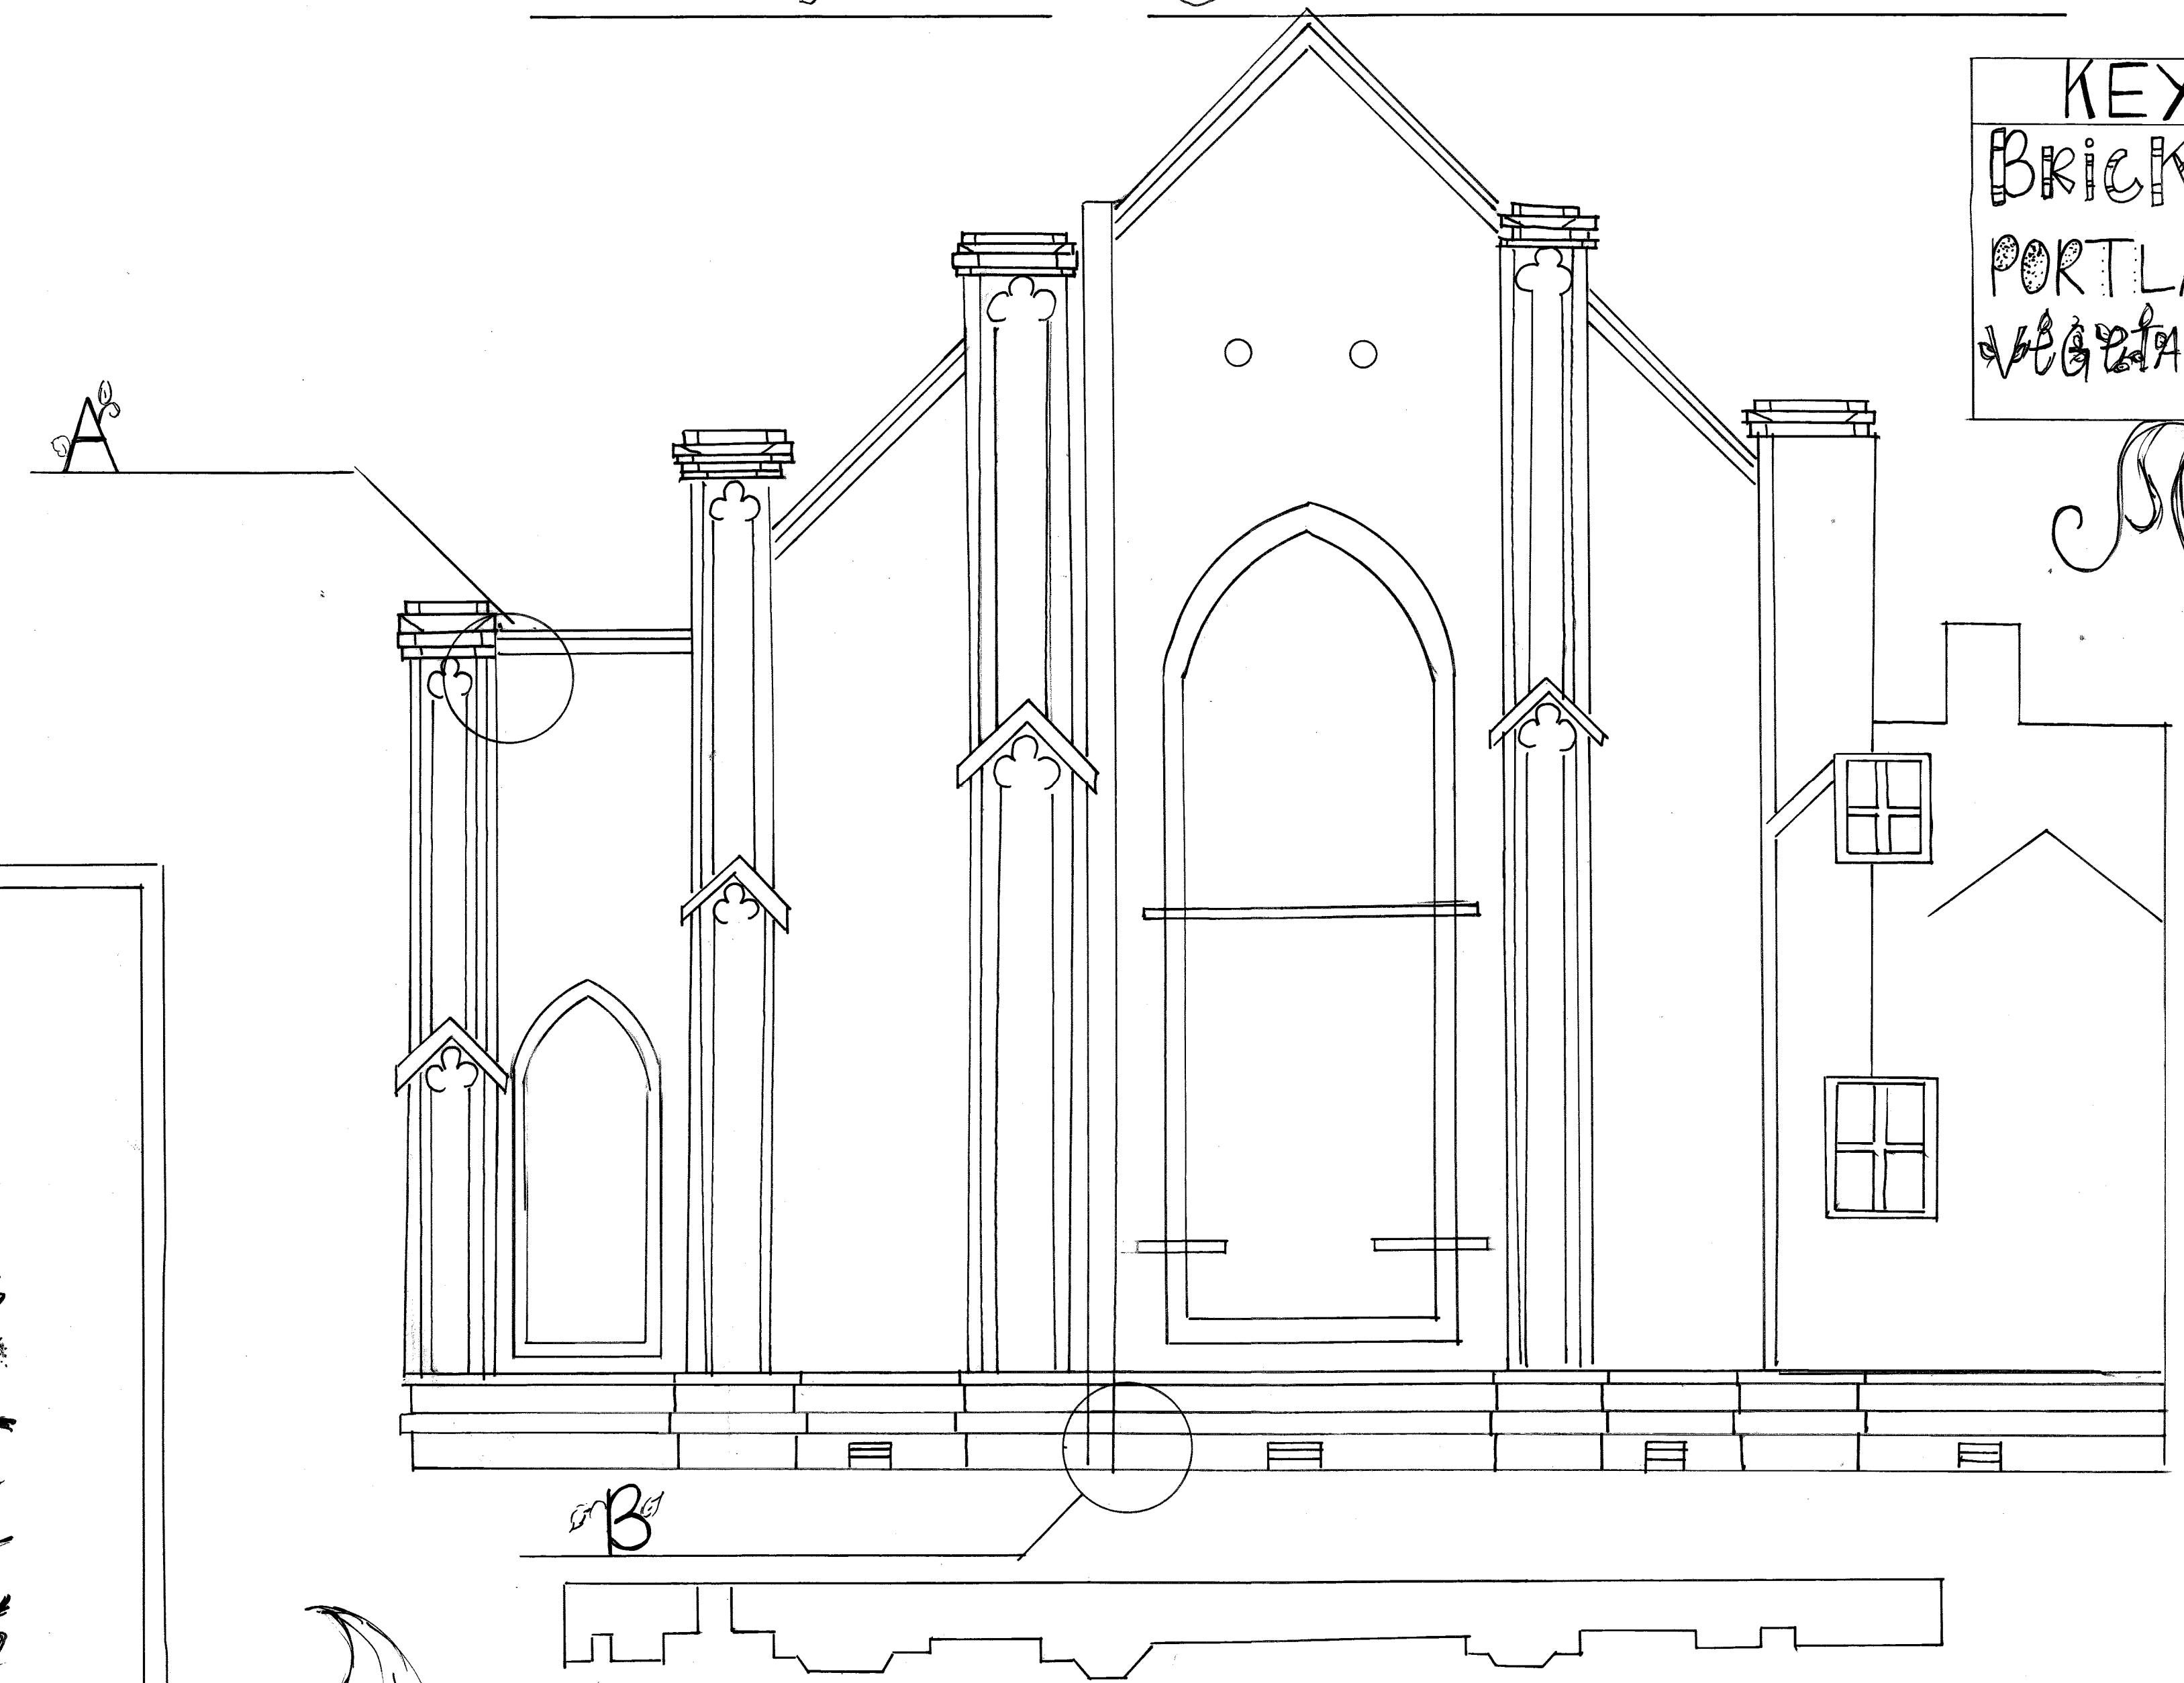
RISING DAMP

ACCURSE WHEN MOISTURE FROM THE OUTSIDE OR CONDENSATION A STRUCTURE DETERIORATES THE BUILDING HSELF. DO TO THE CHURCH'S EXPOSED POROUS BRICK THE STRUCTURE HAS SUFFERED GREATLY. IN ORDER TO CORRECT IS THE CHURCH'S BRICKS WILL HAVE TO BE COVERED BY A SEALANT OR STUCCOED TO PROTECT AGAINST FURTHER EROSION.

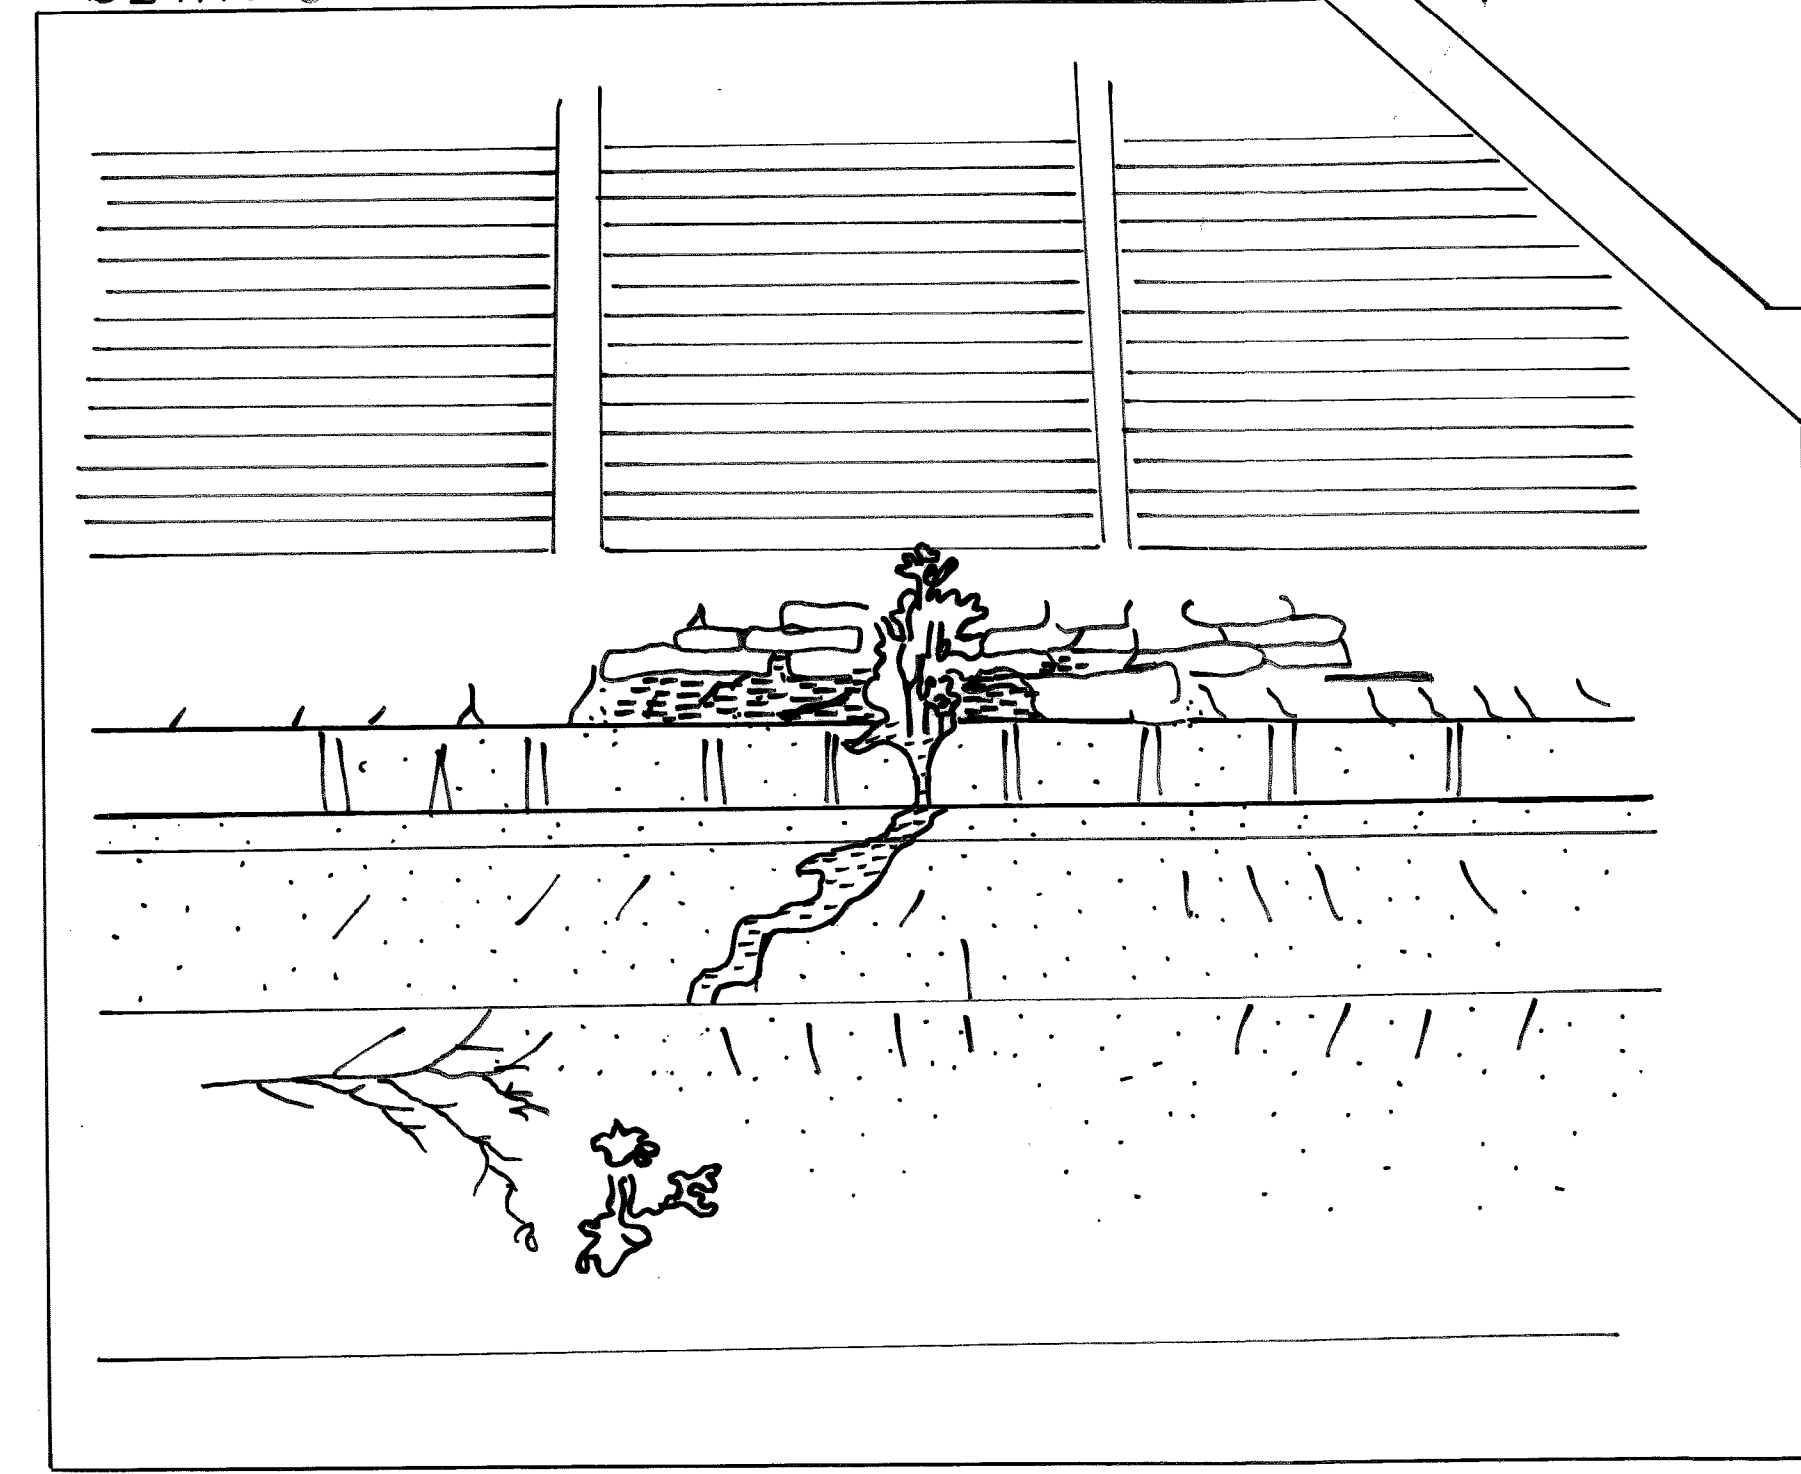
DETAIL B HELPS TO ILLUSTRATE WHAT THE MAJORITY OF THE CHURCH IS FACING. THE EXCESSIVE USE OF PORTLAND CEMENT COMBINE WITH IMPROPER REPAIRS HAS DAMAGED THE CHURCH'S ORIGINAL BRICK. THIS CAN ONLY BE FIXED BY REPOINTING OF THE EXISTING BRICK
