PROFESSOR JAMES WARD		DRAWING TITLE:	
2 BULL STREET		CHARLESTON, SOUTH CAROLINA	
ASSIGNMENT NO.:	DRAWING PREPARED BY: V. KNISELY, K. HILLOCK, M. LAVAGHINA	SCALE: SEE NOTES	SHEET:
DATE: 4-14-07	REVISIONS		
REV.	DESCRIPTION	DATE	APPROVED
4-14-07	ELEVATIONS WEST & SOUTH

2 BULL STREET BACK PORCH DETAIL

JAMES L. WARD ASSISTANT PROFESSOR		BULL & COMING STREET RESIDENCE HALLS	
COLLEGE OF CHARLESTON ARTH 299-SPRING 2007		DRAWING TITLE: #2 BULL ST. BACK PORCH DETAIL	
HISTORIC PRESERVATION & COMMUNITY PLANNING		DRAWING PREPARED BY (TEAM/INDIVIDUAL): MORGAN LAUGHLIN	
ASSIGNMENT NO:		DATE:	04-13-07
SCALE:	3/4"=1'	SHEET:	
REVISIONS			
REV	DESCRIPTION	DATE	APPROVED

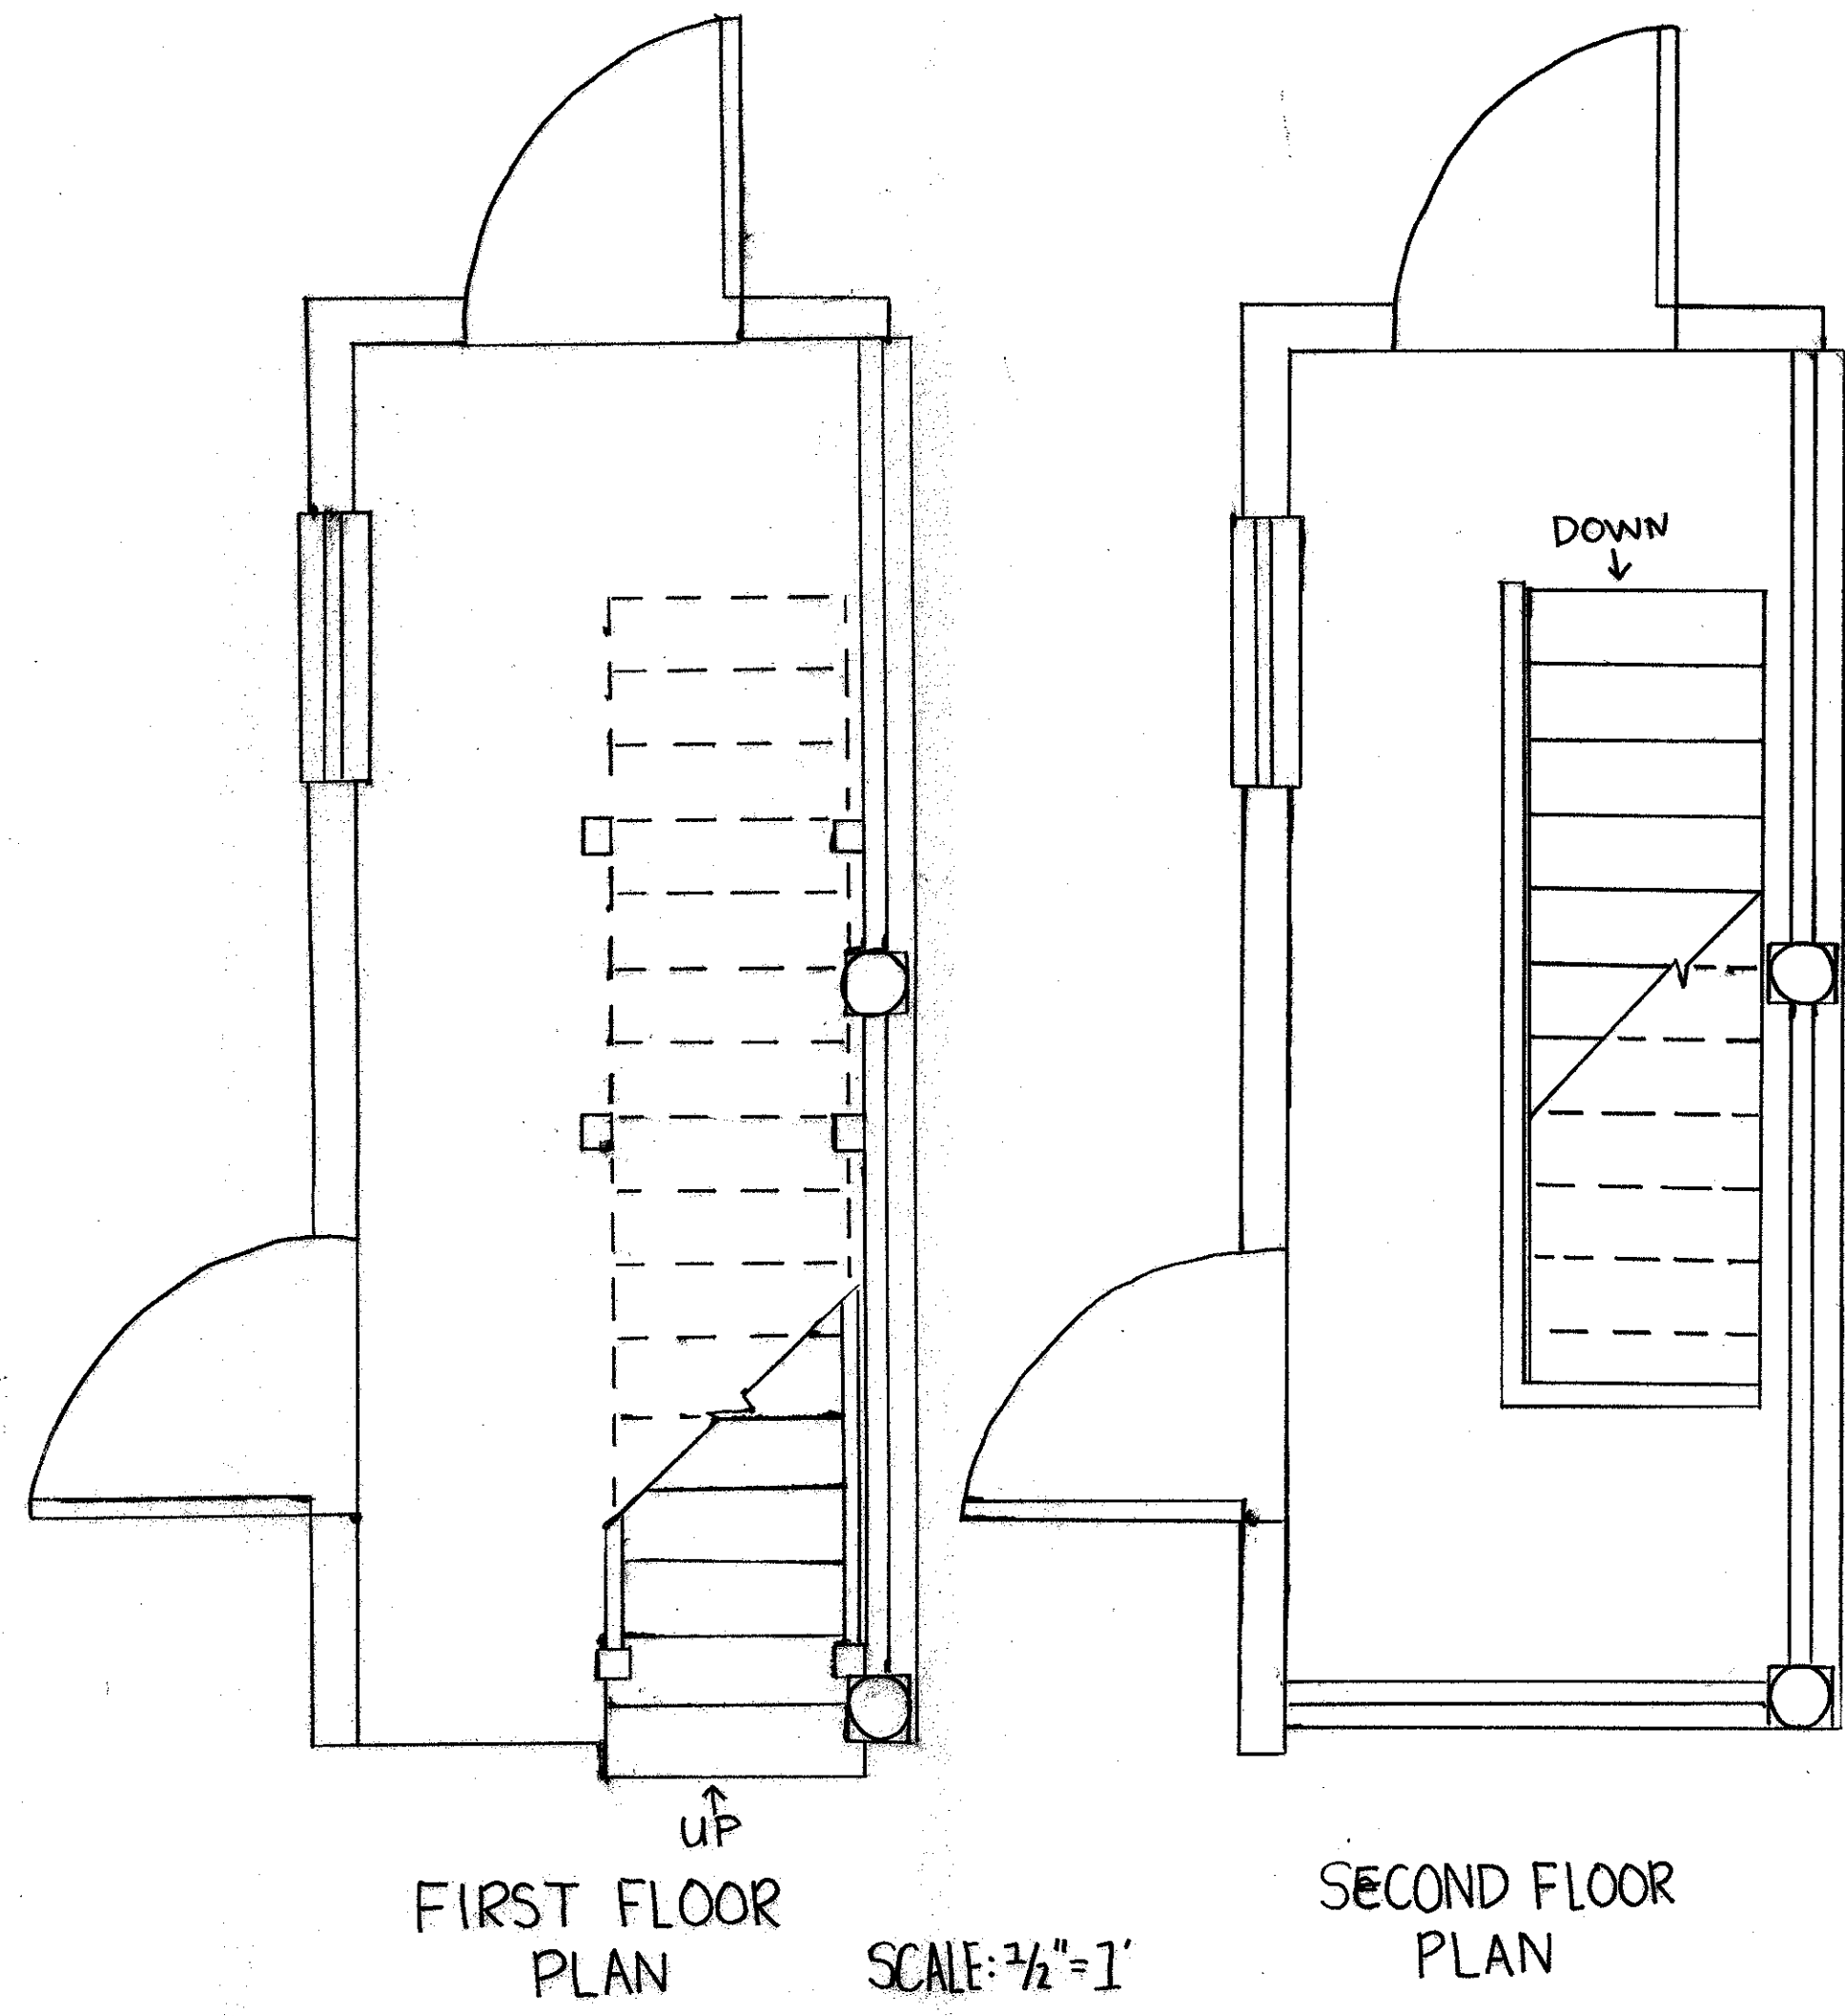
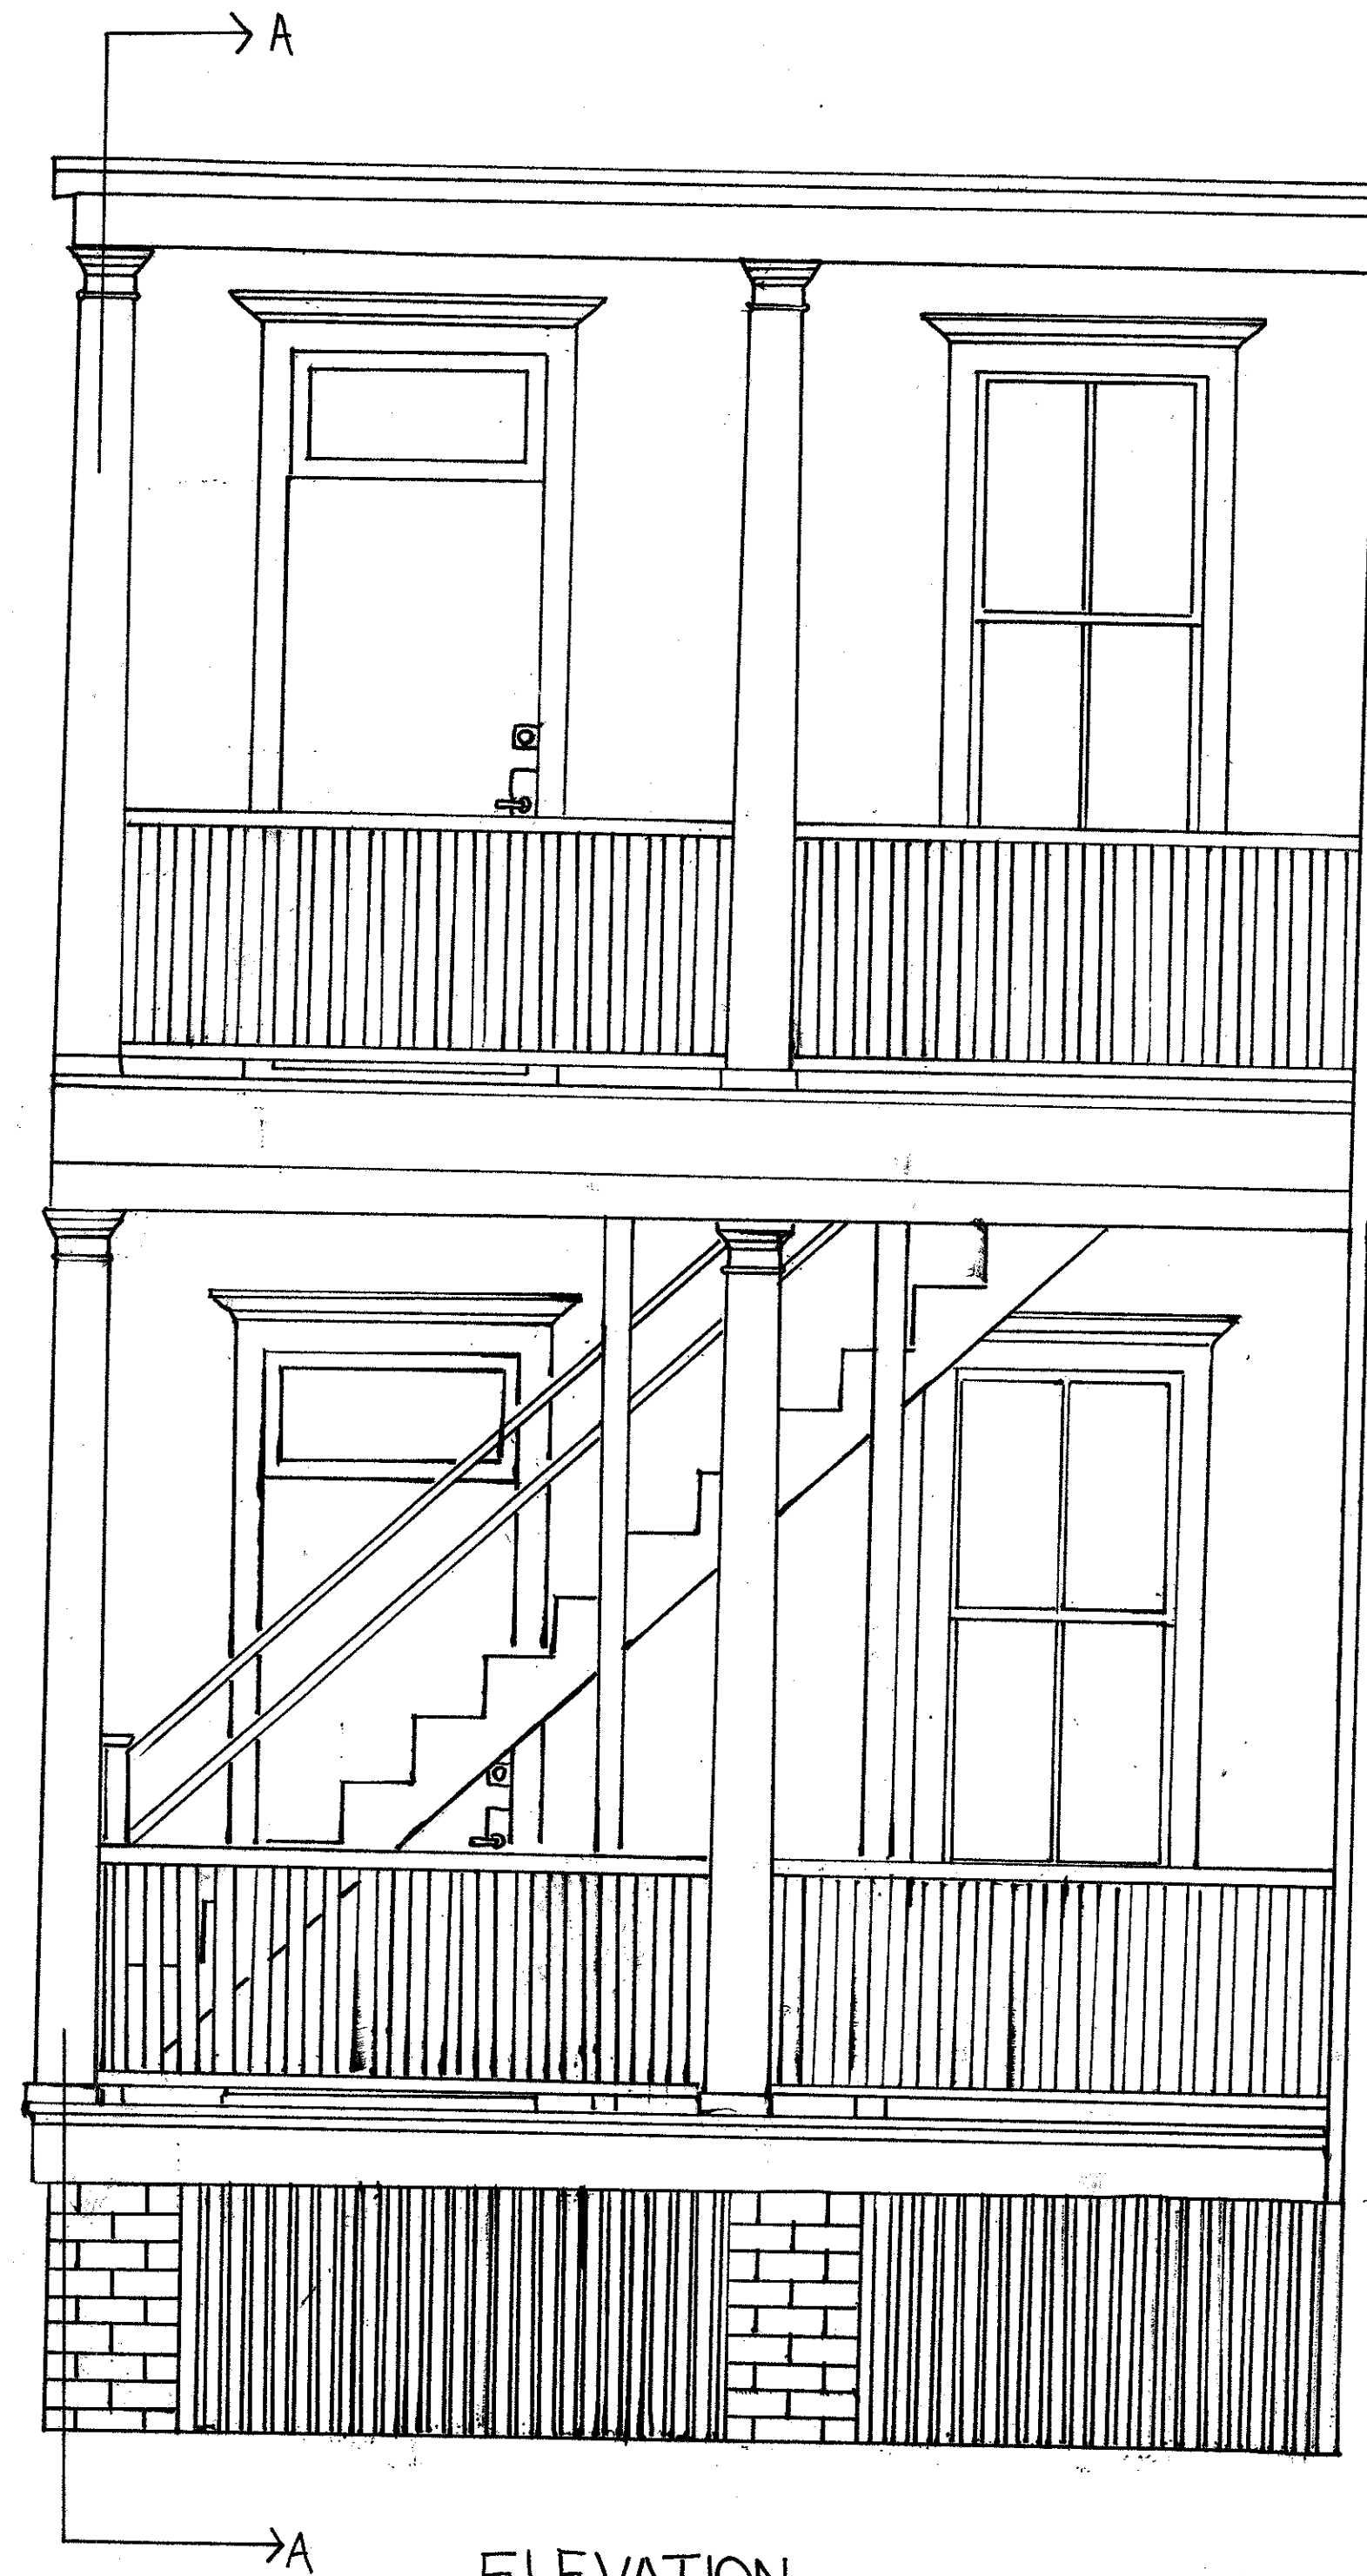
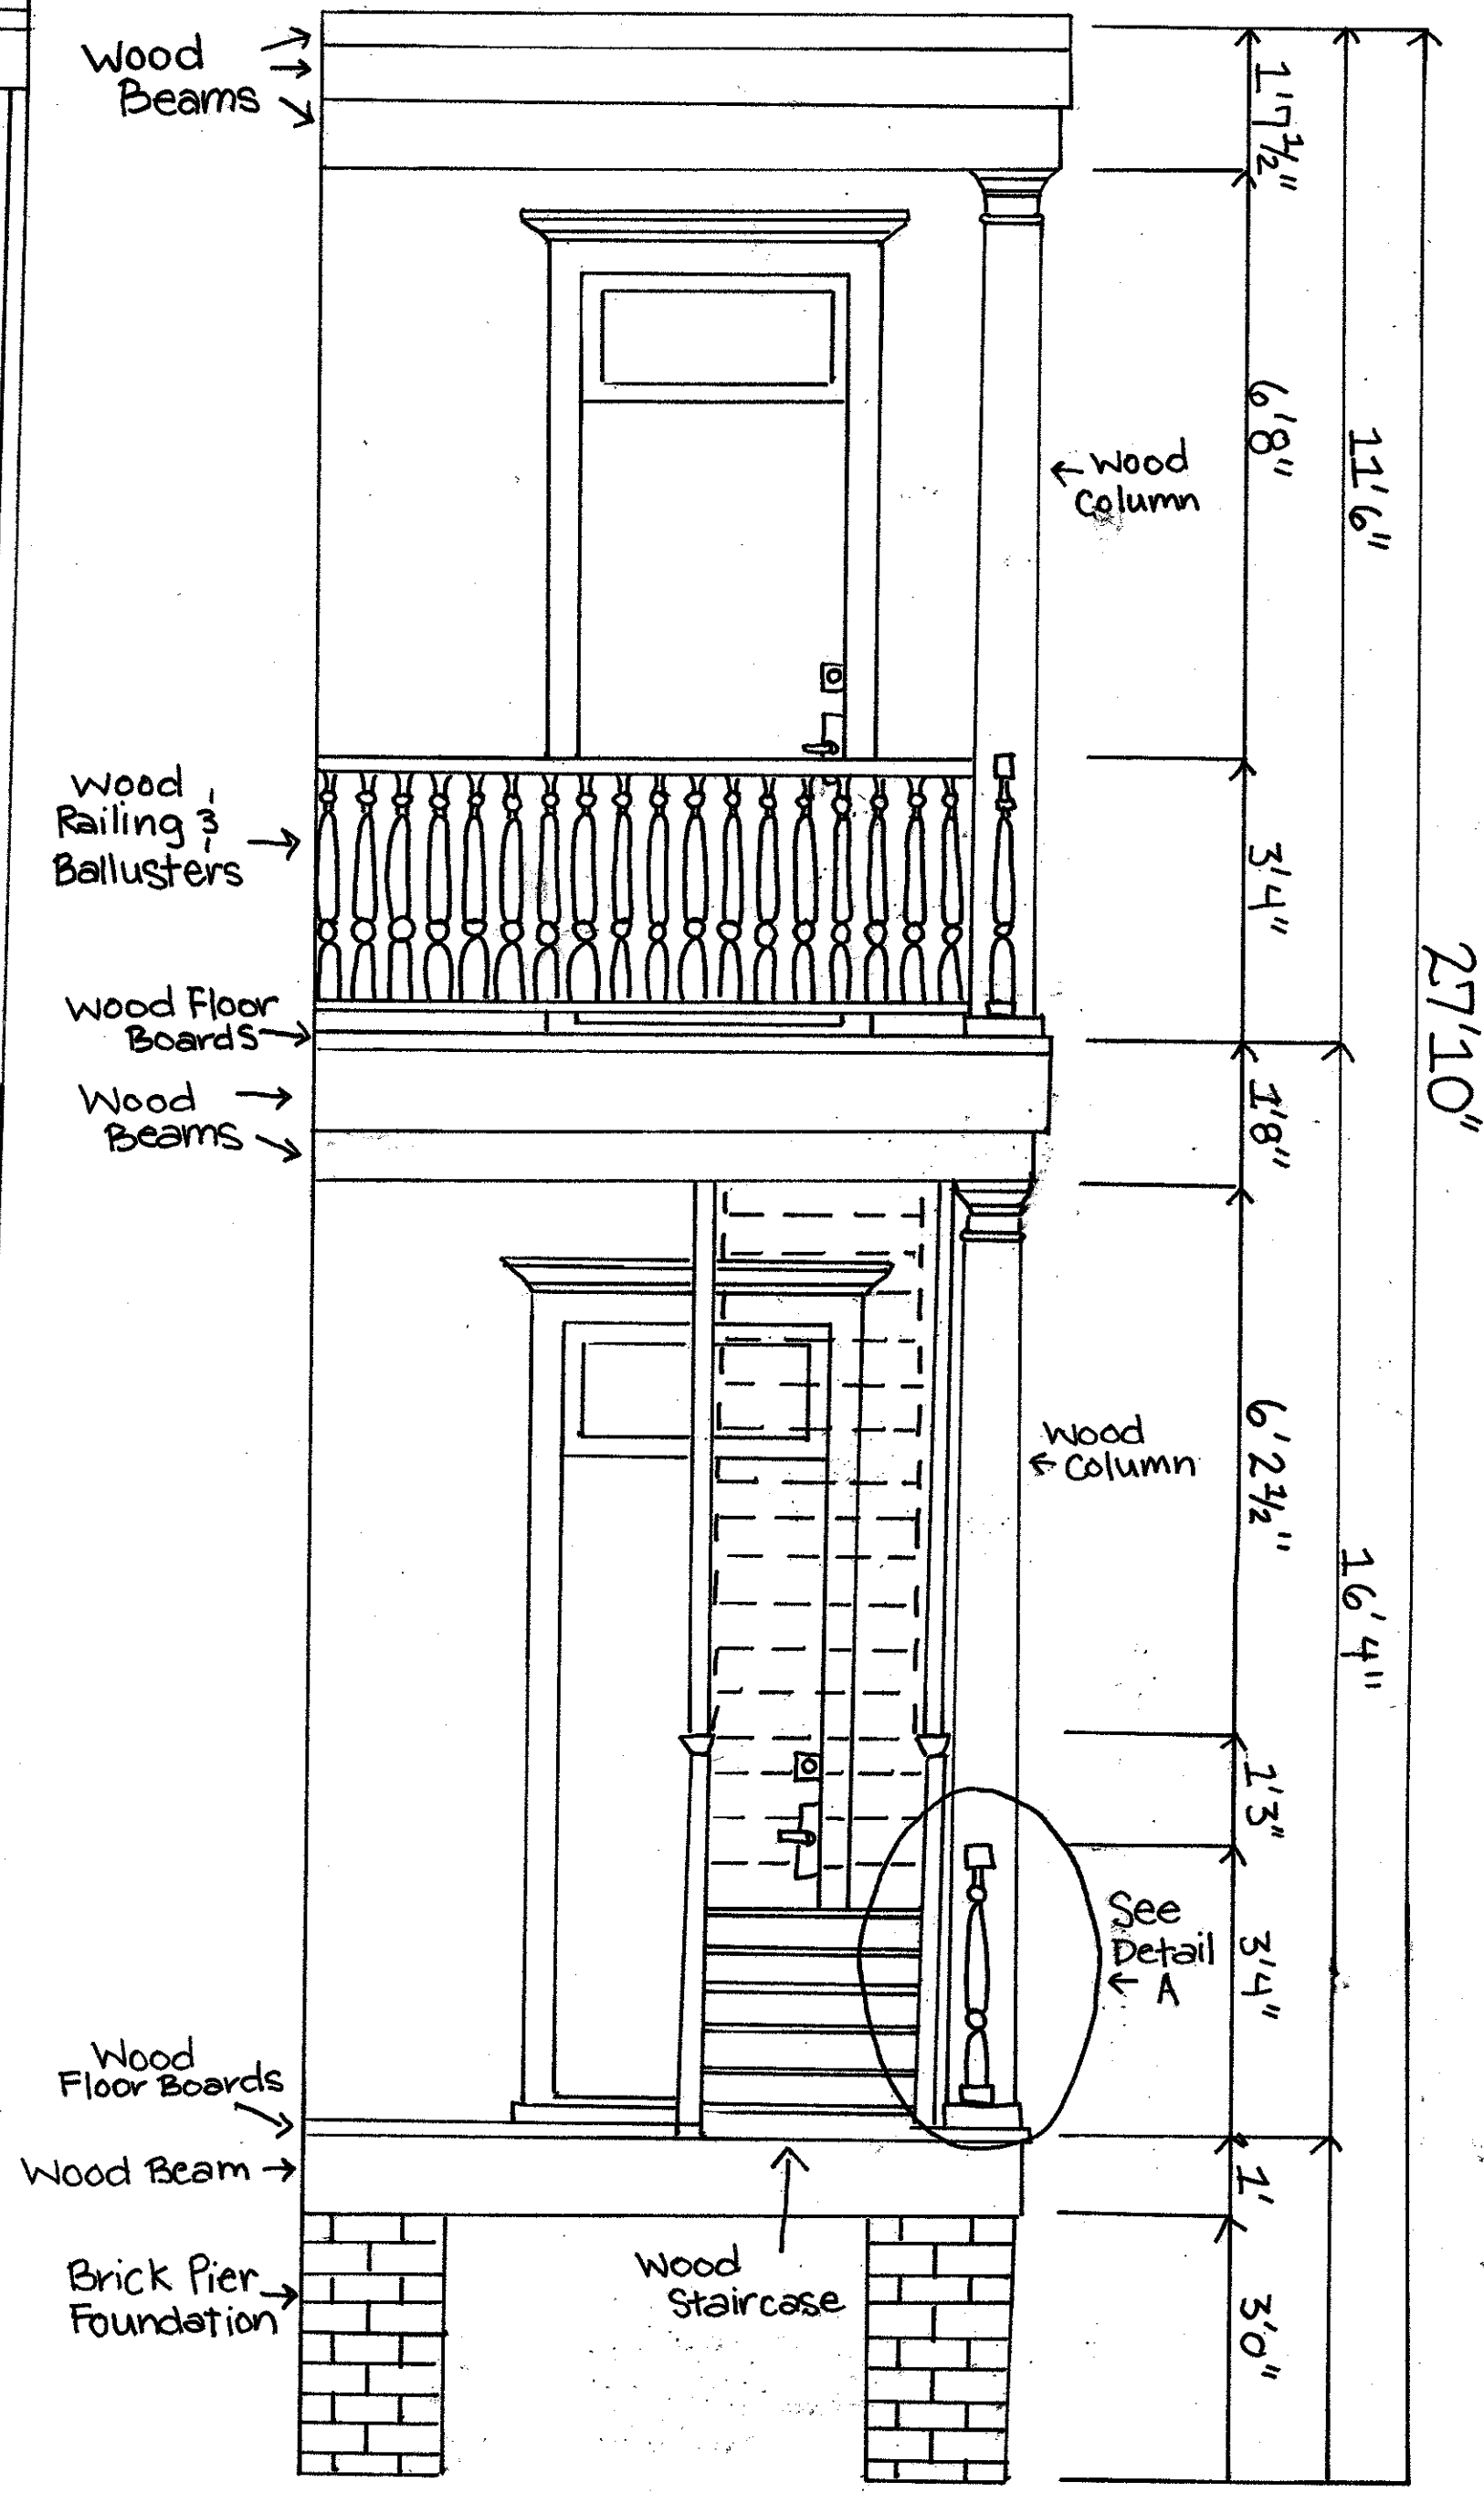
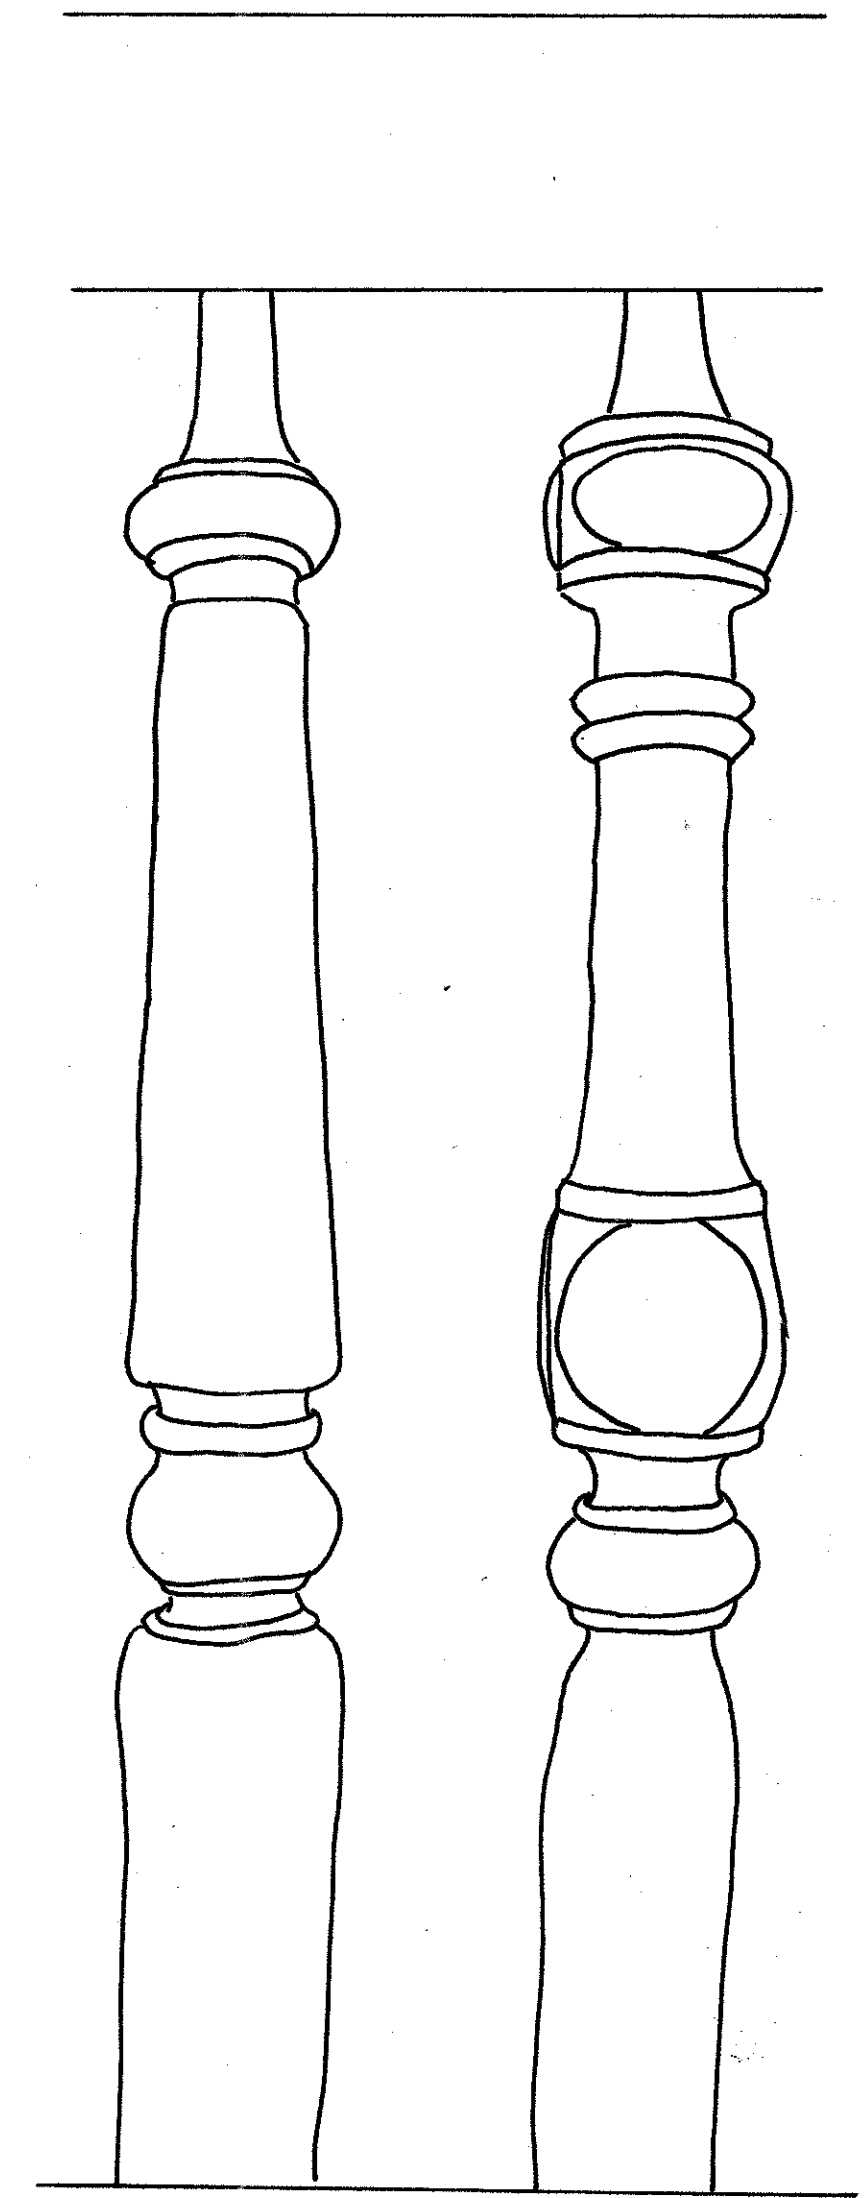
1. THE BRICK PIERS IN THE FOUNDATION APPEAR TO BE STABLE, HOWEVER, REPOINTING OF THE PIERS ALONG THE EDGE OF THE PORCH IS NECESSARY. THE MORTAR IS DISINTEGRATING AND NOT FUNCTIONING PROPERLY CAUSING LOOSE, DAMP BRICKS. IF THE PIERS ARE NOT REPOINTED SOON, THE BRICKS WILL BECOME DAMAGED FROM INCREASING WETNESS. A MORTAR ANALYSIS IS RECOMMENDED TO DETERMINE THE CORRECT MORTAR TO USE IN REPOINTING.

2. THE STAIRCASE IS NOT SECURE. IT IS VERY NARROW AND "WOBBLES" A BIT. THE WOOD MAY BE OF POOR QUALITY AND/OR BE BEGINNING TO ROT. THE WOOD NEEDS TO BE EXAMINED TO DETERMINE THE CAUSE OF THE PROBLEM. THE WOOD WILL HAVE TO BE EITHER REPLACED, OR THE STAIRCASE SUPPORTED WITH MORE SUPPORTIVE BEAMS.

3. THE WOOD FLOOR BEAMS ARE IN BAD CONDITION. THEY ARE WARPED, SPLITTING, AND SEPARATING FROM THE BASE BOARDS. THIS COULD BE DUE TO POOR WOOD QUALITY IN COMBINATION WITH ABRASION AND WEAR FROM HIGH FOOT TRAFFIC. THESE BOARDS MUST BE REPLACED SOON WITH MORE DURABLE BOARDS.

4. THERE ARE MANY LAYERS OF PAINT ON THE REMAINING WOOD BEAMS, DOORS, WINDOWS, COLUMNS, AND SIDING. THIS MAY HAVE BEEN DONE TO COVER UP PROBLEMS WITH THE WOOD. A LARGE AMOUNT OF PAINT COULD BE PREVENTING THE WOOD TO BREATHE. IT IS NECESSARY THAT THE FOLLOWING IS DONE, AND ANY PROBLEMS FIXED TO AVOID MAJOR STRUCTURAL PROBLEMS:

5. THE PAINT ON THE WOOD RAILING, BEAMS, AND COLUMNS SHOWS SIGNS OF CRAZING. CRAZING IS WHEN THERE ARE JAGGED BREAKS IN THE TOP LAYER OF PAINT. THIS IS OCCURRING BECAUSE THE PAINT IS UNABLE TO MOVE WITH THE WOOD AS IT EXPANDS AND CONTRACTS. THIS CAN BE FIXED BY HAND SANDING THE SURFACE (DO NOT USE A MECHANICAL SANDER) AND REPAINTING. WHEN REPAINTING, USE AN OIL PAINT IF THE PAINT LAYER UNDERNEATH IS OIL BASED. LATEX PAINT CAN BE USED IF THE LAYER UNDERNEATH IS LATEX. IF A LATEX PAINT IS USED OVER AN OIL PAINT, AN OIL PRIMER SHOULD BE APPLIED FIRST.

- CAREFULLY EXAMINE BEAM ENDS, BOND TIMBERS, AND JOIST ENDS BY PROBING AND TESTING FOR MOISTURE IN THE WOOD AND LOOK FOR FUNGAL DECAY, ROT, OR INSECTS.

- EXAMINE DOORS, WINDOW SASHES AND SILLS FOR SIGNS OF MOISTURE, ROT, AND FUNGAL DECAY.
 - EXAMINE THE WOOD BEAMS ALONG THE ROOF AND LOOK FOR WATER STAINS, MOLD, FUNGUS, AND INSECTS THAT CAN CAUSE STRUCTURAL DAMAGE.
