FORT DORCHESTER  
 38DR 4  
 1757-1781

JAMES L. WARD COLLEGE OF CHARLESTON ARTH 209-FALL 2010 HISTORIC PRESERVATION & COMMUNITY PLANNING		DRAWING TITLE: <b>COLONIAL FORT DORCHESTER</b> Ashley River, South Carolina	
ASSIGNMENT NO. 1		DRAWING PREPARED BY: (TEAM/INDIVIDUAL) Johanna Szokman, Taylor Fort, Callie Boatgoff, Robert Query	
DATE 11-12-10	SCALE 1/8"	SHEET 1	
REV	DESCRIPTION	DATE	APPROVED

JAMES L. WARD COLLEGE OF CHARLESTON ARTH 299- FALL 2010 HISTORIC PRESERVATION & COMMUNITY PLANNING		<b>COLONIAL FORT DORCHESTER</b> Ashley River, South Carolina DRAWING TITLE: <b>FLOOR PLAN</b>	
ASSIGNMENT NO: 1 DATE: 11-12-10	DRAWING PREPARED BY: (TEAM/INDIVIDUAL) Johanna Szotkman, Taylor Fort, Callie Badgett, Robert Query	SCALE: 1/8"	SHEET: 1
REV	DESCRIPTION	DATE	APPROVED

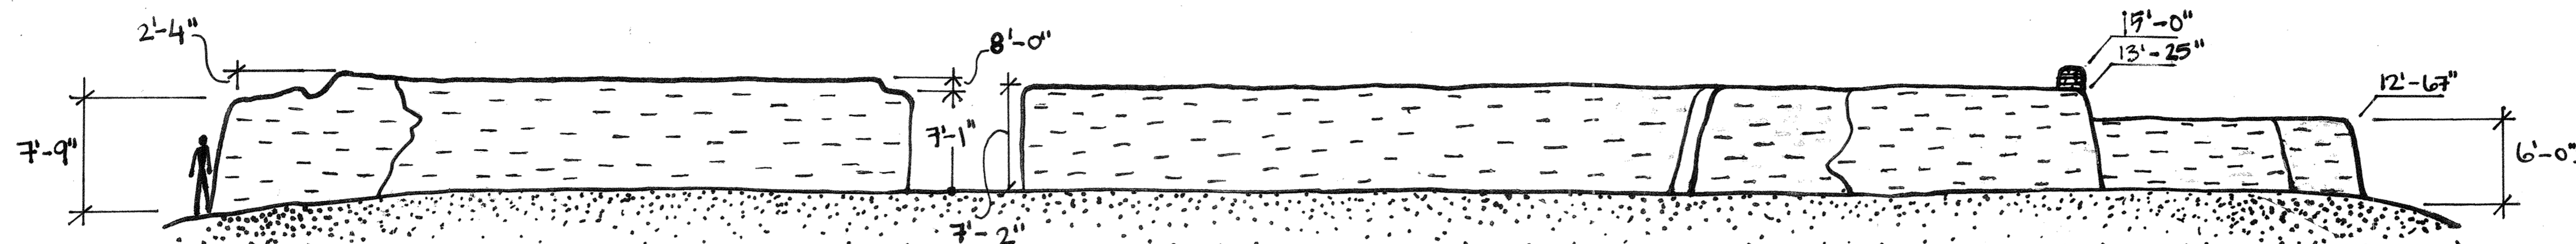
NORTH ELEVATION

- Width of walls was measured at top and bottom of both entrances.
- Average wall batter +/- 8".
- Average width of walls: top +/- 2'-1", bottom +/- 2'-9".
- Average width of cracks +/- 3".
- Western wall is topped with deteriorating brick. Purpose unknown.
- Walls composed of tabby: a porous substance made with lime, sand, water, and crushed up oyster shells.
- Due to limited technology, average wall height could vary +/- 1'.
- Differences in slope are shown by separate ground levels.
- Differences in wall height are shown by shifting elevations on single plain.

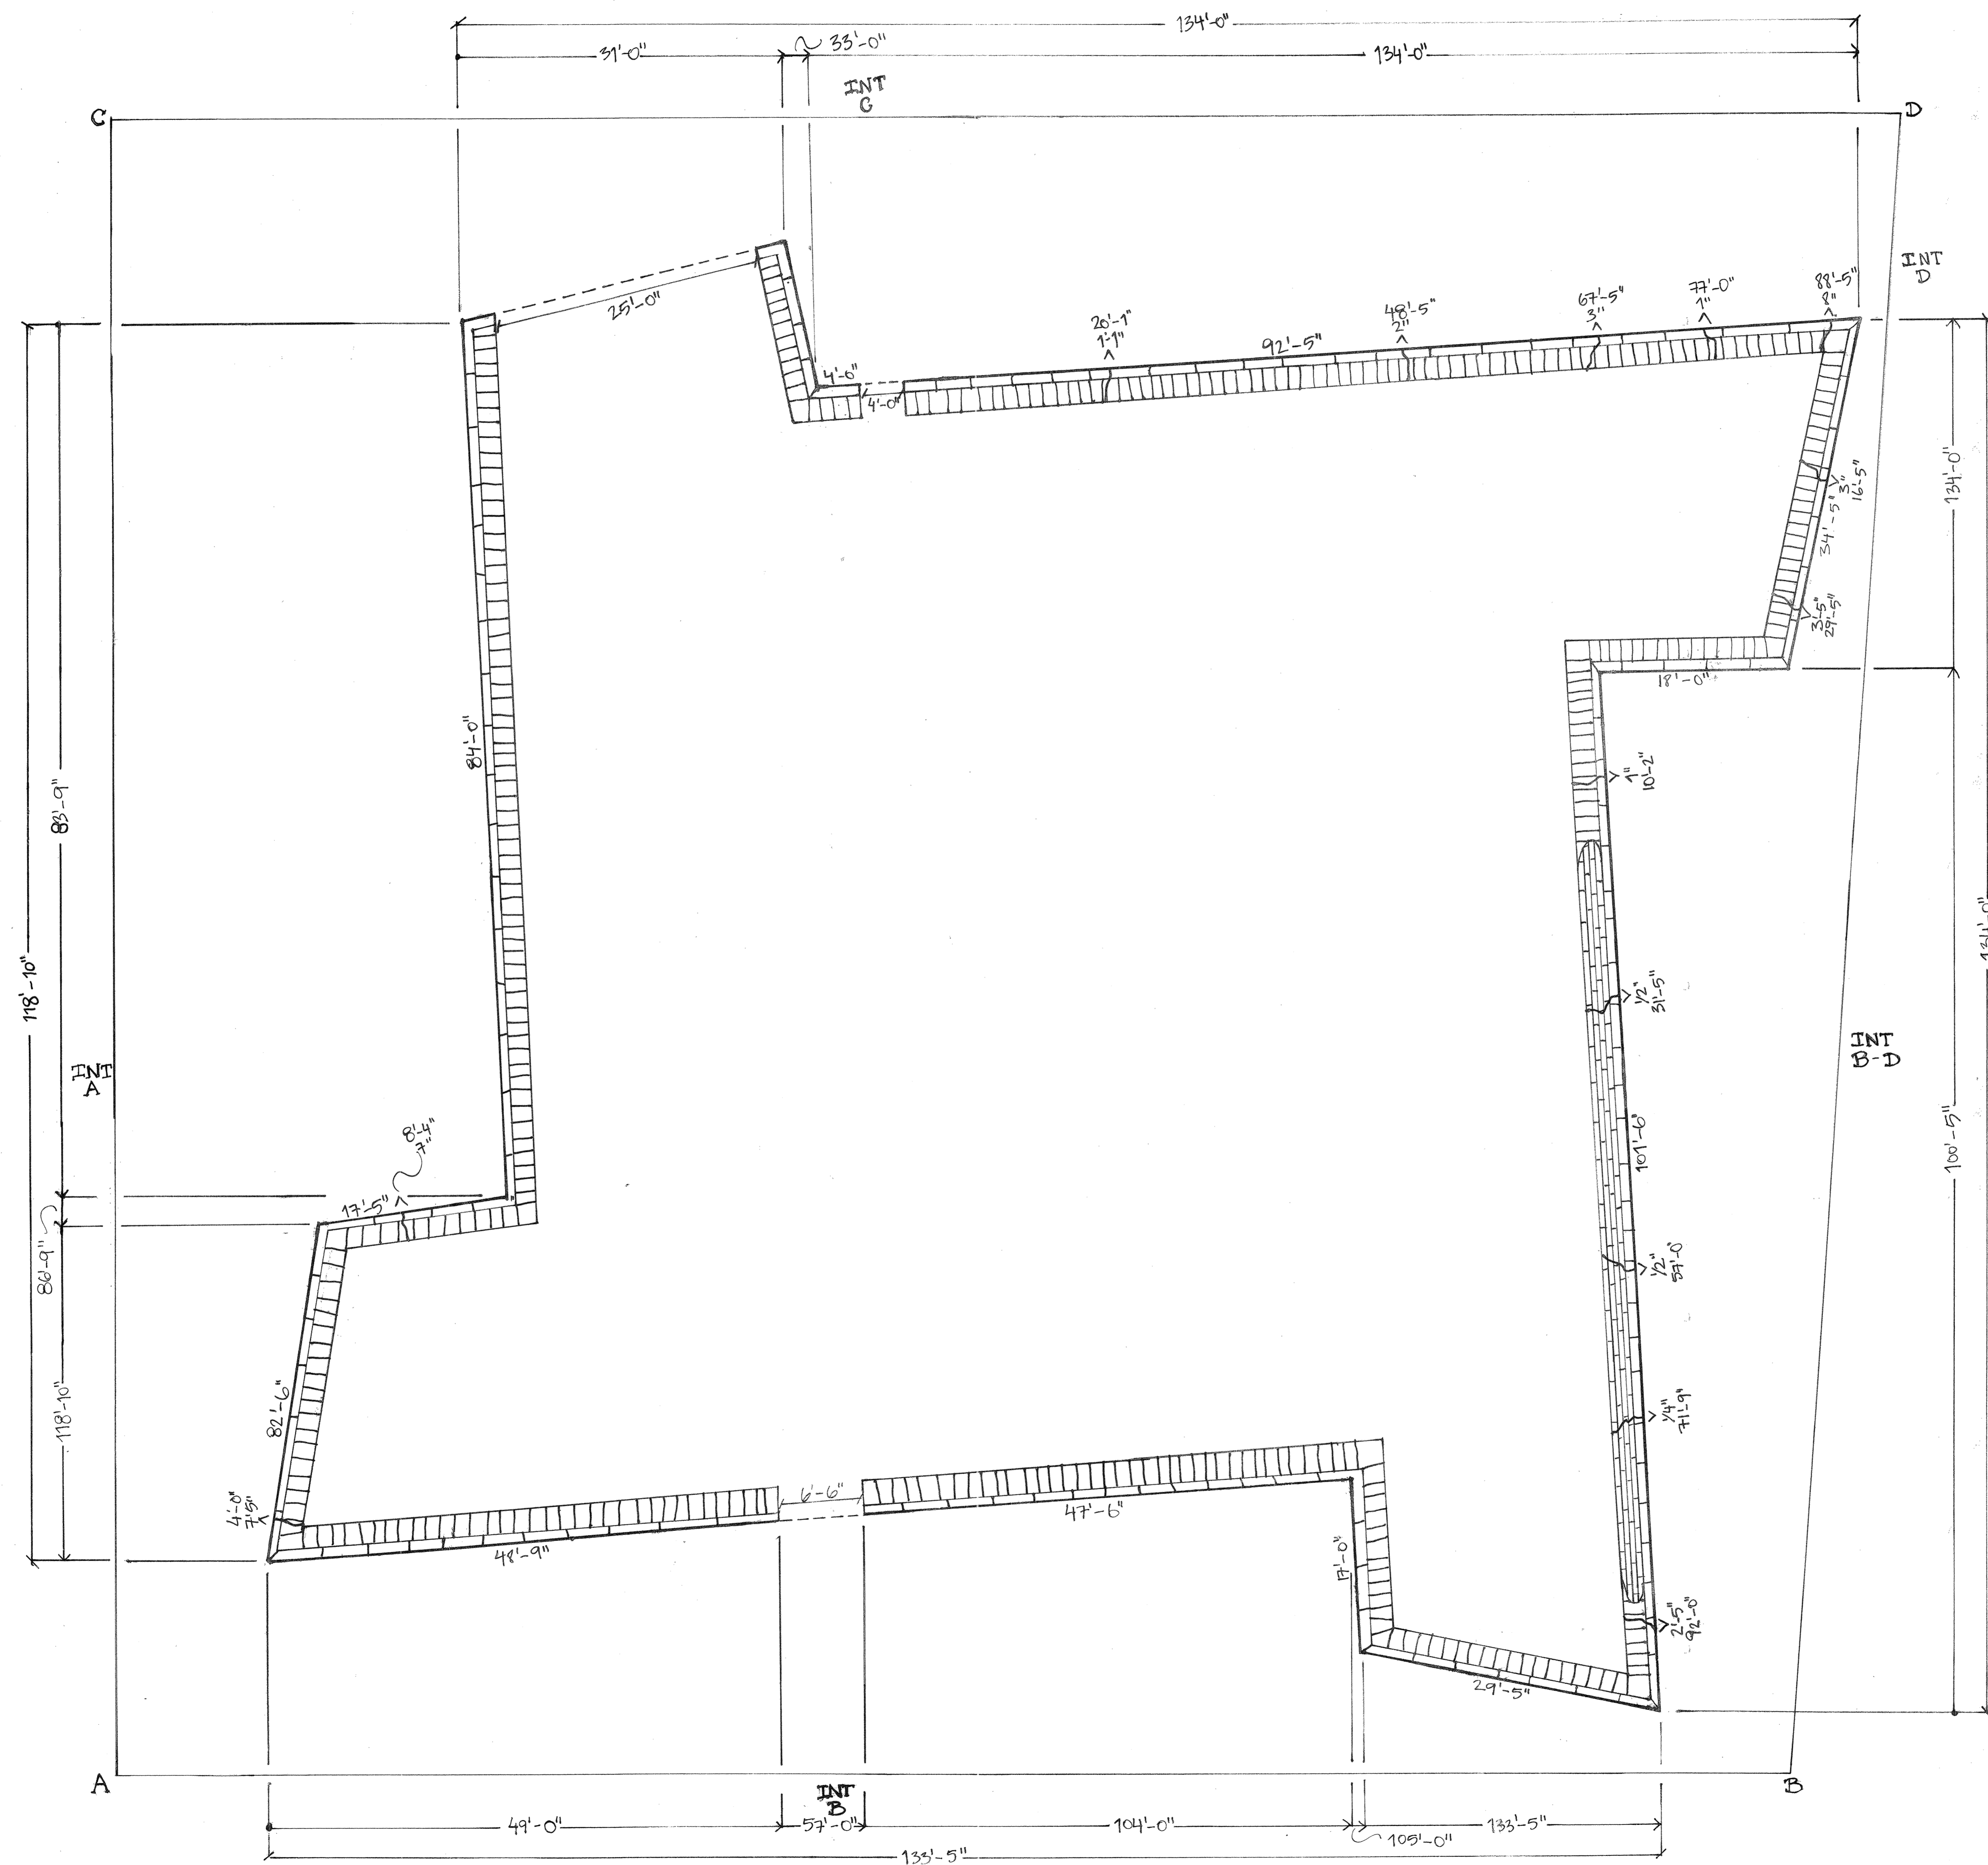
- All reference points taken from total station have margin of error due to slope.
- Measurements shift due to erosion.
- Points A, C, and D are affected by slope causing variation on running dimensions.
- Corners are estimated due to weathering around the bases.
- Erosion causes walls to deteriorate significantly, making it difficult to determine corner points.

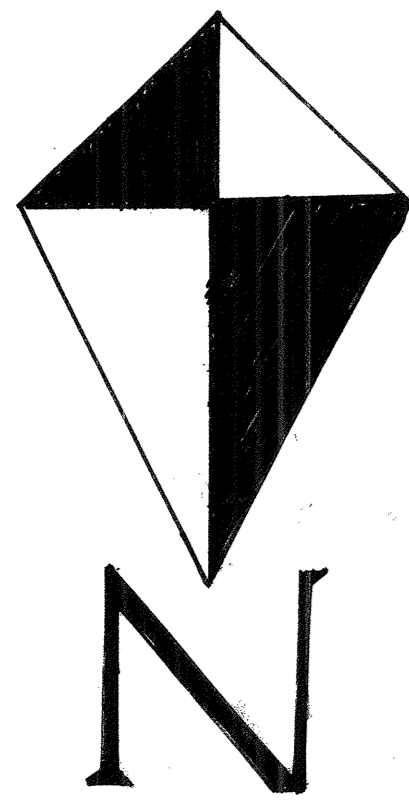
**NOTES**

- Team triangulated  
Measurements From  
Interior control line  
- Angles are not 90° +  
are dimensioned in 2  
directions onto a  
square reference line

SCALE: 1/4" = 10'

LEGEND: = BRICK  
 = CRACK  
 = WALL OPENING

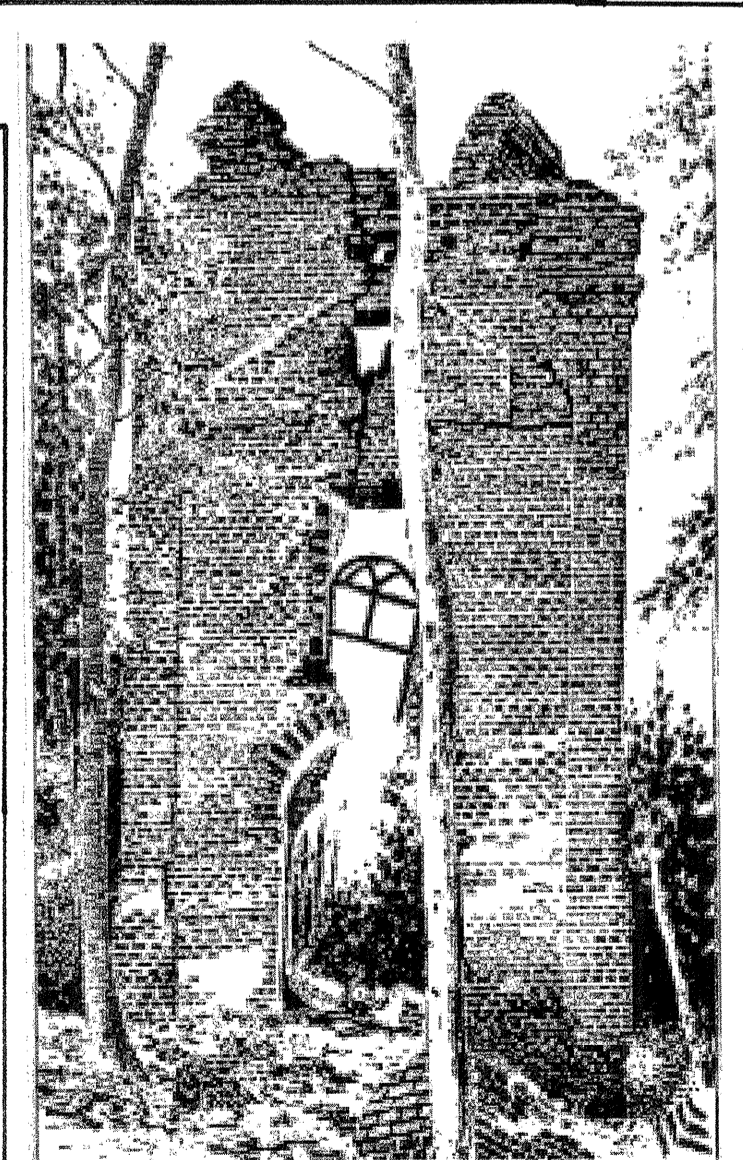
The Earthquake of 1886 split the tower and toppled most of its octagonal cap.

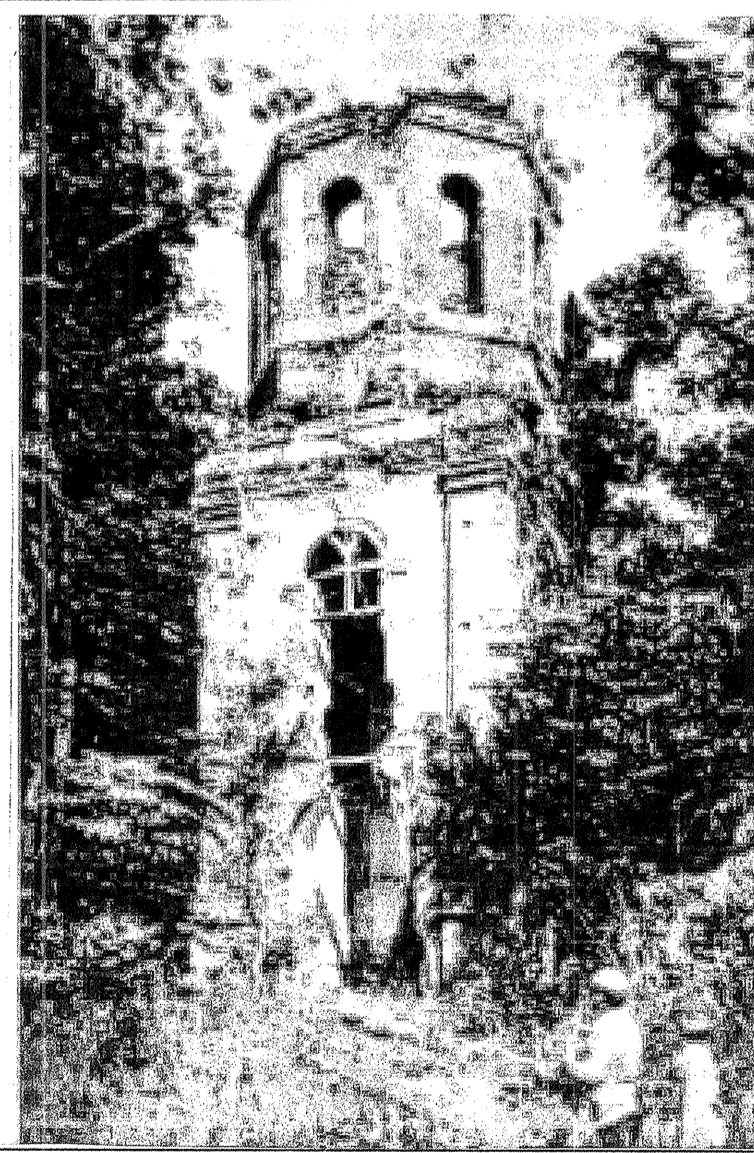
Taken in the 1870s, this photograph shows that by this time scavengers and fire had left only the bell tower.

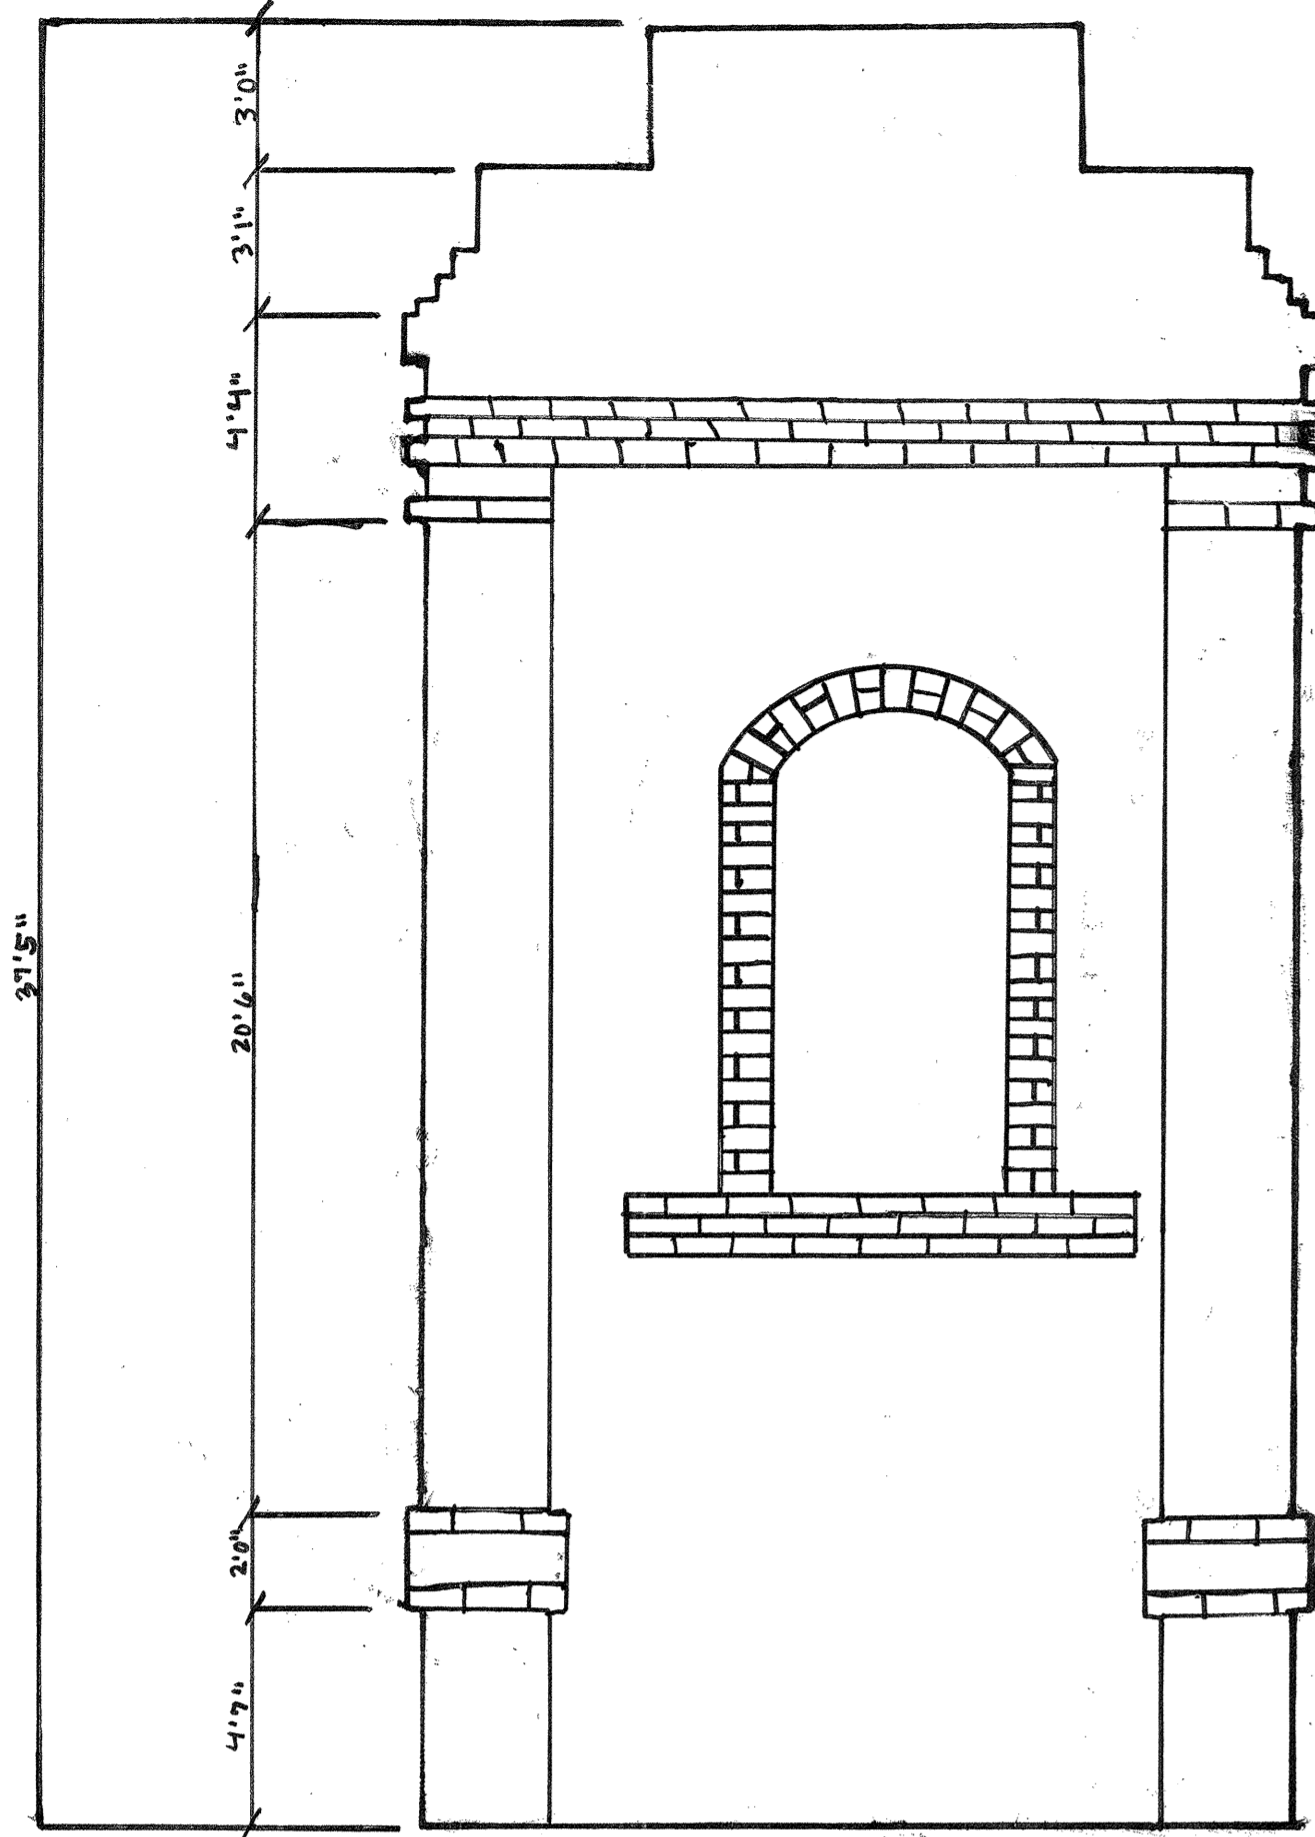
SOUTH ELEVATION

1. Plan is oriented with North arrow in the bottom right corner.
2. Does not include South Window structural support.
3. The bell tower is built on an incline, so the various sides have different measurements.
4. Bricks laid differently, creates different length measurements.
5. Drawings do not show demolished bricks or cracking

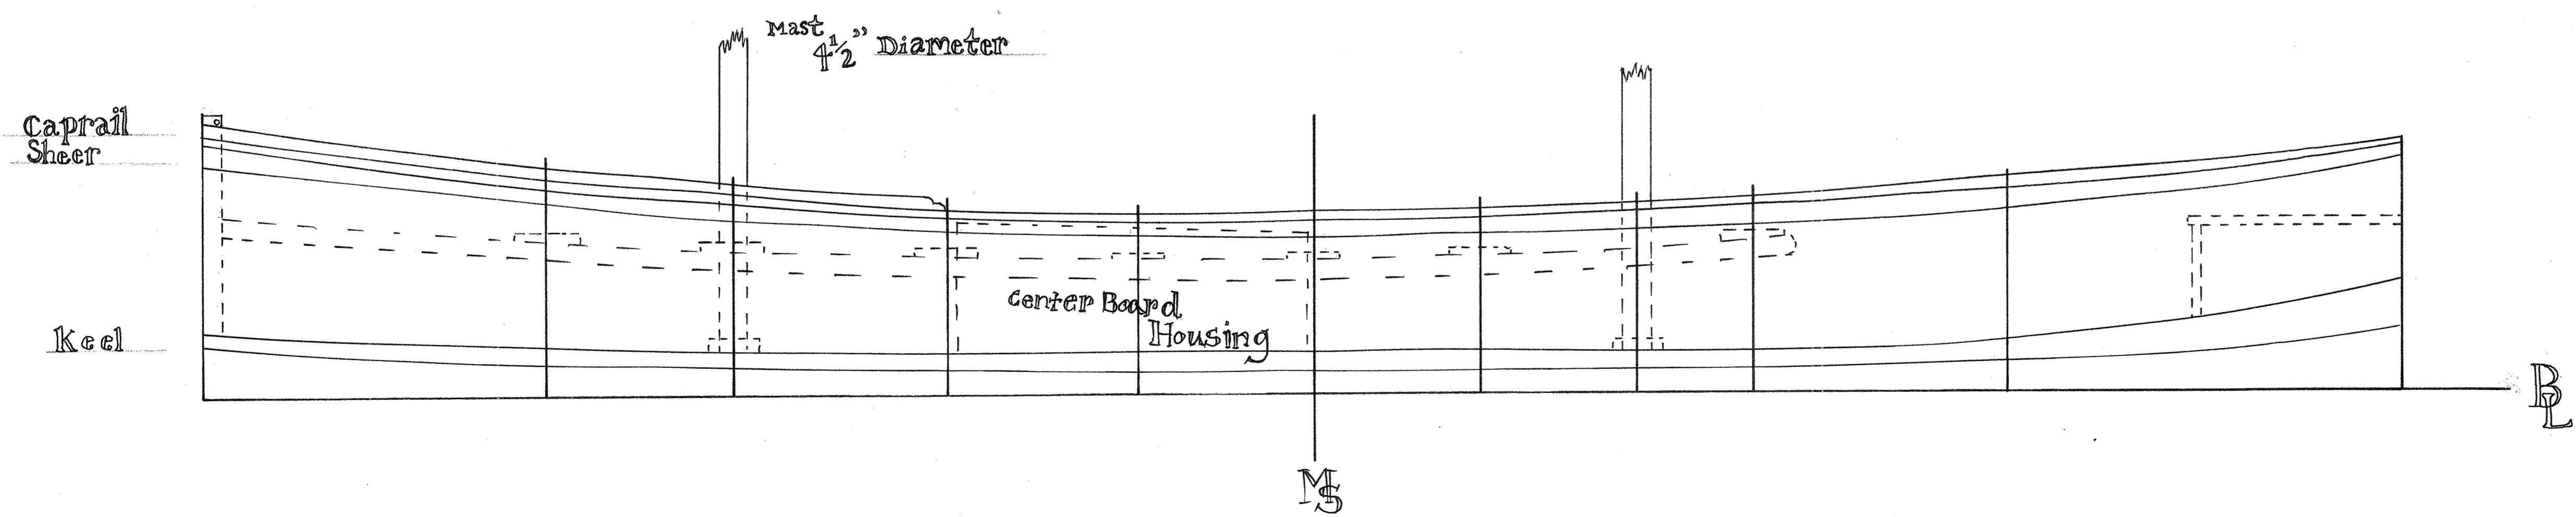
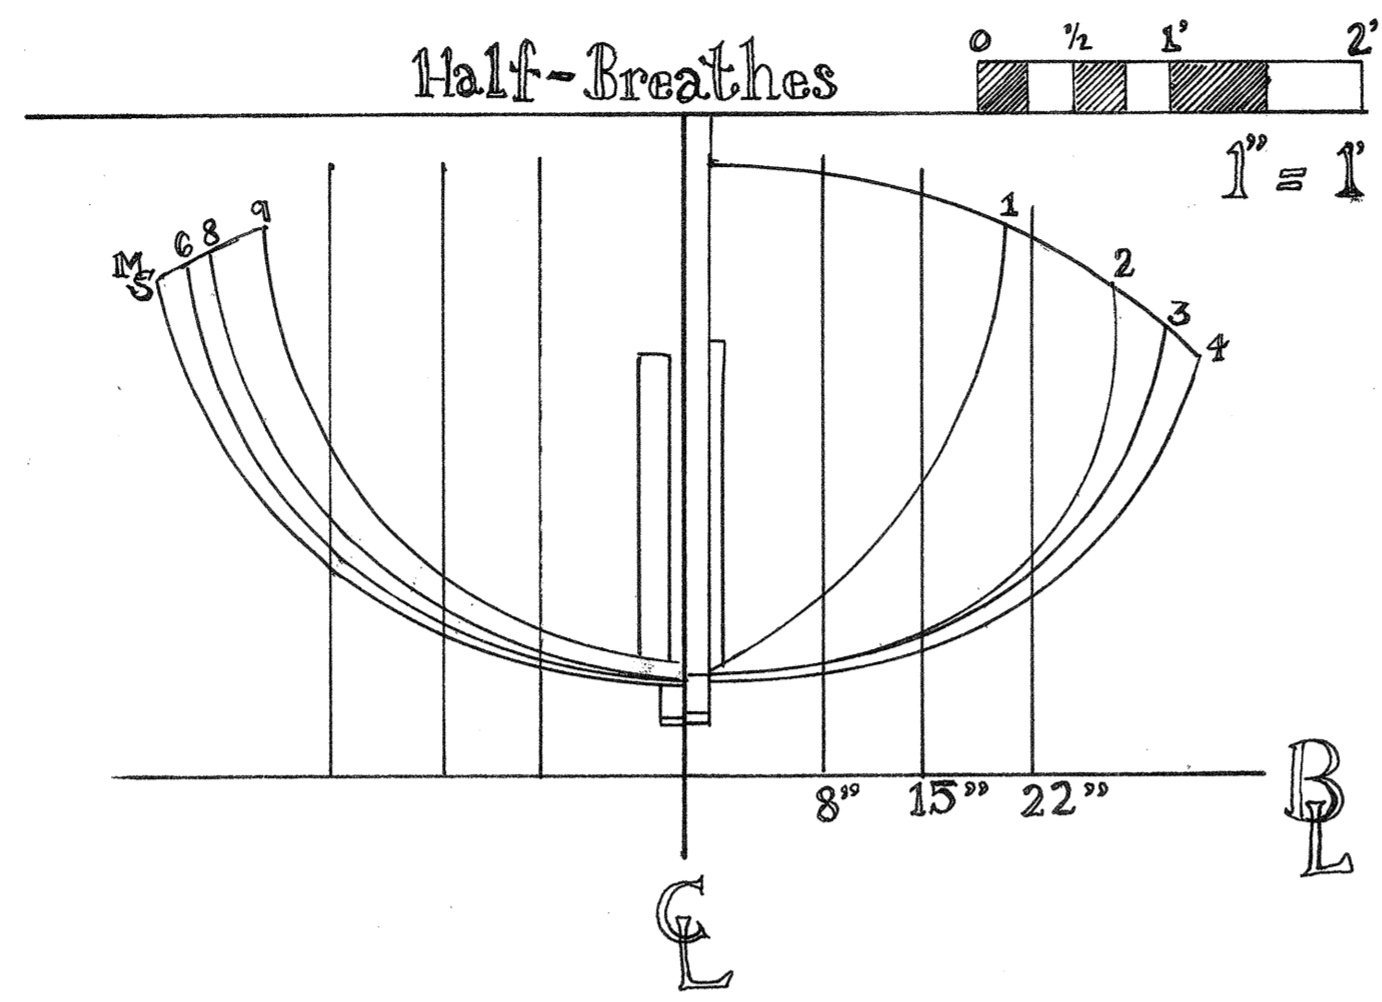
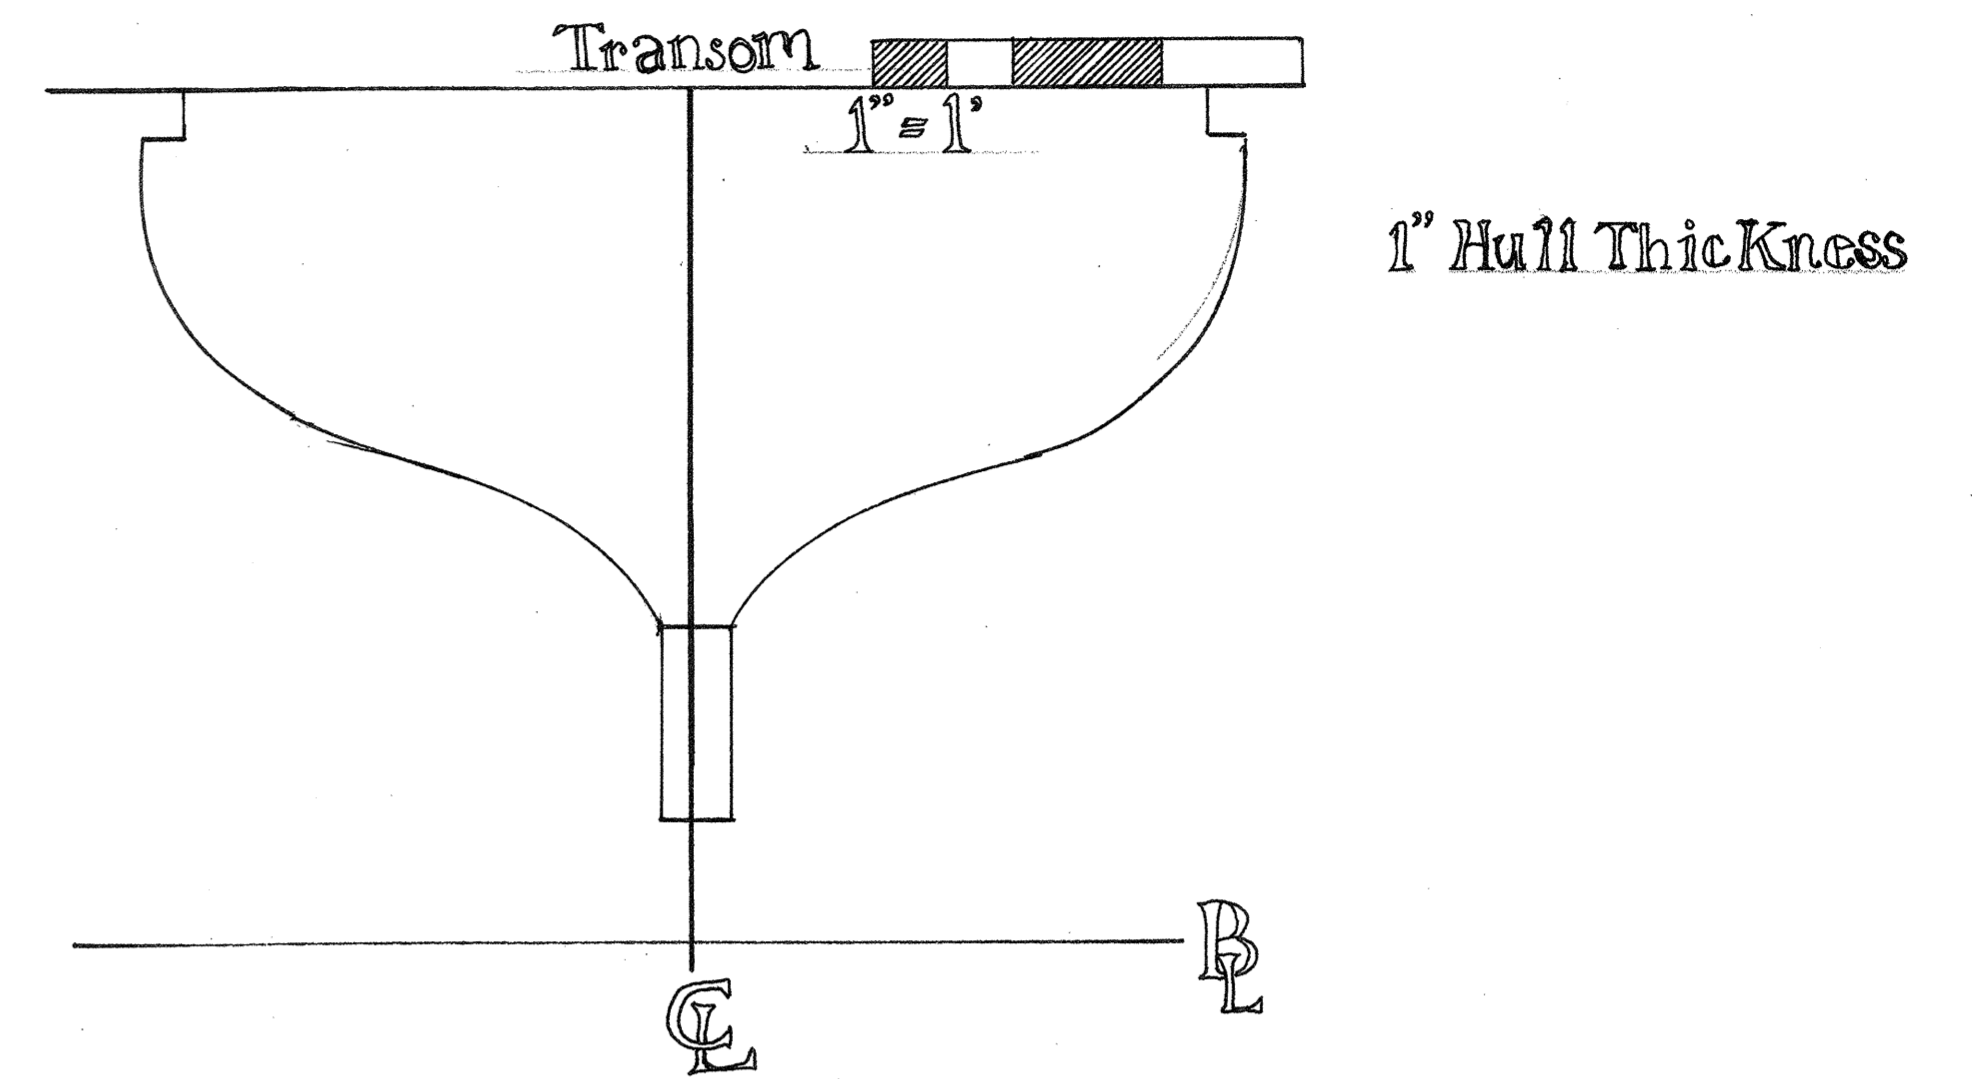
Produced by: Wren Ferrero & Will Weaver  
 The "Bessie" - property of: The Charleston Museum  
 May 5<sup>th</sup>, 2010

1. Measurements were taken from an existing relic, "Bessie", which resides at the Charleston museum. The "Bessie" was resting on three blocks spaced evenly beneath its hull. Due to this a baseline had to be created from which measurements could be taken. The drawings have been created by joining curves associated with measurements.
2. Boat hull is a modified dugout, being constructed of a single tree trunk hollowed out but fit with ribs, a stem, seats, a center board housing, and a keel and skeg.
3. Transom was carved out of trunk and therefore open end grain. The aft seat made the interior of the transom inaccessible for measurement.
4. Station 6's and 7's dimensions were identical and thus are both represented by 6 in half breath.

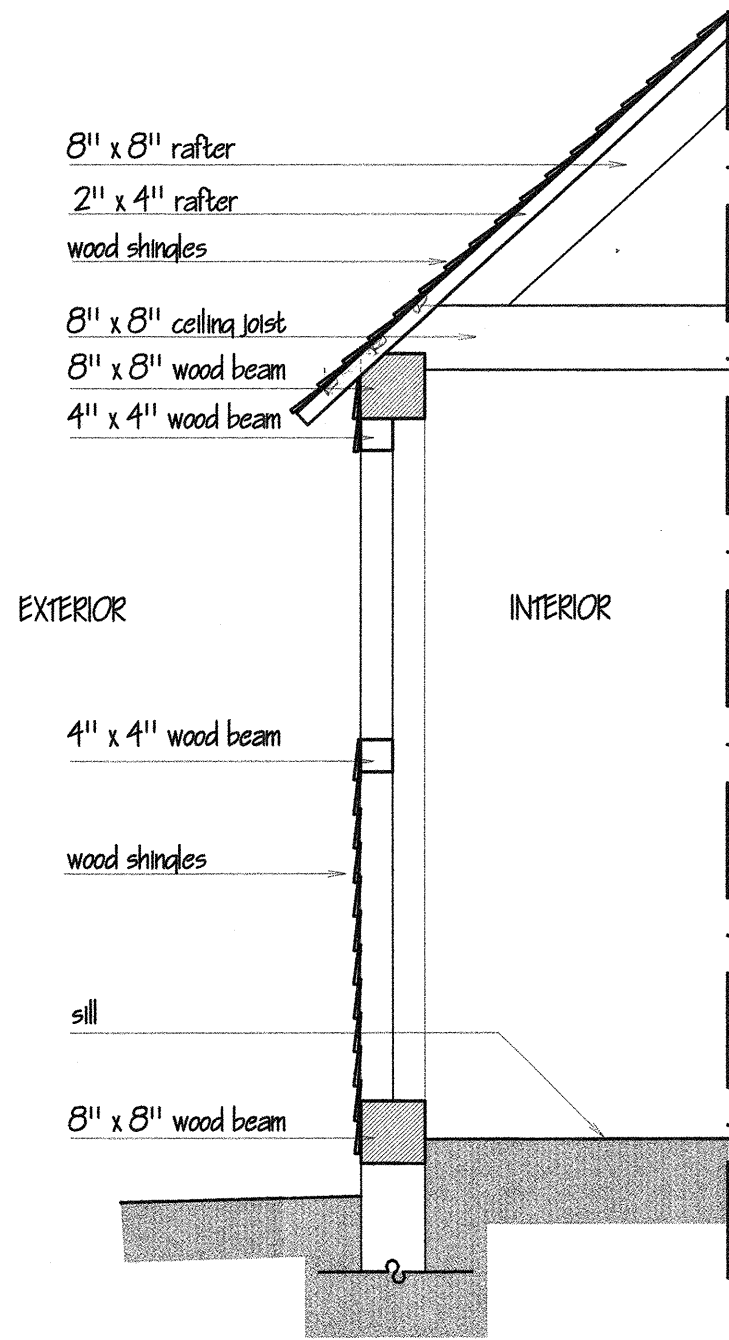
SECTION A-A  
 scale 1/4" = 1'-0"

COMMON HOUSE  
 DETAIL OF WALL / ROOF SECTION

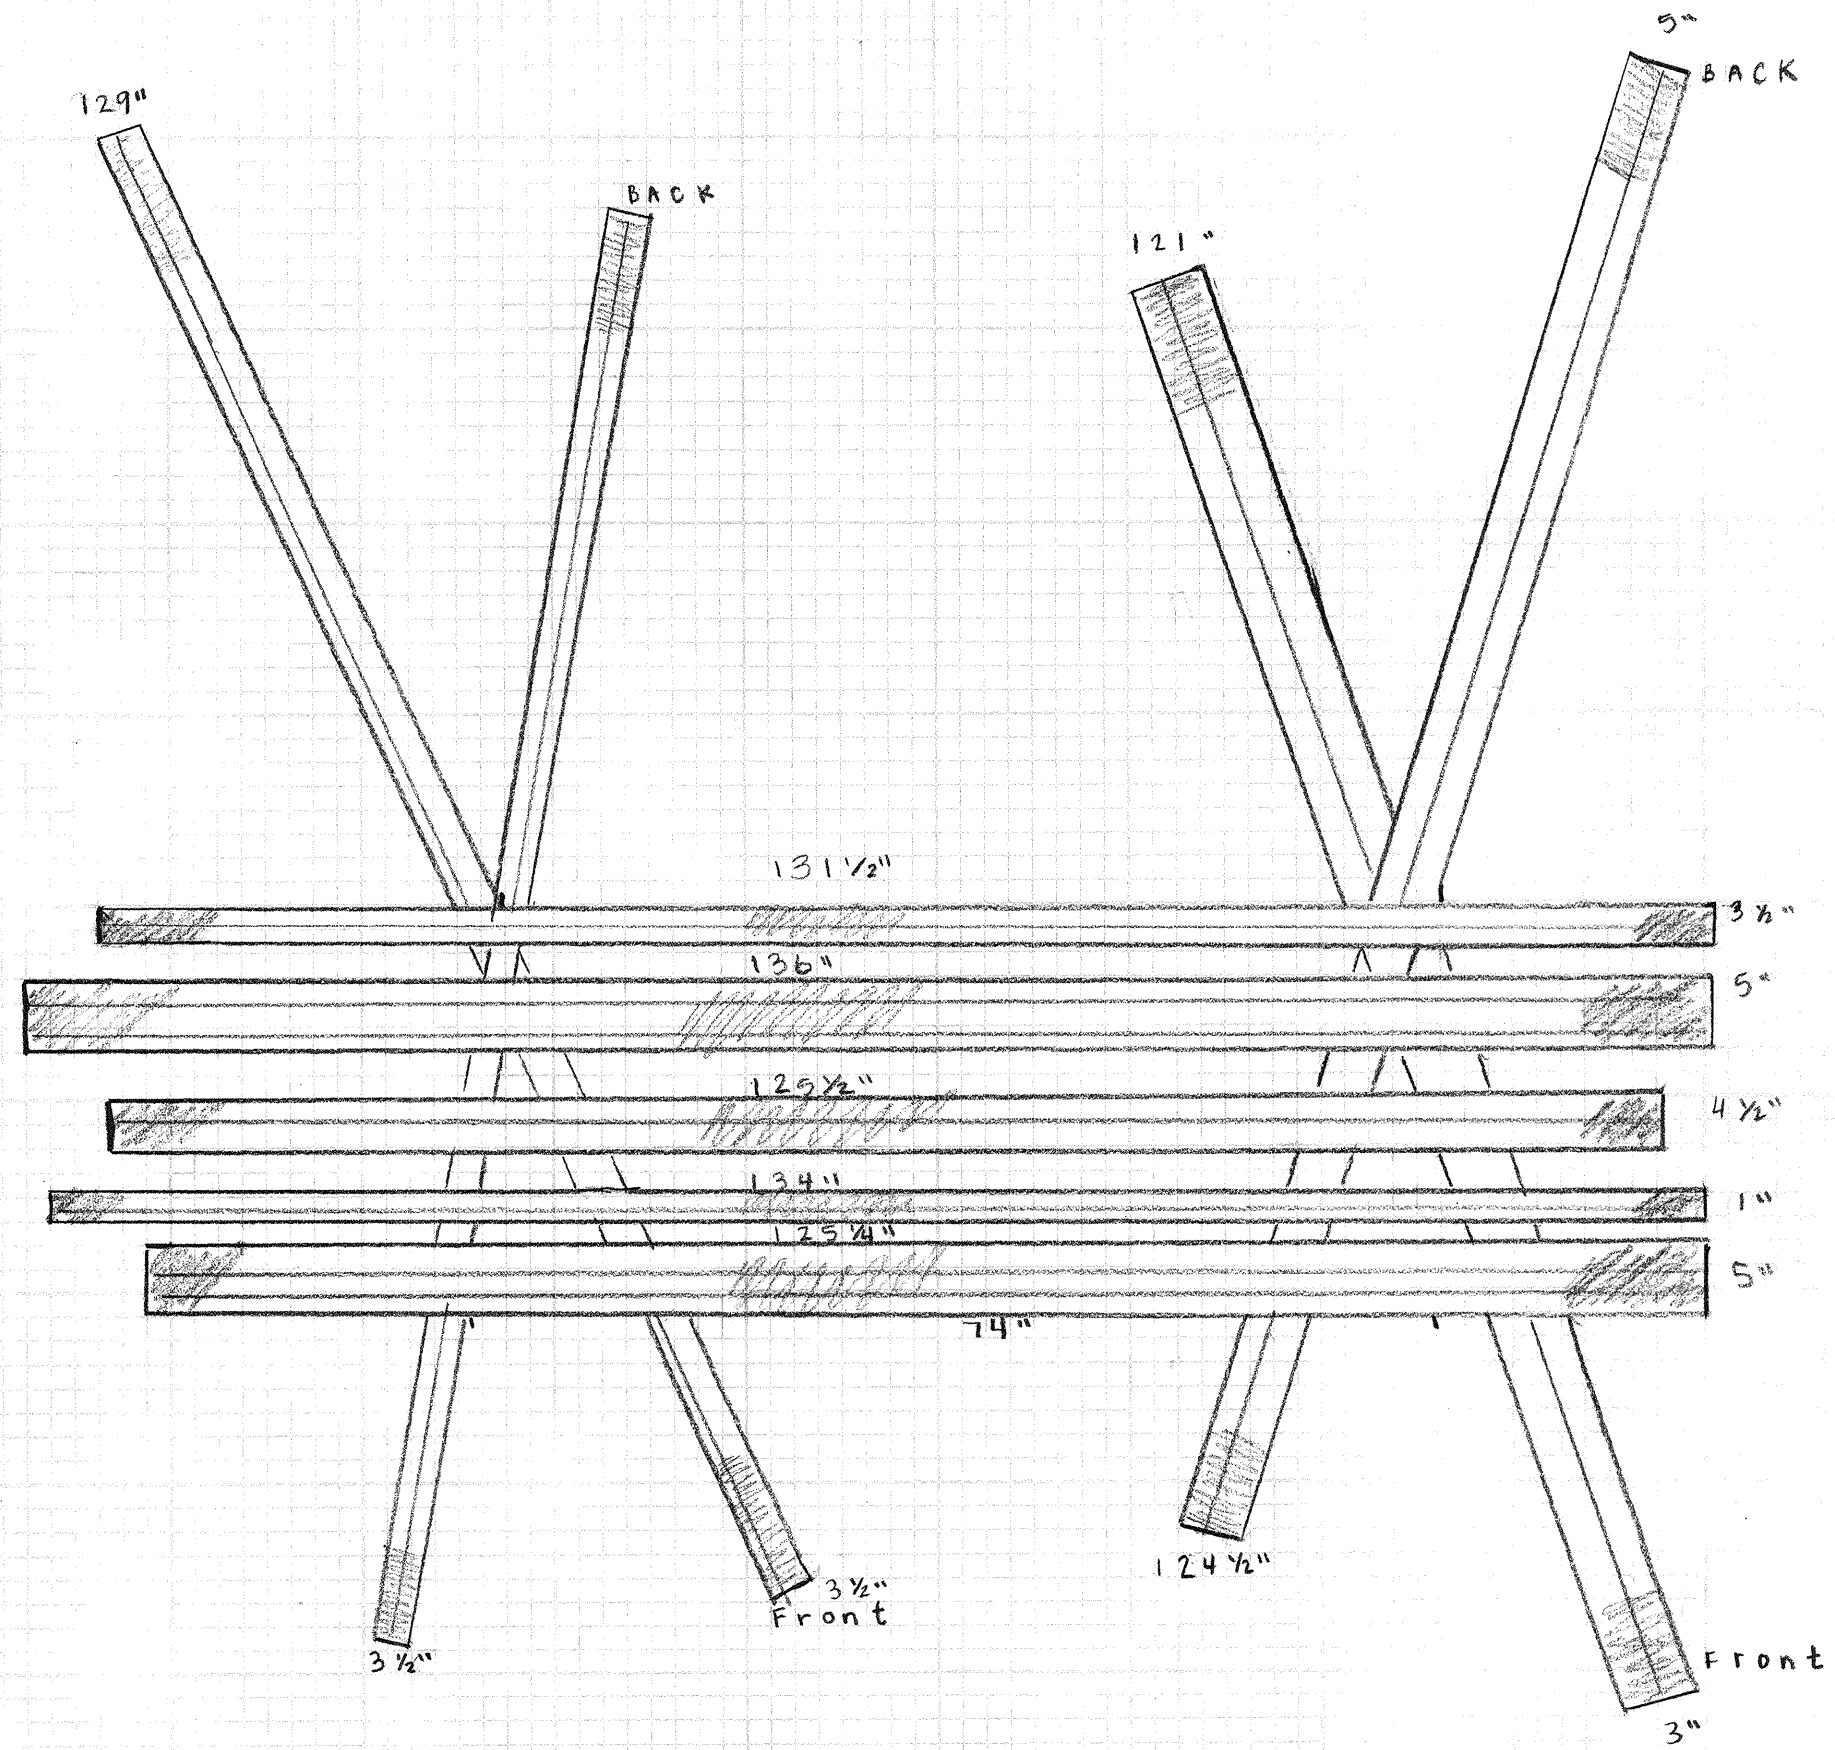
# Zig-Zag

NOTES  
 WOOD  
 1/4" SCALE = 1' 0"  
 Zig-zag Fence  
 RANDI STEPHENS  
 HDCP 299 FALL 10  
 Prof. WARD 12-9-10  
 FINAL DETAIL
