HISTORIC AMERICAN BUILDING SURVEY
NEW TABERNACLE FOURTH BAPTIST CHURCH
HABS #SC-535

Documentary Drawings for New Tabernacle Fourth Baptist Church (Old St. Luke's Episcopal Church)

Prepared by the College of Charleston Historic Preservation
and Community Planning Program
HPCP 299 - Spring 2013
James L. Ward, Assistant Professor

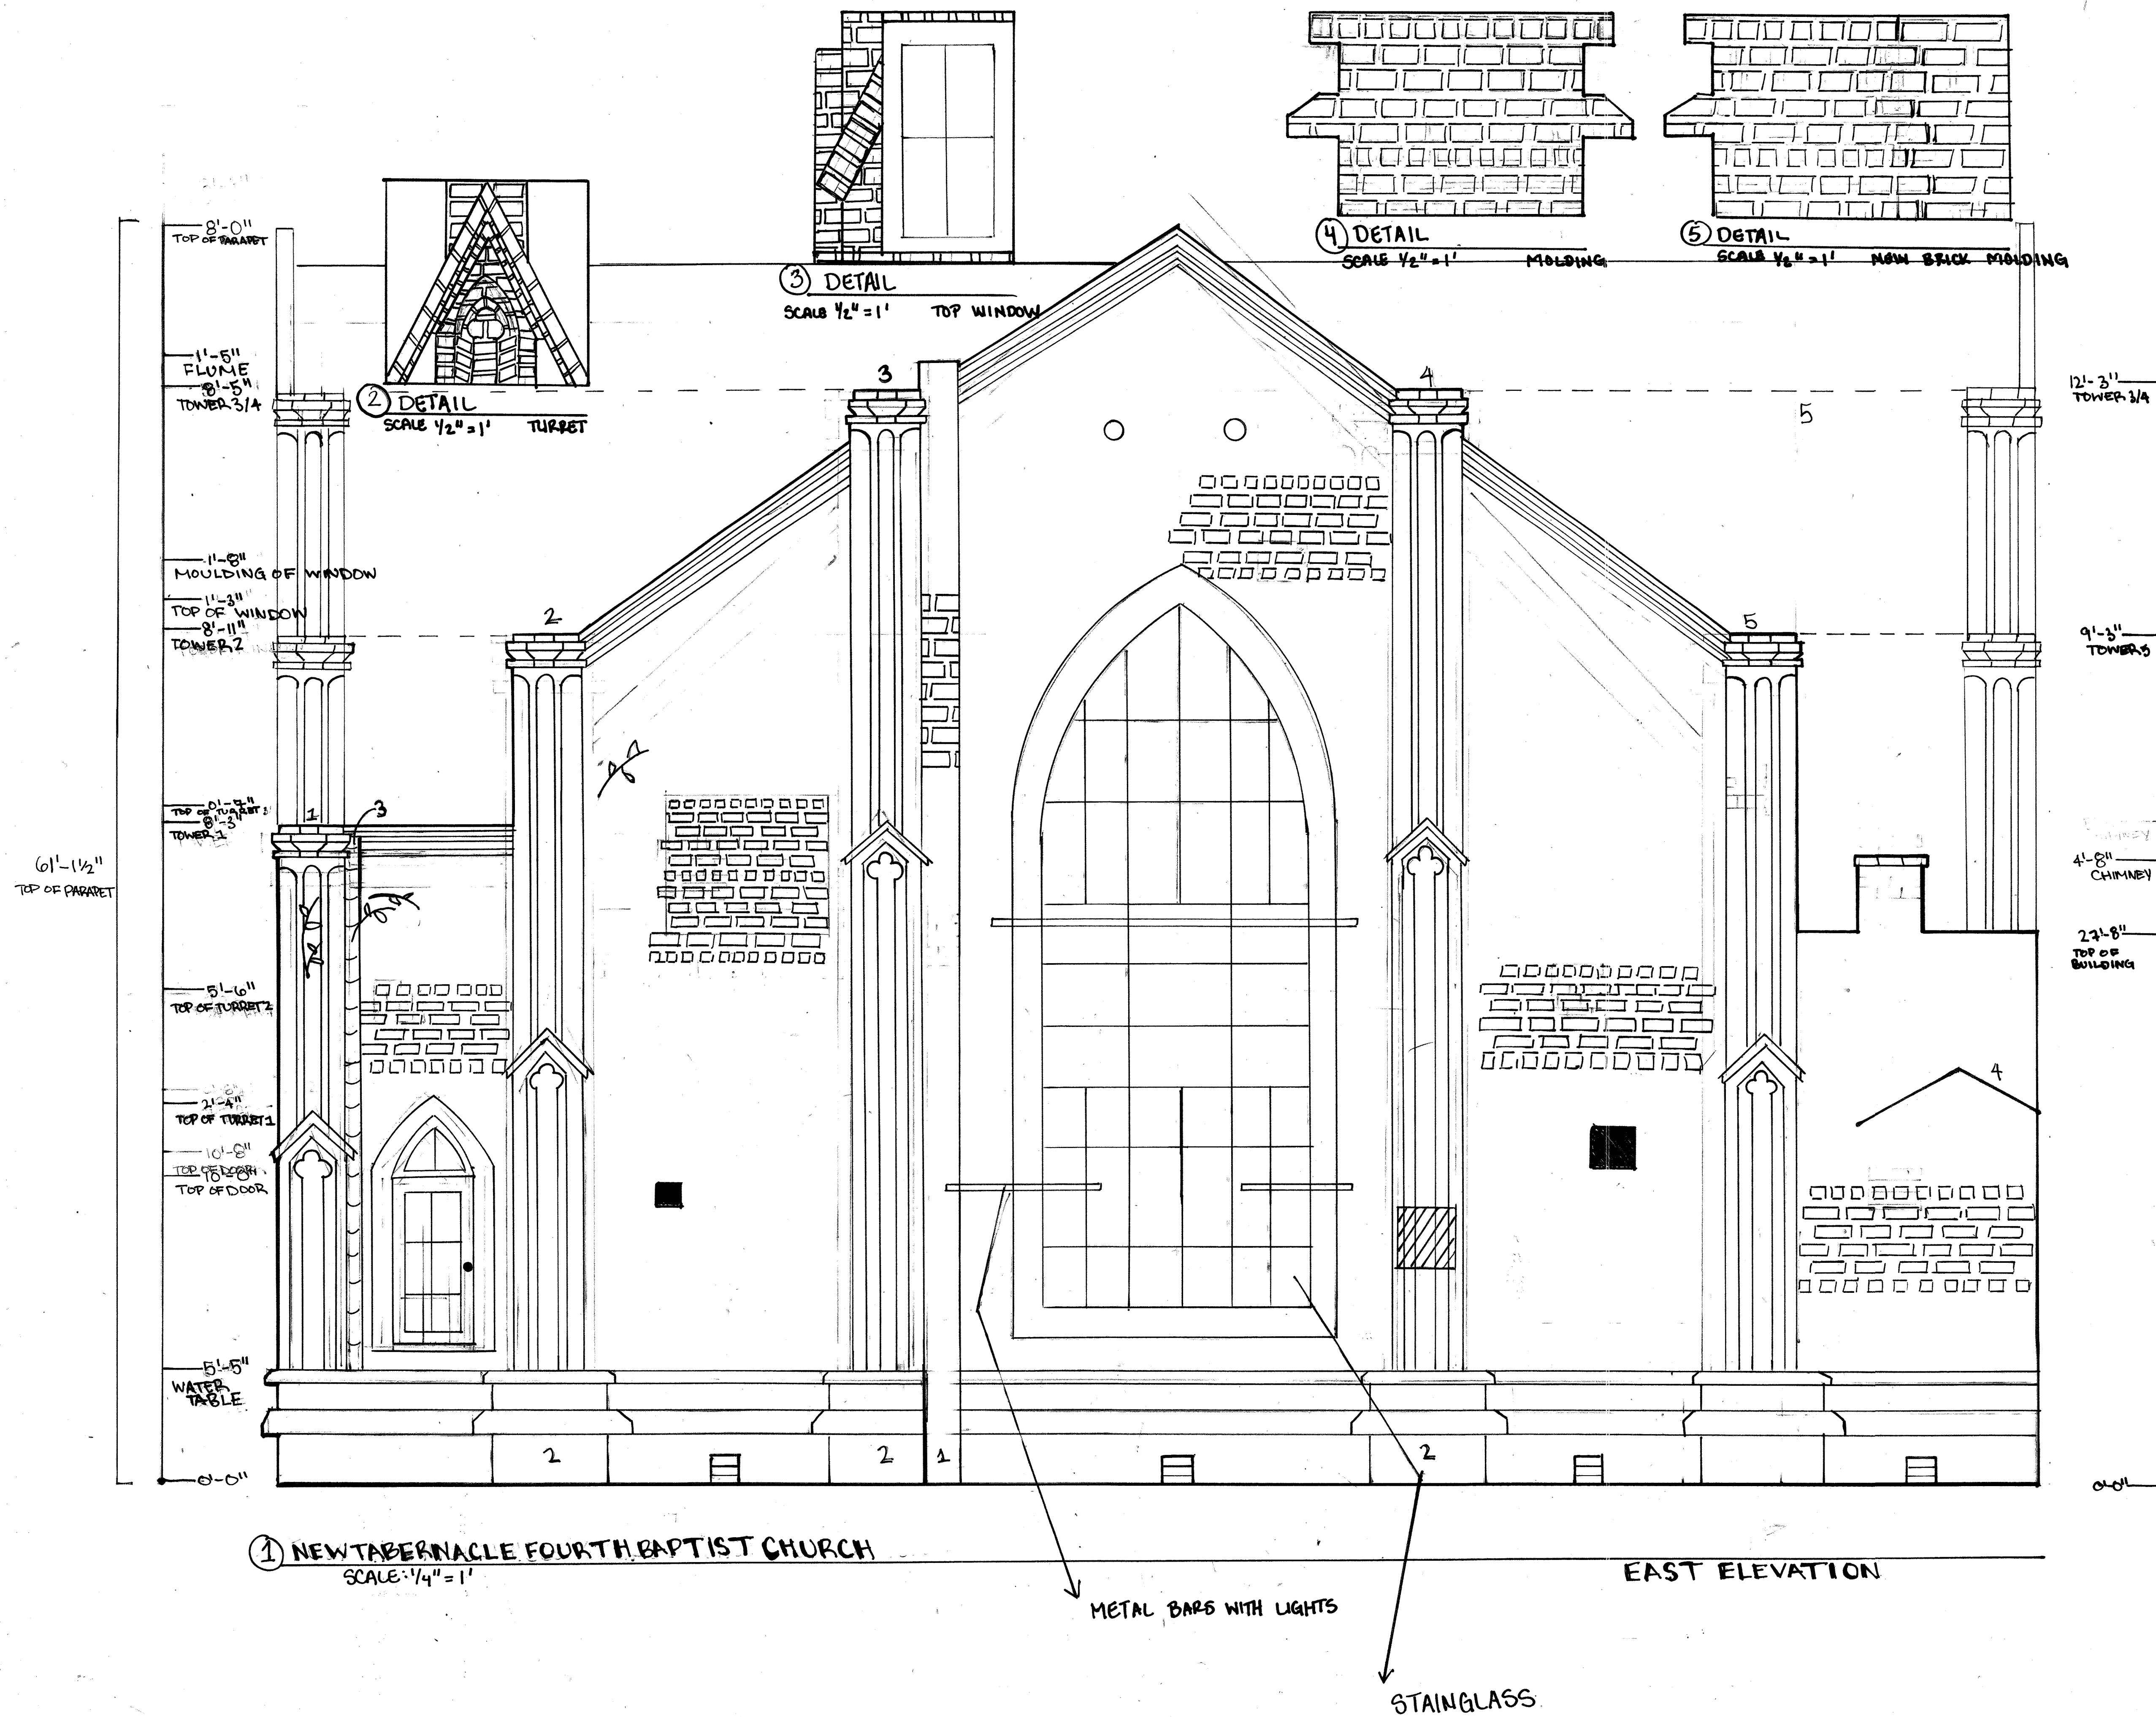
- MISSING BRICK
- MISSING MORTAR
- METAL BASEMENT VENTS
- EARTHQUAKE BOLTS
- PLANTS GROWING IN MORTAR

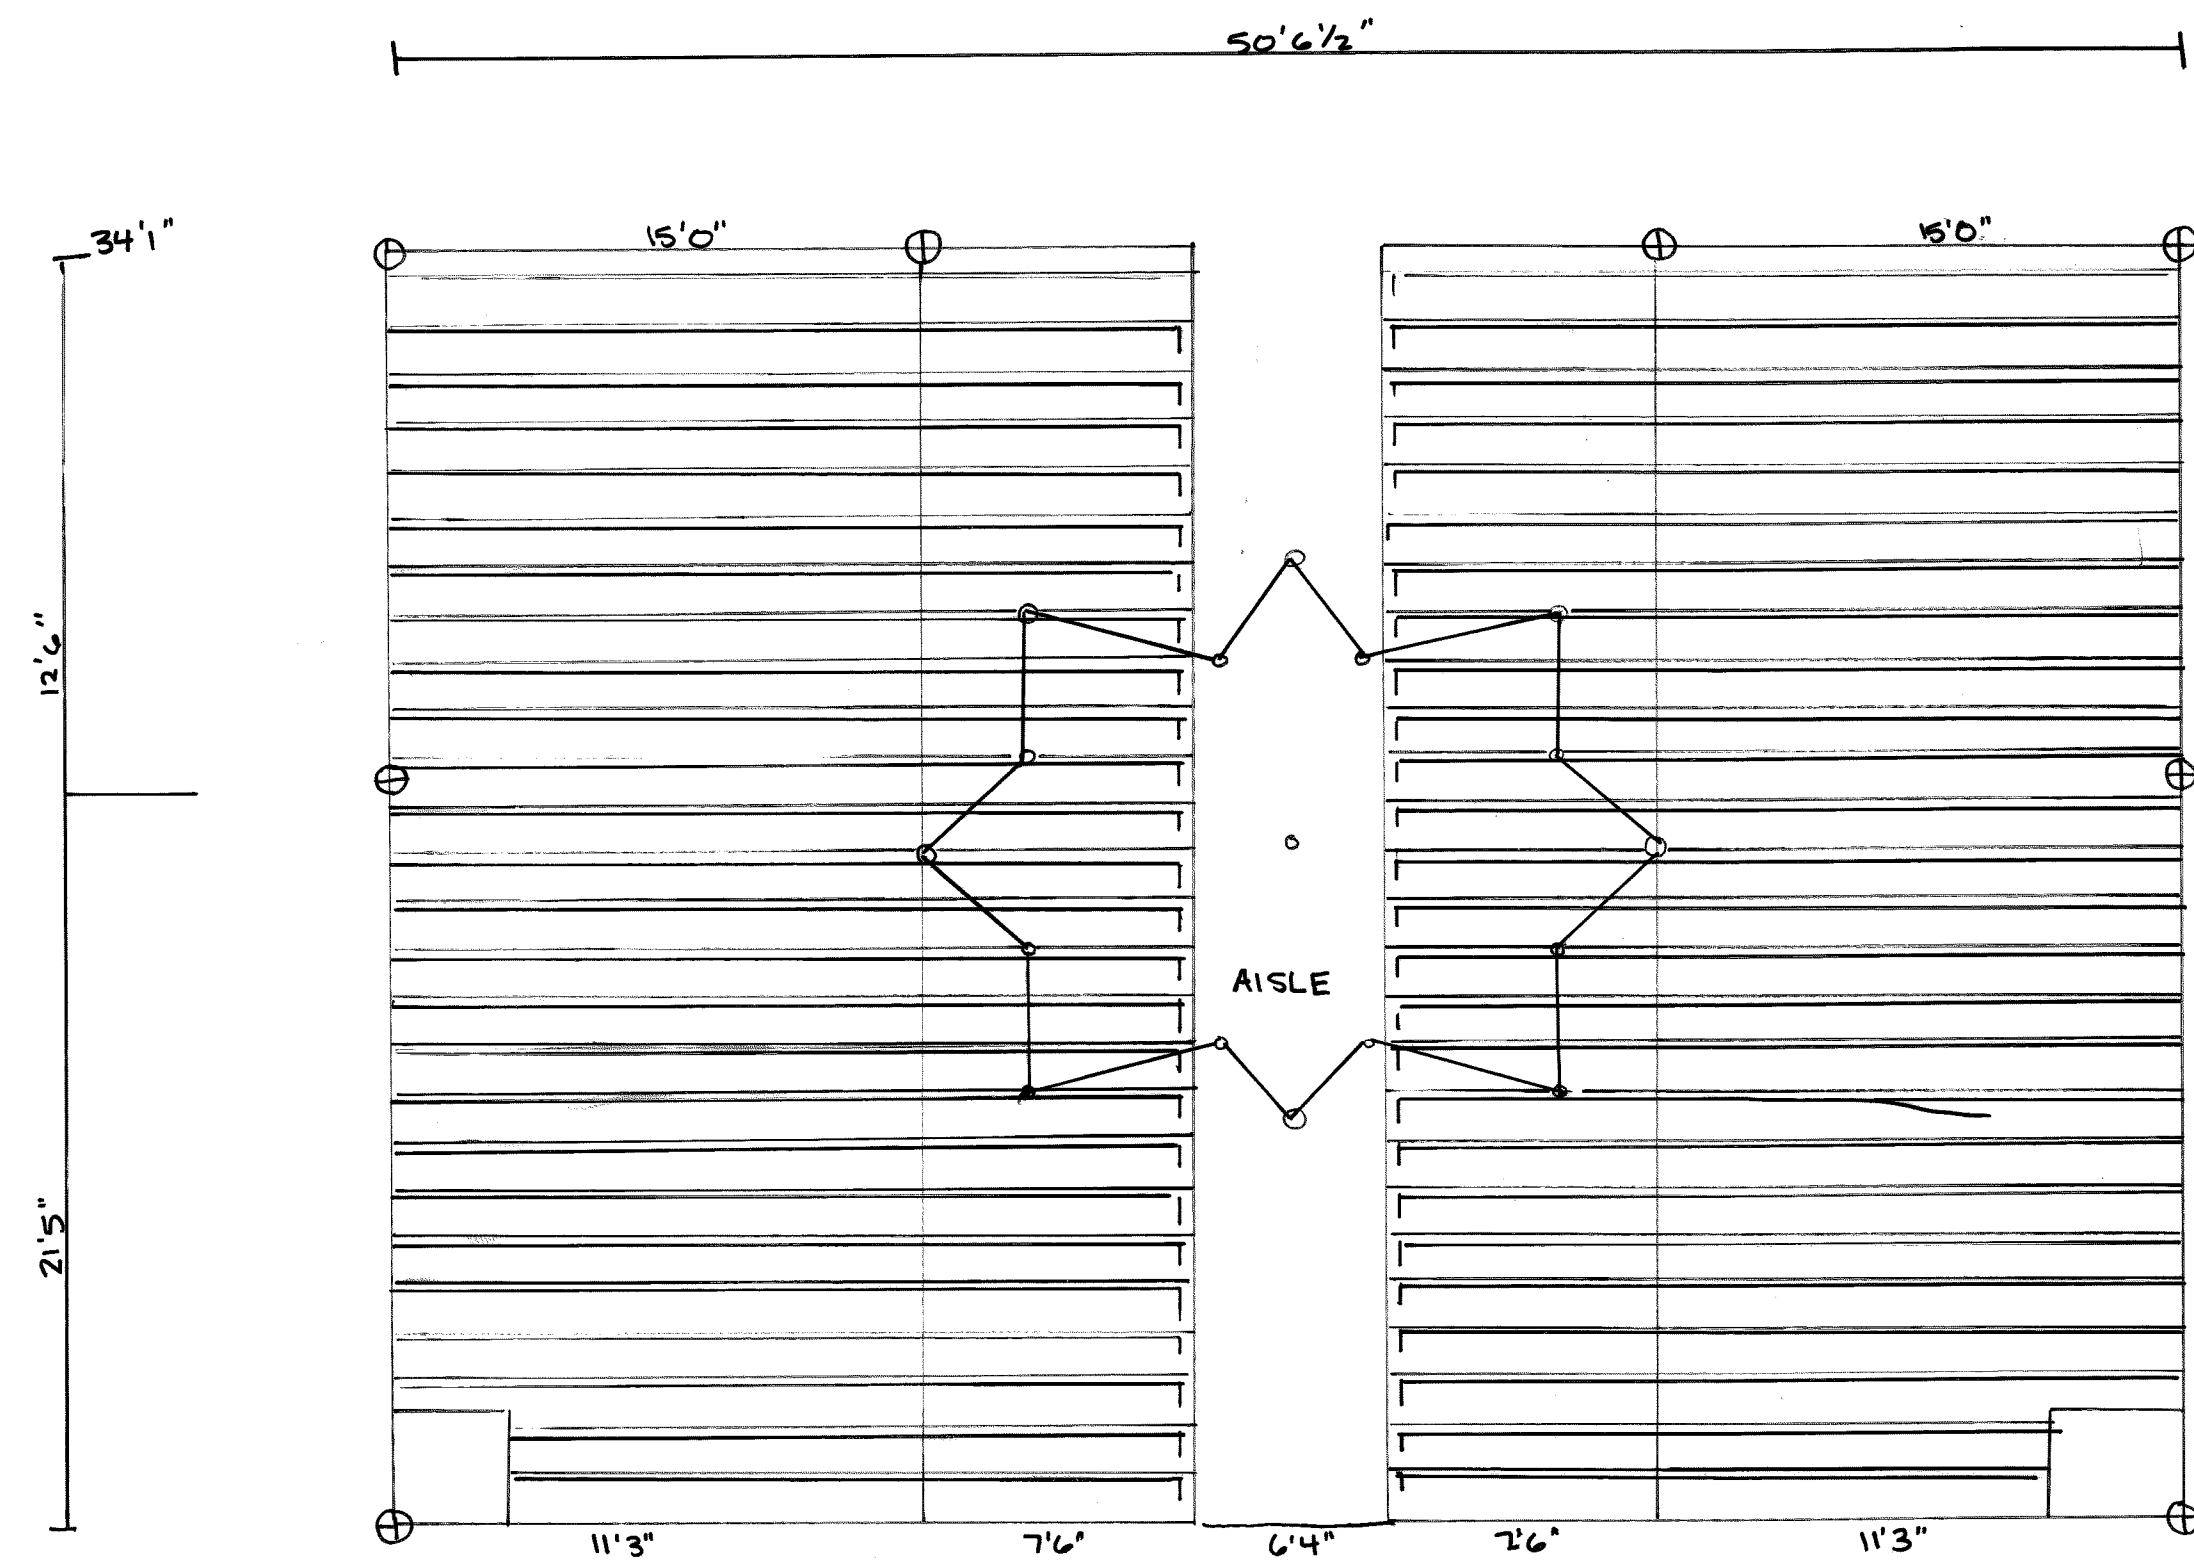
MOLDINGS ON REFLECTED CEILING

A plaster ceiling in a historic home gives character to the building. In this case, the New Tabernacle Fourth Baptist Church was built for St. Luke's Episcopal Church, as a Gothic Revival structure, in 1862. Later in 1950, the New Tabernacle Fourth Baptist Church purchased the property and made it their own. Along with the new property came great responsibility. The plaster ceiling had faded, some ceiling moldings were broken, and there was significant water damage.

If the plaster ceiling has faded, a new coat over the previous coat can fix the problem. For the ceiling medallions, some have been broken off completely, so using research to find the specific details for how the plaster medallions was originally designed should be used in restoring the medallions of New Tabernacle. According to Preservation Brief 23, historic ornamental plaster is made of gypsum and lime which are stable and durable materials. An extremely versatile material, plaster can be modeled, cast, incised, colored, stamped, or stenciled. However, as an integral part of the building system it is subject to the typical problems of water intrusion, structural movement, vibration and insensitive alterations, and pieces that are deteriorated or damaged beyond plain patching must be removed and replaced with new pieces that exactly match the existing historic plaster. There are multiple sources of water damage in the Church, occurring from the walls, windows, drainage, and roof leaks. Preservation Brief 21 explains that with roof leaks causing ceiling damage, coatings applied to the interior are not effective in the long run. The moisture problem must be stopped on the outside of the wall.

The ceiling at New Tabernacle Fourth Baptist Church needs to undergo major repairs to stop the historic ceiling from deteriorating, and to stop water damage from influencing the deterioration.

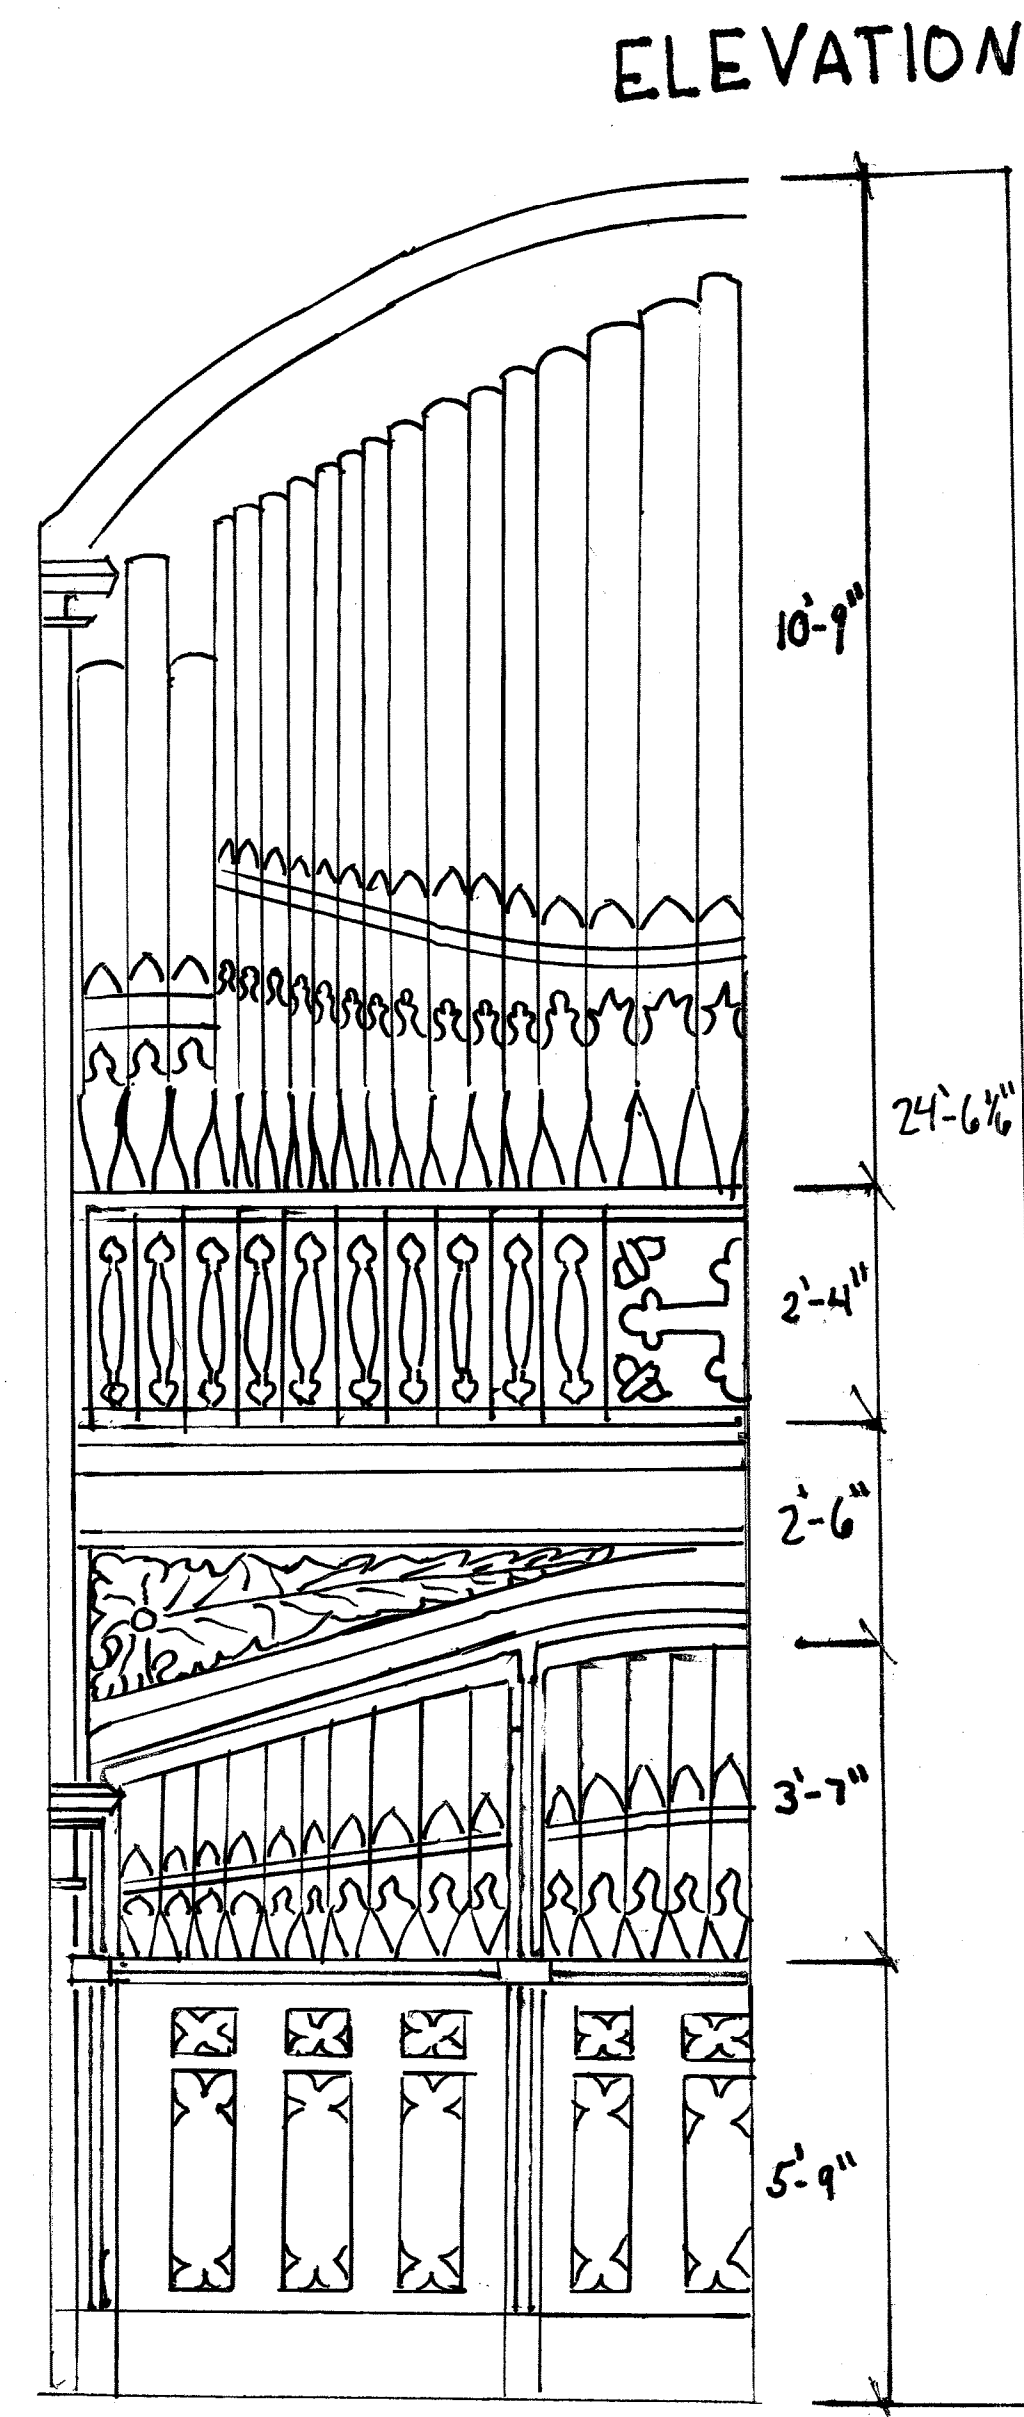
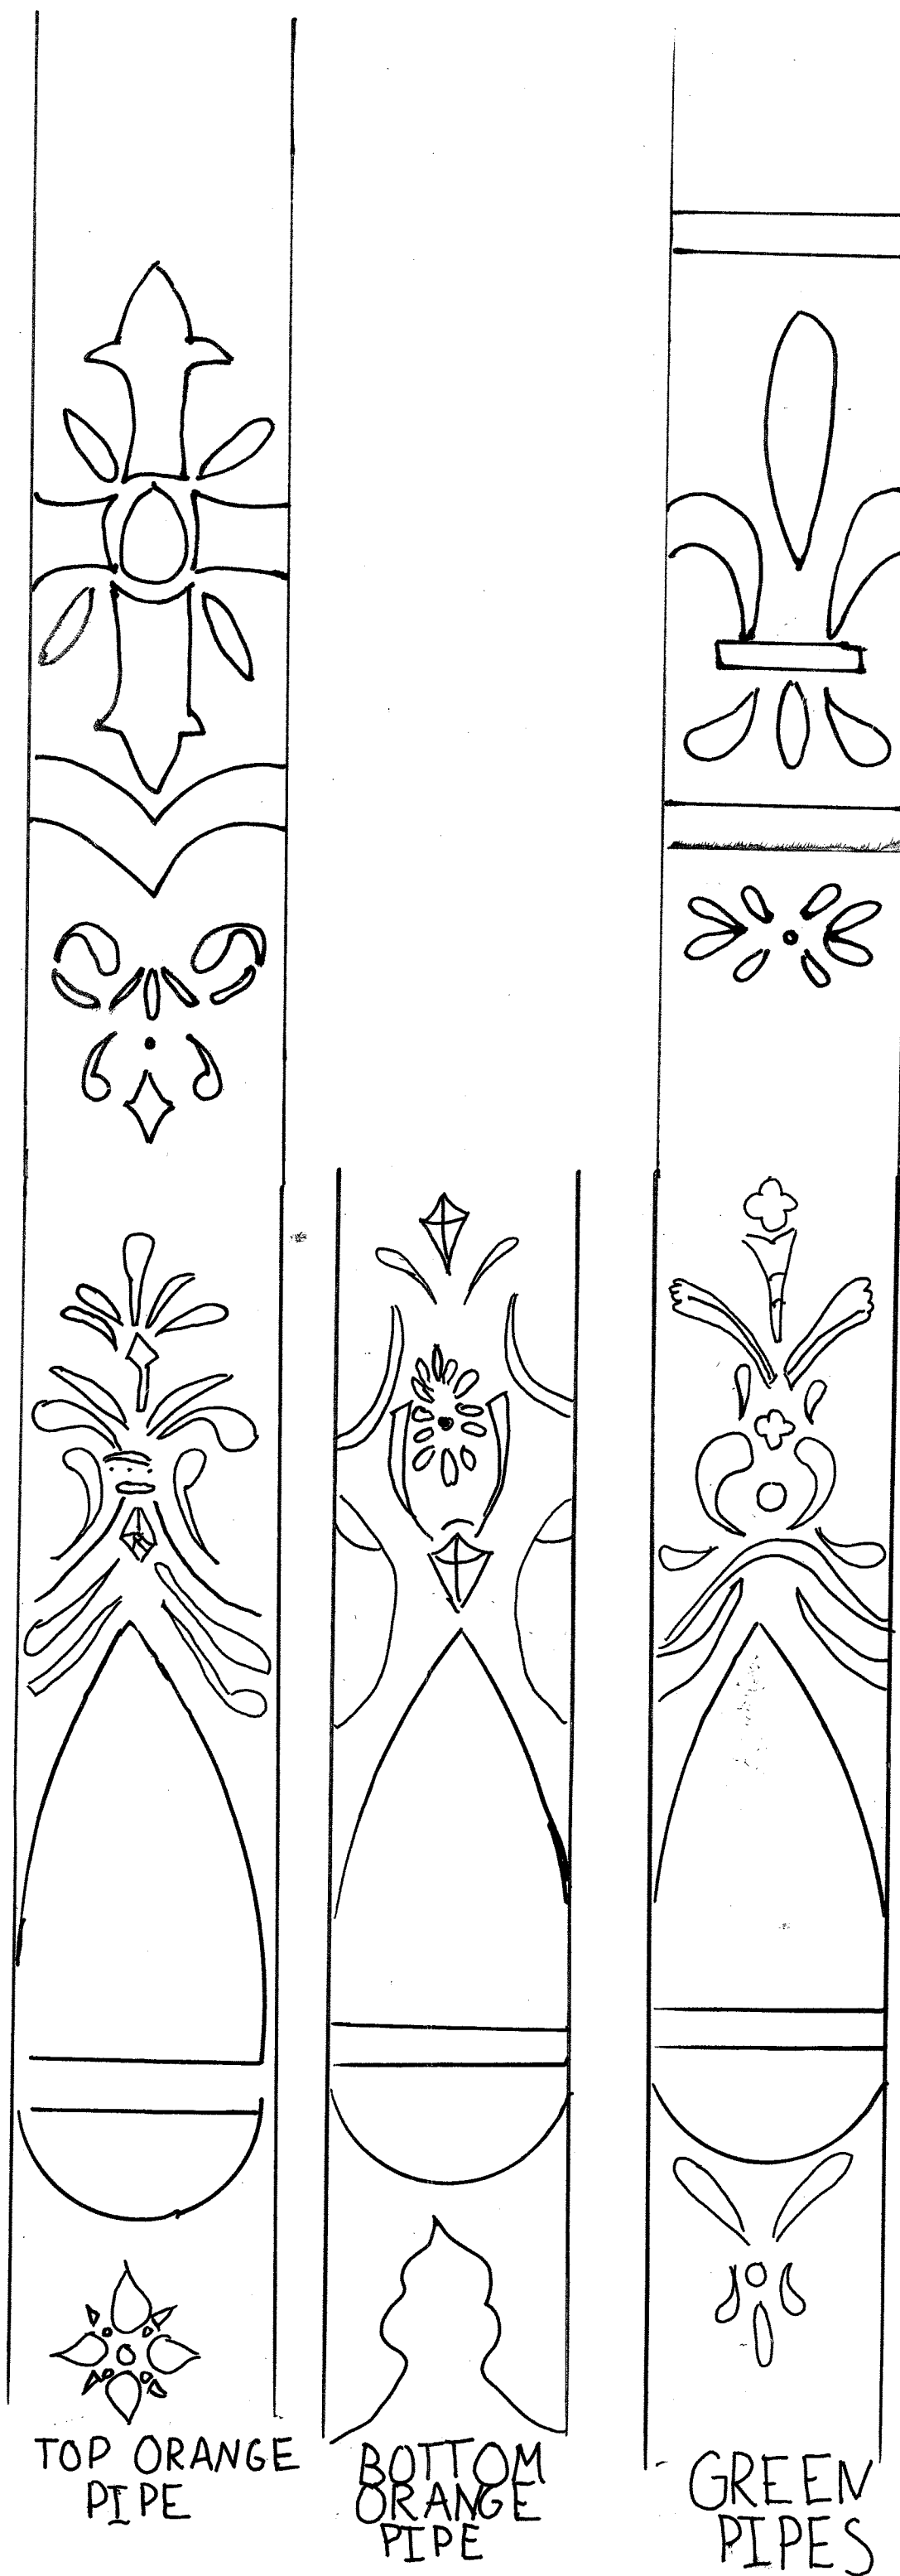
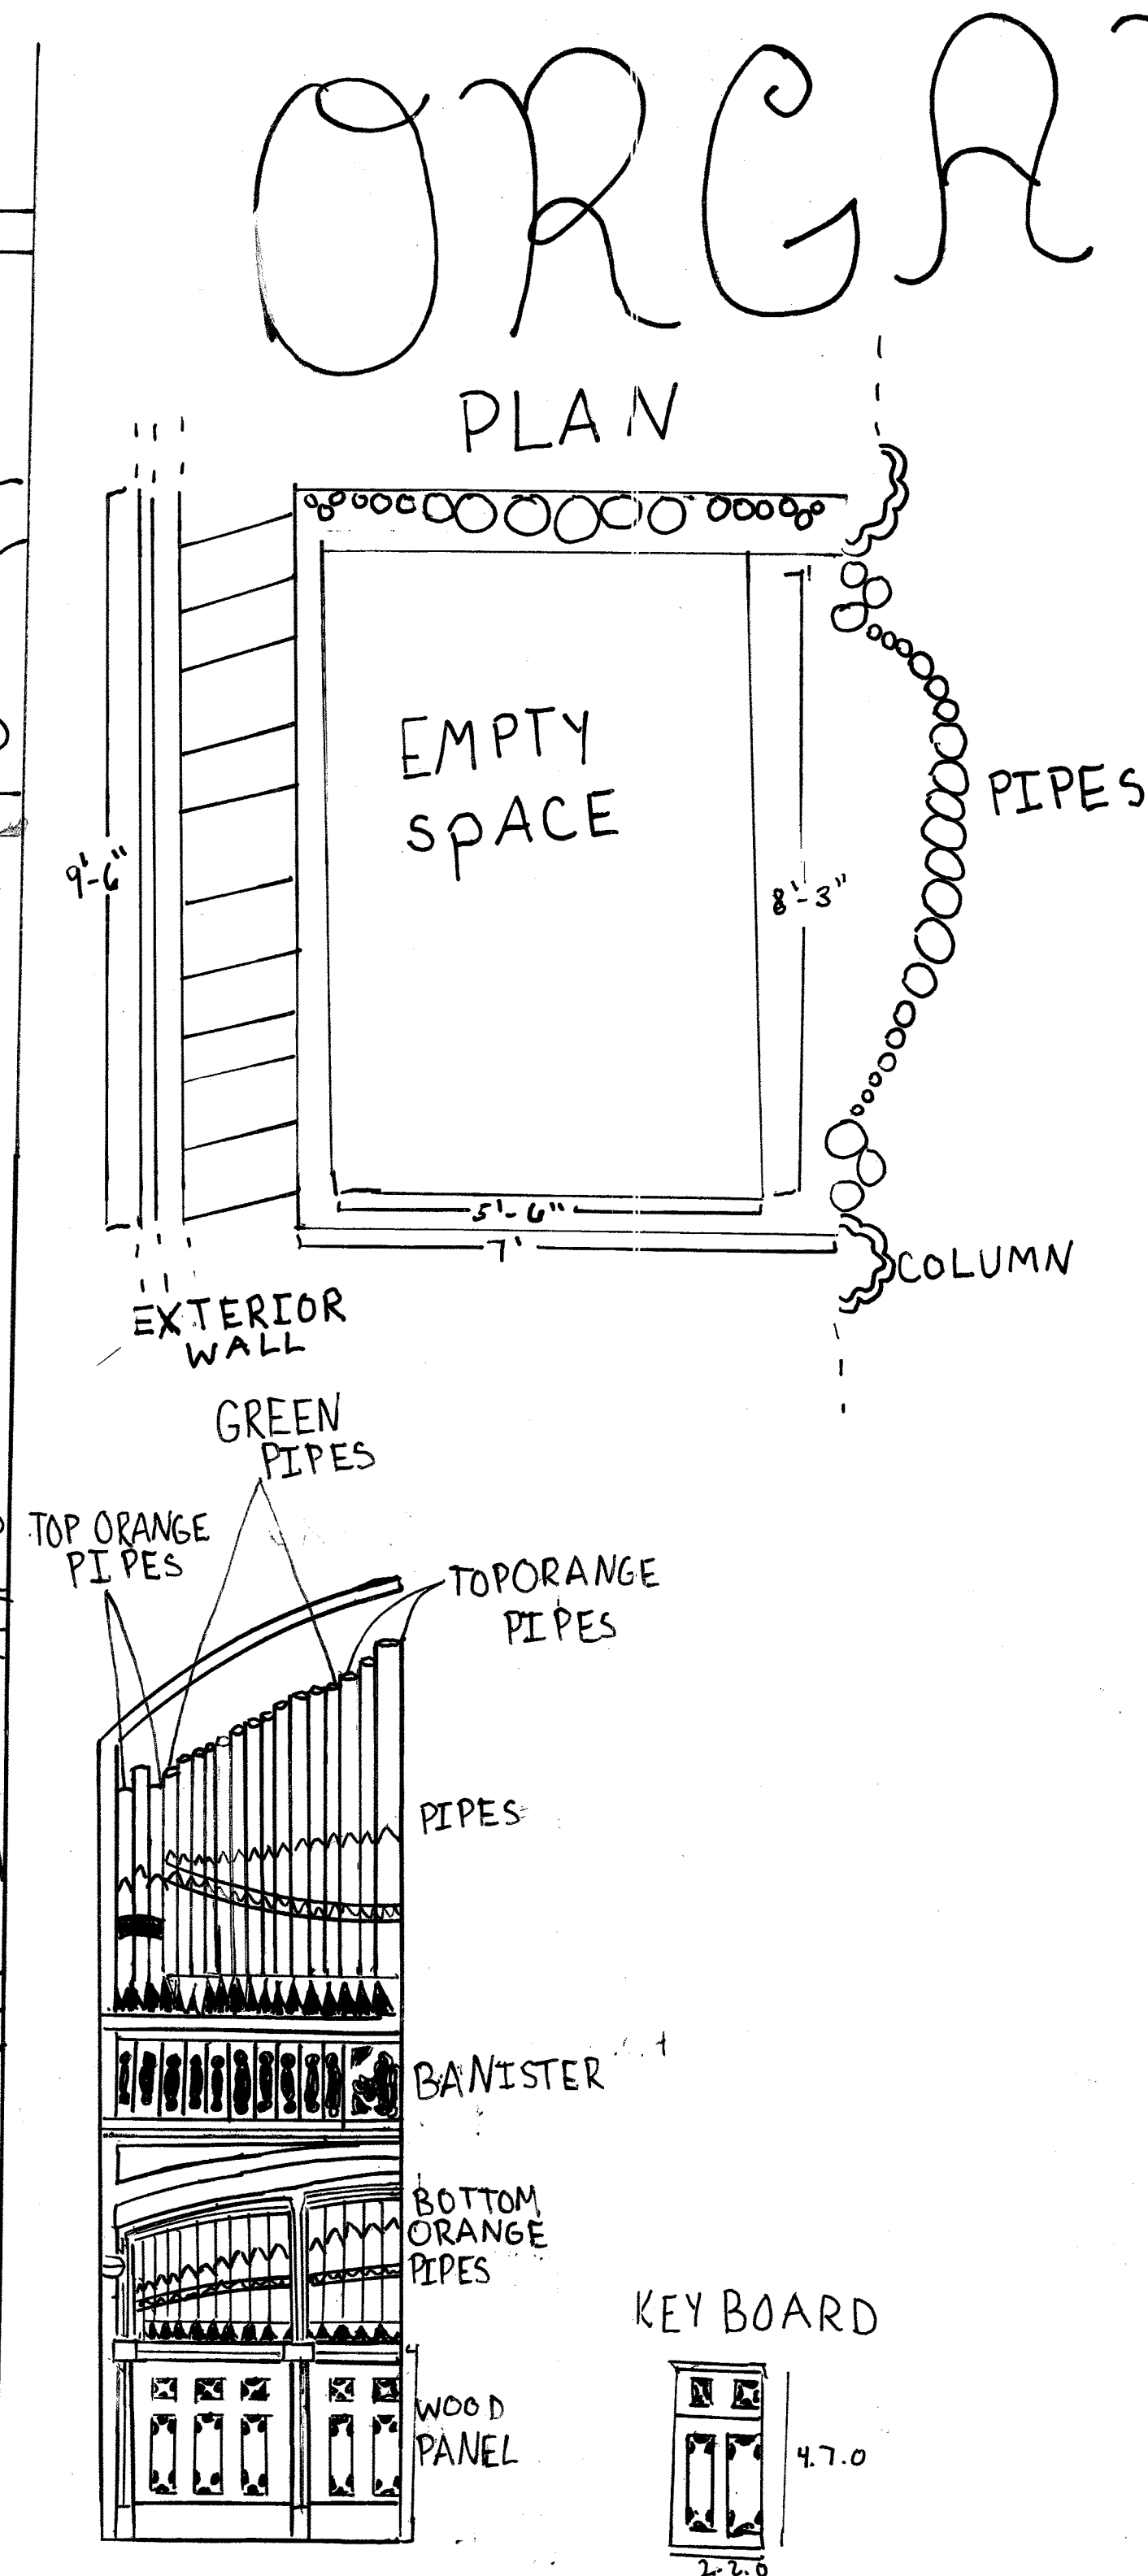
PIPE
DETAIL

- NOTES
- PIPES OF THE ORGAN COULD NOT BE MEASURED
 - LEFT AND RIGHT SIDE IDENTICAL
 - KEY BOARD IN FRONT OF FAR RIGHT SIDE
 - THICKER TOP PIPES ARE ORANGE OTHERS ARE GREEN
 - BOTTOM PIPES ARE ORANGE

The first step in maintaining this organ is to check all the systems in it. The pipes of the organ need to be cleaned so there are no foreign substances lodged in the pipes. To do this, the pipes must be gently brushed. No harsh cleaners can be used or abrasive brushing/ blowing methods. The stoppers, which control pitch, have to be checked to make sure they have not moved. The move when temperature changes dramatically. The keys on the organ need to be looked out. They have to have the right amount of friction to be effective. Moisture and dust in the pin and felt of a key, which help is where a key is connected to make vibrations, can cause too much or not enough friction. In cleaning the keyboard there needs to be care if the keys are handled roughly they can break. In general, organs do not react well in humidity. Their needs to be a balanced temperature and moisture content in the church to make sure the organ does not deteriorate. Along with a steady atmosphere, a professional should do an annual maintenance on it. Also the general public should not handle it.

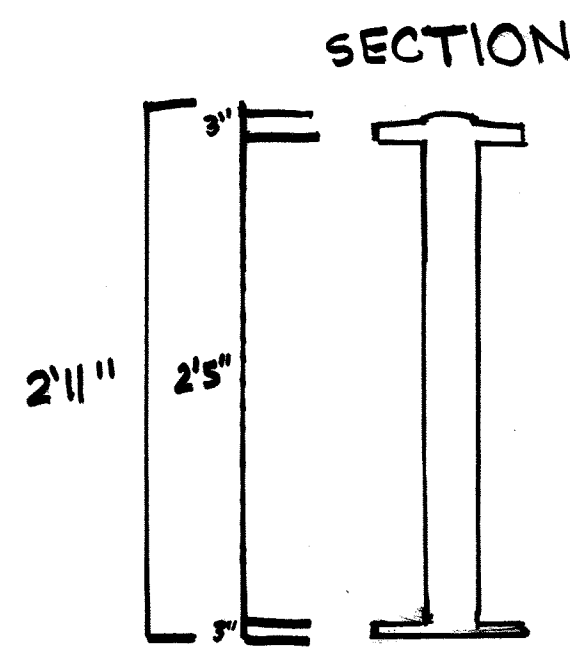
BALCONY RAILING AND SPANDREL

The impact of the detail featured in the drawing is to remain as historic as possible in its original state if possible. The condition needs proper care and changes need to be made in order to maintain the function of the balcony as well as its historic features and design. In order to preserve the balcony and its features, one needs to take into consideration the materials that were used in the initial construction, as well as to make sure that all necessary alterations and fixes are done in the proper manner to preserve its character.

As a preservationist, I would suggest using the West Systems to repair any affected areas on the balcony and surrounding detail, mainly because it appears to be the most affective. Sanding down the balcony for repainting also needs to be done in order to restore the entire finish of the wood. Proper paint needs to be matched as closely to the original paint as possible in order to keep as much historic character as possible. Any support that needs to be done for the entire structure also needs to be considered during repair. Always consider proper safety measures for the structure, and furthermore for whoever may be making the repairs to protect themselves from exposure to paint and other harmful agents.

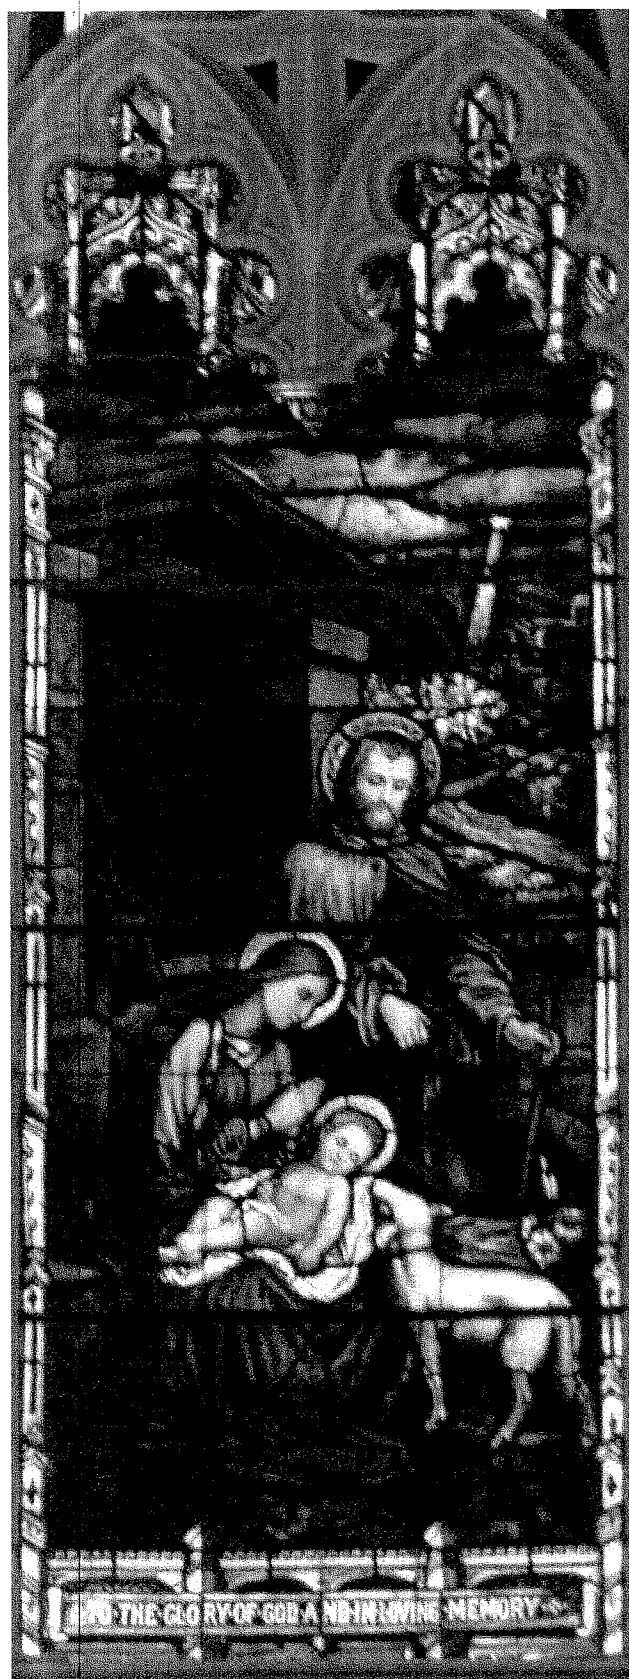
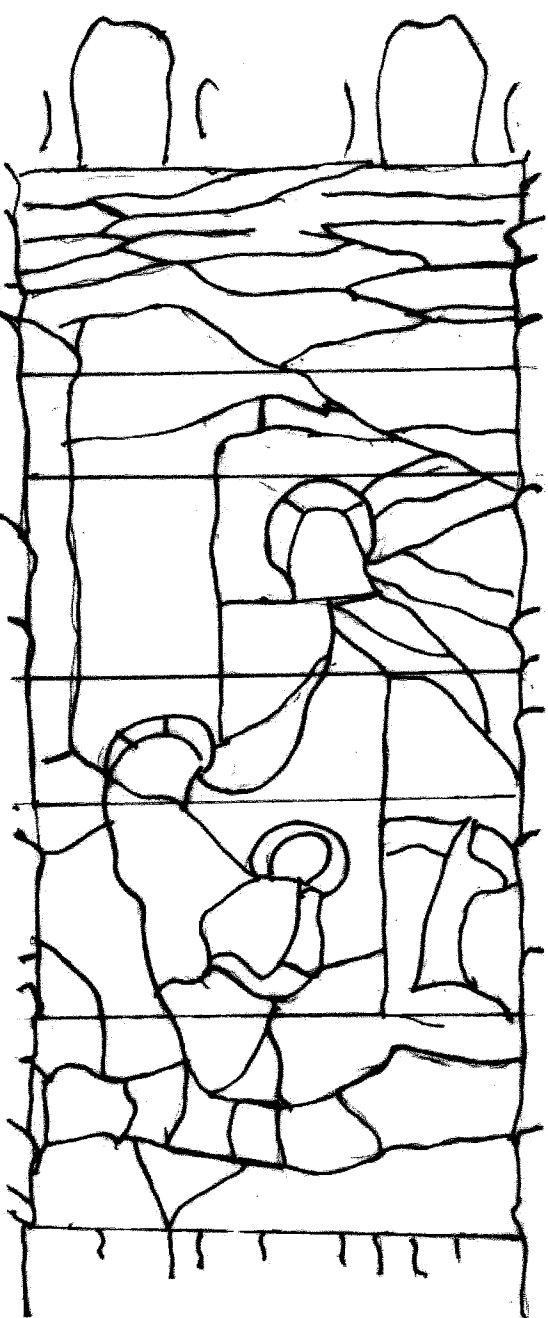
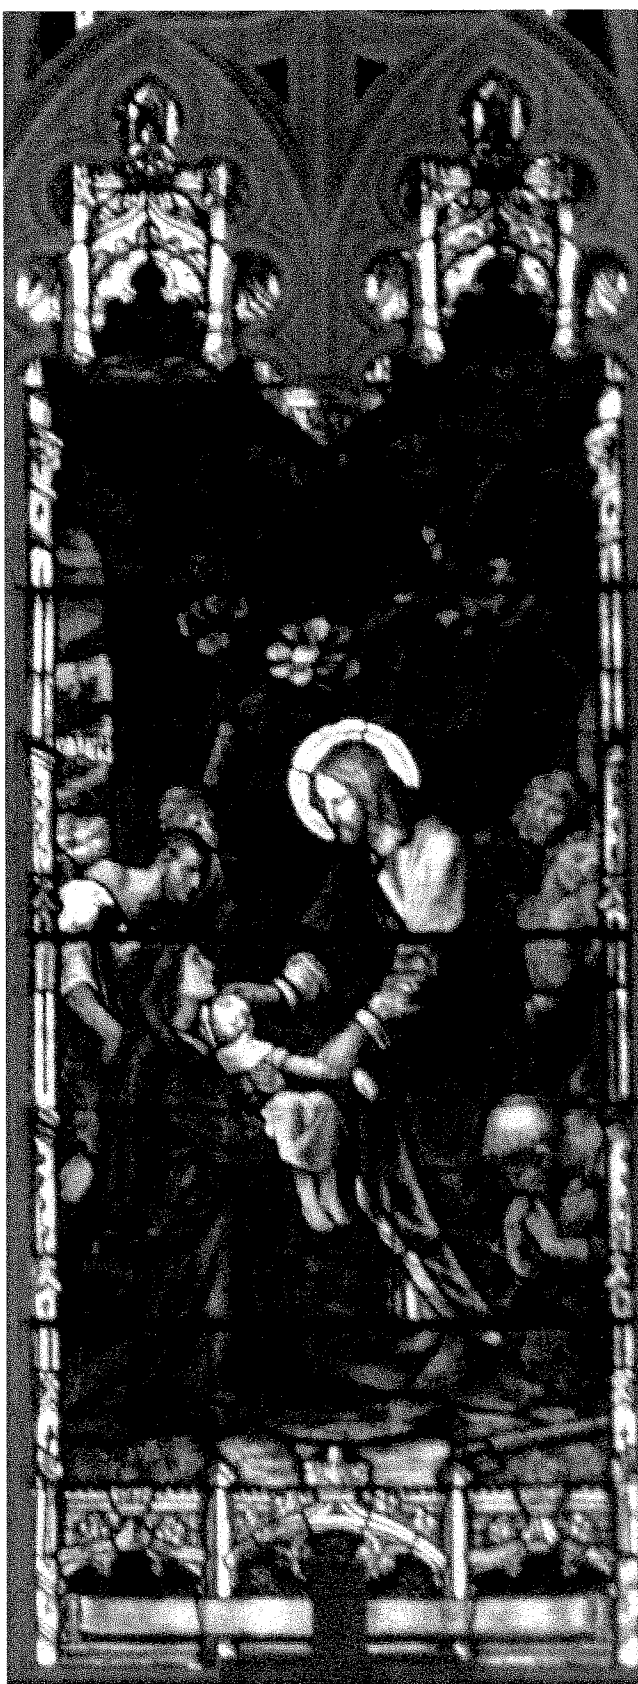
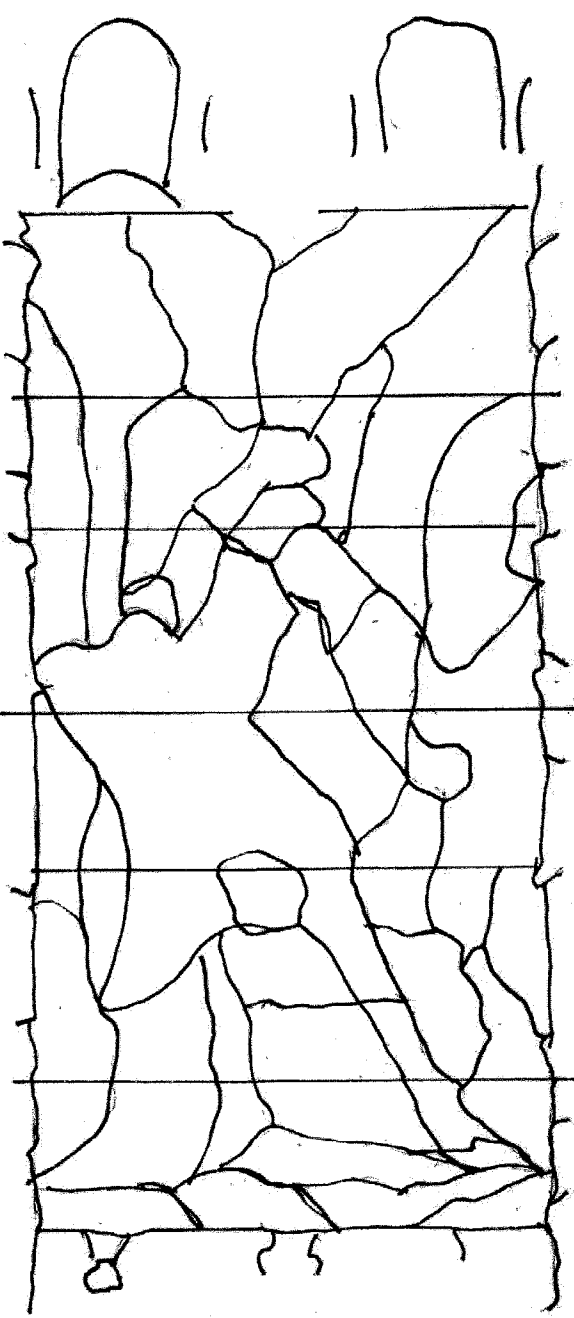
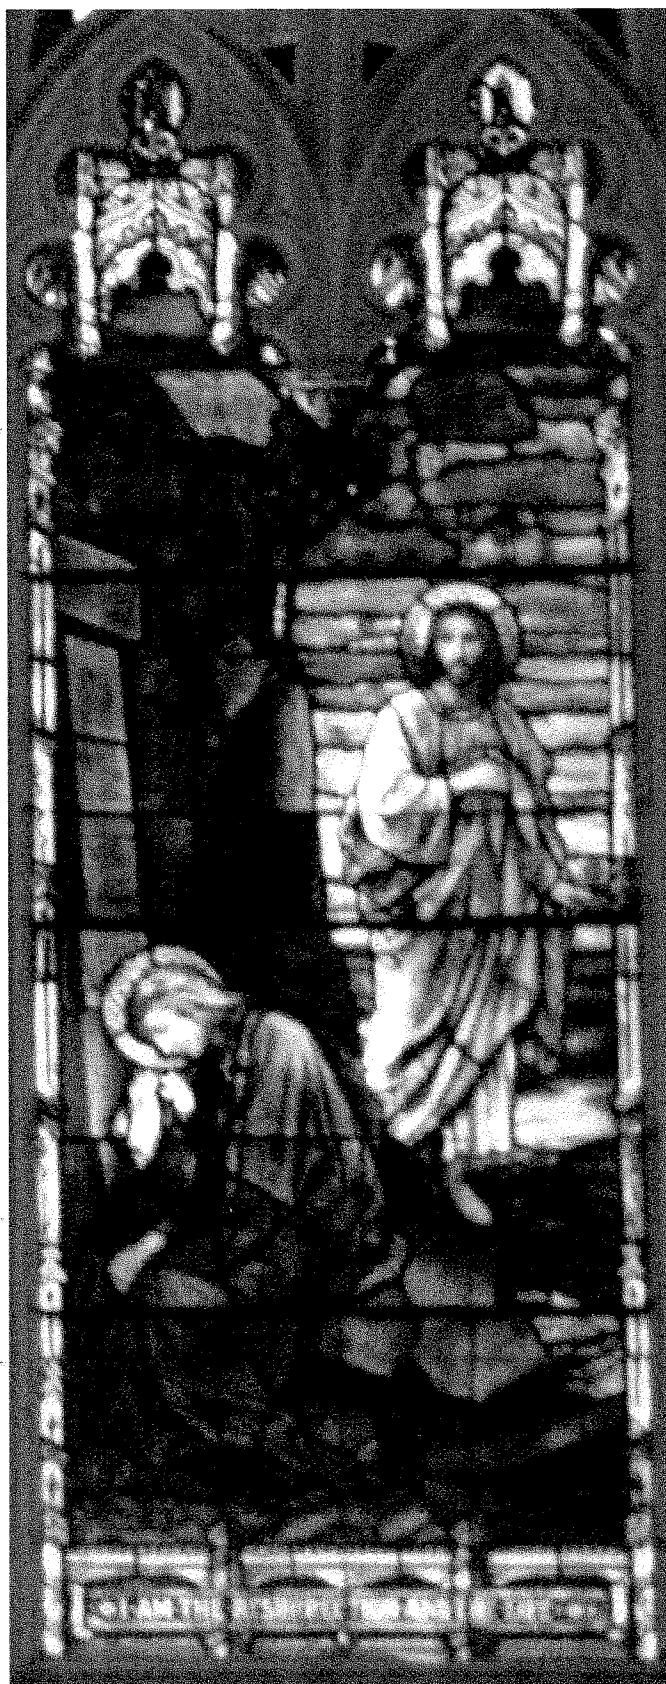
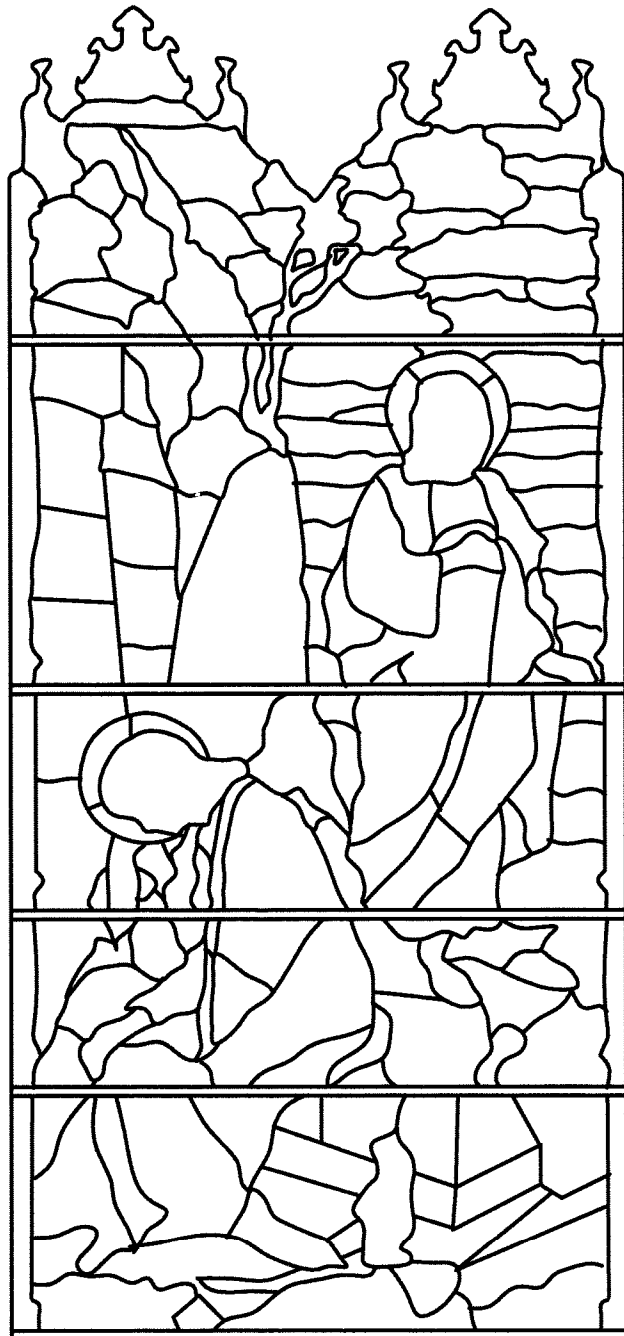
THE GREATEST THREAT TO THE WINDOW MATERIALS THEMSELVES IS PHYSICAL IMPACT. THIS IS ESPECIALLY TRUE AT NEW TABERNACLE WHERE THE WINDOWS TAKE UP SUCH A LARGE SURFACE AREA OF THE FACADES AND THE BUILDING IS LOCATED ON SUCH A PROMINENT STREET CORNER, UPPING ITS EXPOSURE TO FLYING ROCKS AND OTHER THREATS. GLASS CAN ALSO CRACK WHEN EXPOSED TO TOO MUCH PRESSURE OR VIBRATION FROM NOISE AND TRAFFIC. THE PAINTING ON STAINED GLASS IS ALSO AN IMPORTANT CONSIDERATION, AS THE WINDOWS SIGNIFICANCE IS REFLECTED IN THE SCENE IT PORTRAYS. IMPROPERLY FIRED GLASS CAN LEAD TO PAINT DETERIORATION AND FLAKING. THIS WINDOW IS MADE OF PAINTED GLASS AND THEREFORE MUST BE CLEANED VERY GENTLY.

DIFFERENT PIECES AND COLORS OF GLASS ARE SUPPORTED AND HELD IN PLACE BY THIN LEAD BARS CALLED LEAD CAME. IF THESE METAL PIECES ARE TO CORRODE OR FAIL, THE GLASS WILL FOLLOW SUIT AND BEGIN TO CRACK. THE STRENGTH OF THE LEAD CAME IS DEPENDENT UPON ITS CROSS SECTION AND THE RATIO OF THE HEART TO FLANGES. OVERLAPPING THE CAME ALSO LEADS TO AN INCREASED STRENGTH OF THE STRUCTURE. THE LEAD CAME IN THIS EASTERN WINDOW IS OF PARTICULAR IMPORTANCE AS IT WAS CUSTOM DESIGNED FOR THESE PAINTED GLASS PIECES. THIS MEANS THAT THE QUALITY AND CRAFTSMANSHIP OF THIS WINDOW ARE OF THE HIGHEST DEGREE. IT ALSO MAKES THEIR PRESERVATION BOTH IMPORTANT AND DIF- FICULT.

THE WINDOWS AT NEW TABERNACLE ARE FRAMED IN WOOD WHICH LEADS TO SEVER- AL ISSUES. MOISTURE INTRUSION IS PARTICULARLY EVIDENT AT WINDOW OPENINGS AND AS THE WOOD ROTS IT BECOMES A THREAT TO THE INTEGRITY OF THE ENTIRE STRUCTURE.

THE WINDOWS SHOULD BE GENTLY CLEANED AND THE PROPER PRECAUTIONS SHOULD BE USED TO REINFORCE THE WATERPROOFING AROUND AND WITHIN THE WOODEN FRAME. THIS MAY REQUIRE RECAULKING OF THE STRUCTURE AND A RE- POINTING OF THE SURROUNDING MASONRY. THE GLAZING WHICH ADHERES THE LEAD CAME TO THE GLASS SHOULD ALSO BE CHECKED FOR CONDITION AND THE PROPER REPAIRS SHOULD BE MADE.

IMPROPERLY CARED FOR GLASS AND LEAD CAME ARE MUCH MORE LIKELY TO DE- TERIORATE. YET, IT IS IMPORTANT TO MAINTAIN THAT THE WINDOWS ARE CARED FOR IN THE GENTLEST MEANS POSSIBLE, AS HARSH CHEMICAL SUBSTANCES CAN RE- MOVE PAINT AND LEAD TO FURTHER LEAD CAME CORROSION. THE WINDOWS NOW, HAVE NOT BEEN PROPERLY CLEANED AND THE DIRT AND DEBRIS IS LEADING TO A MORE RAPID BREAKDOWN OF THE PAINTED SCENES. MAINTENANCE, PROTECTION AND PRESERVATION SHOULD START BY CONTACTING A CERTIFIED STAINED GLASS STUDIO TO EVALUATE THE WINDOWS. AFTER THE INITIAL EVALUATION A PRESER- VATION AND MAINTENANCE PLAN SHOULD BE MADE SPECIFIED TO THE WINDOWS. THE SPECIALIST CAN ALSO COME UP WITH A CLEANING PLAN FOR THE CONGREGATION. IT IS RECOMMENDED THAT THE SPECIALIST CHECK UP ON THE WINDOWS EVERY FIVE YEARS
