HISTORIC AMERICAN BUILDING SURVEY
NEW TABERNACLE FOURTH BAPTIST CHURCH
HABS #SC-535

Documentary Drawings for New Tabernacle Fourth Baptist Church (Old St. Luke's Episcopal Church)

Prepared by the College of Charleston Historic Preservation
and Community Planning Program
HPCP 299 - Spring 2013
James L. Ward, Assistant Professor

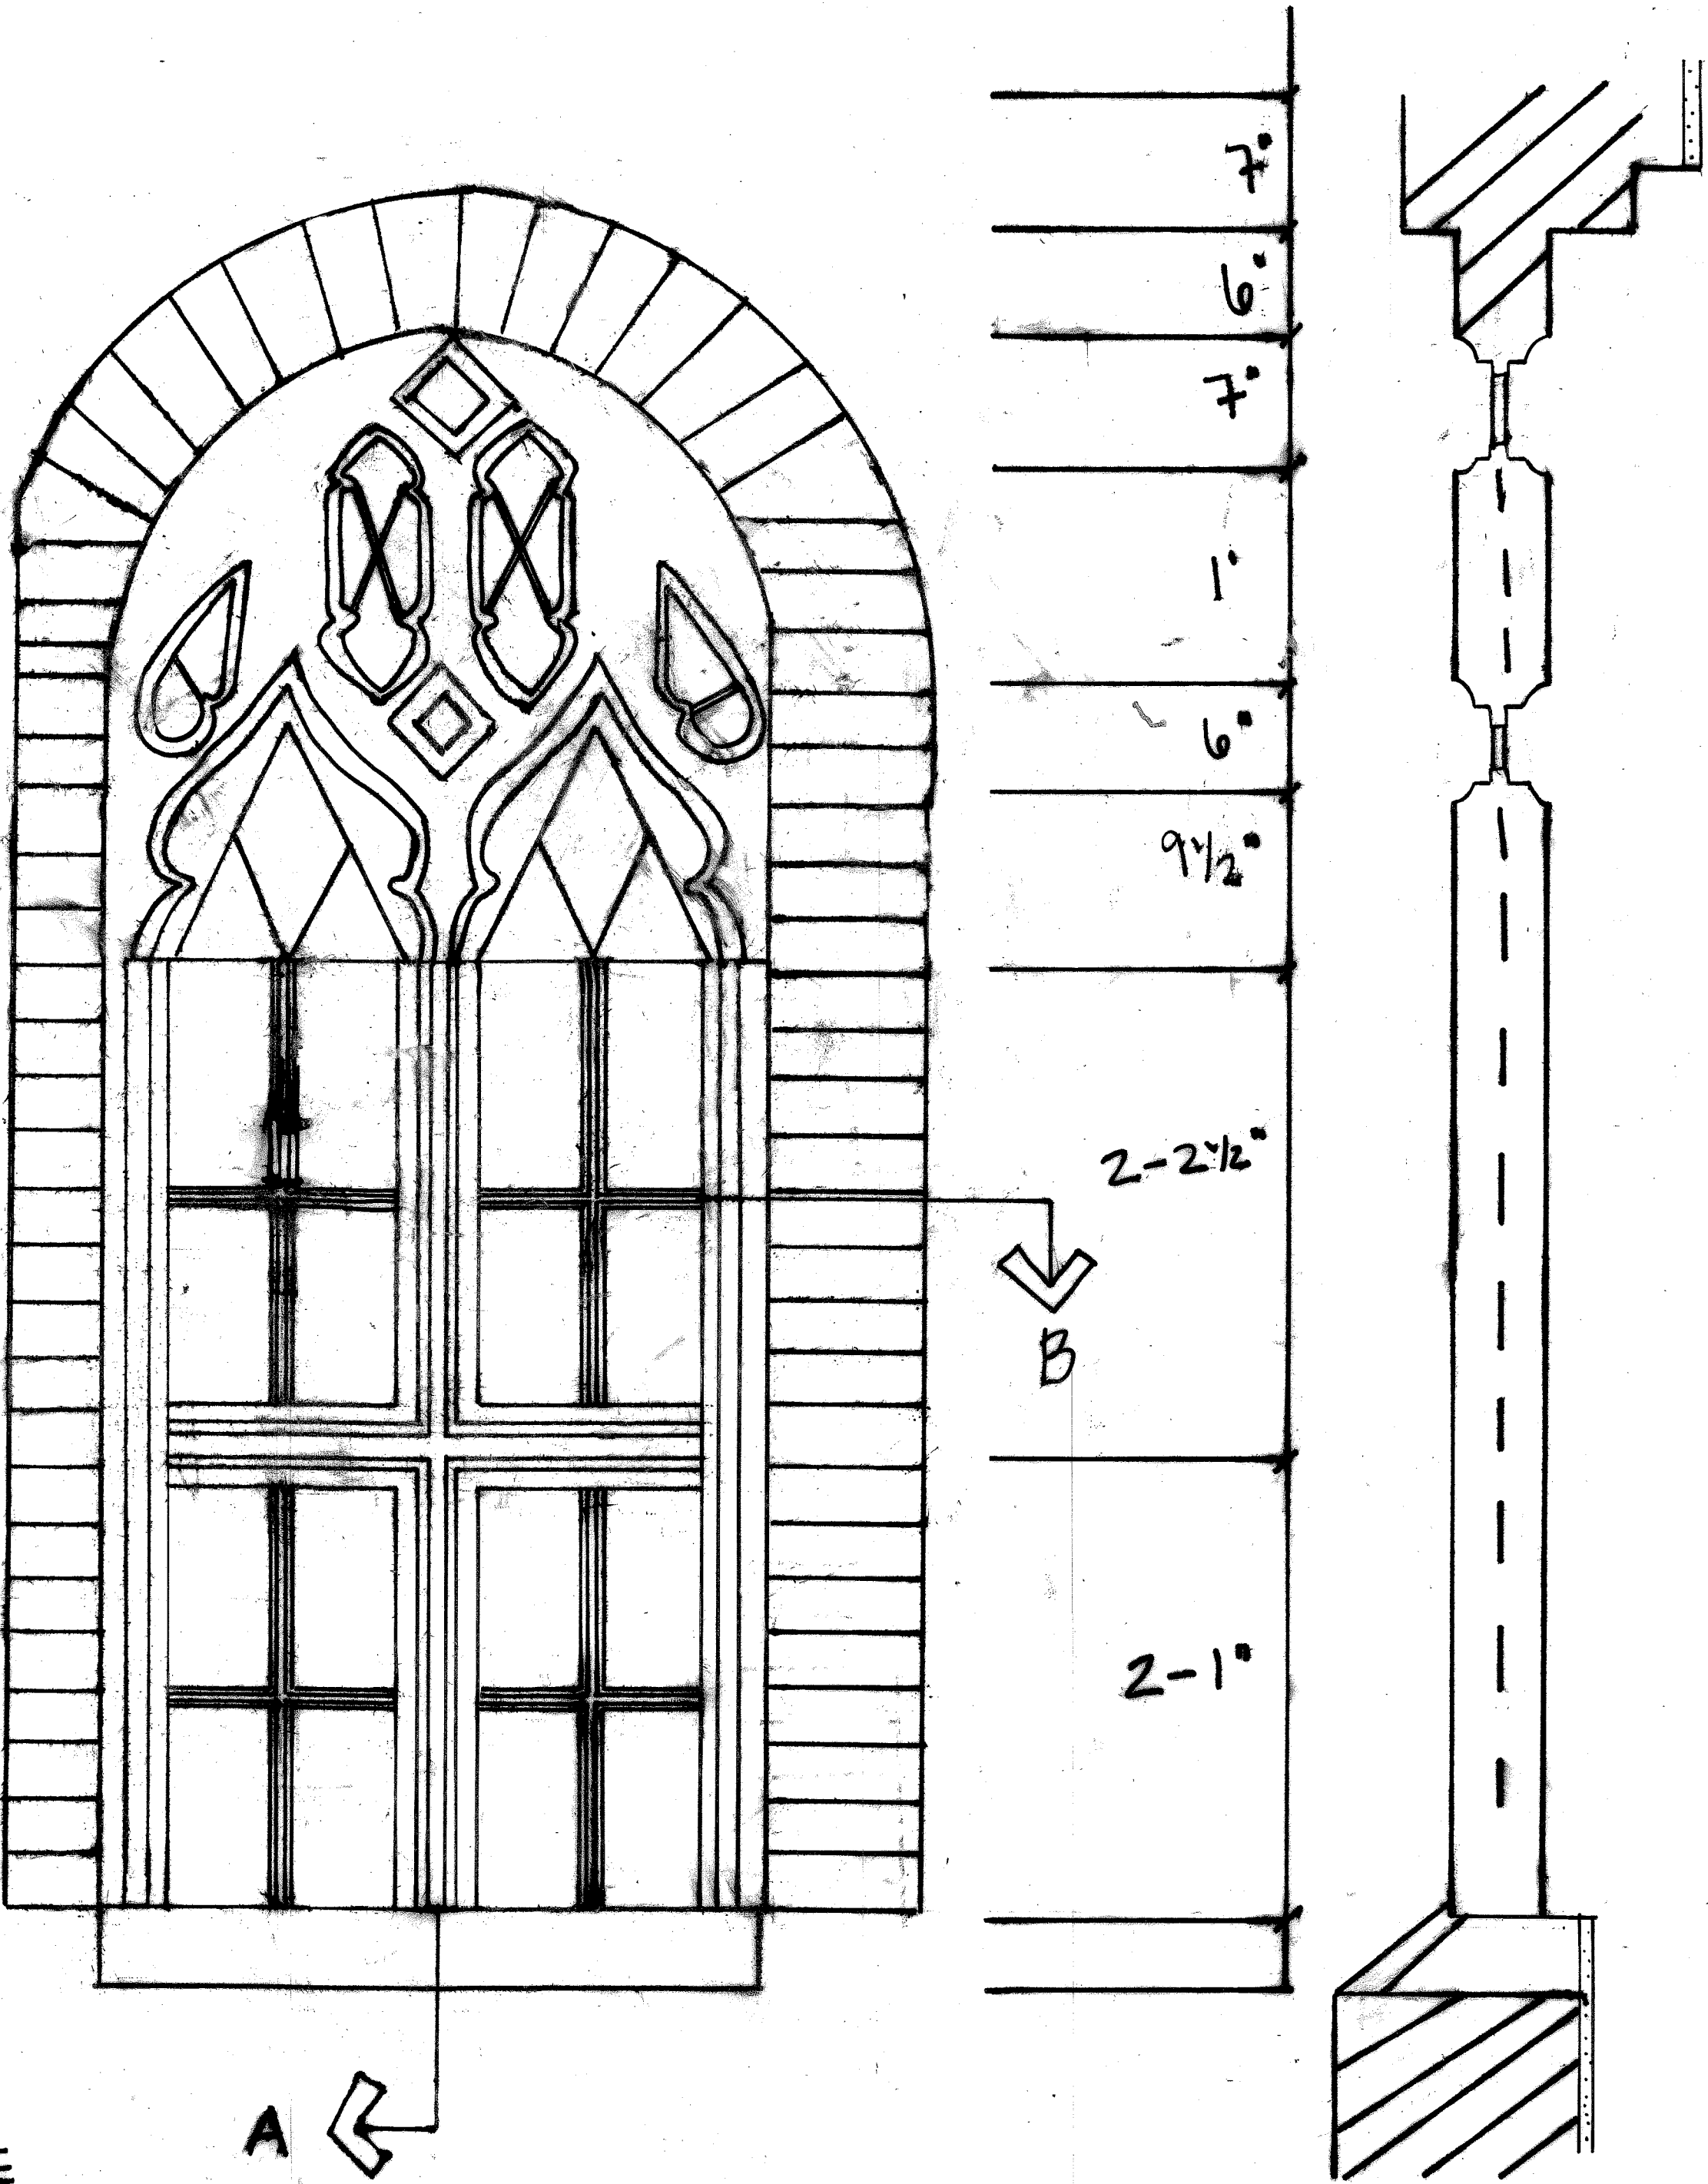
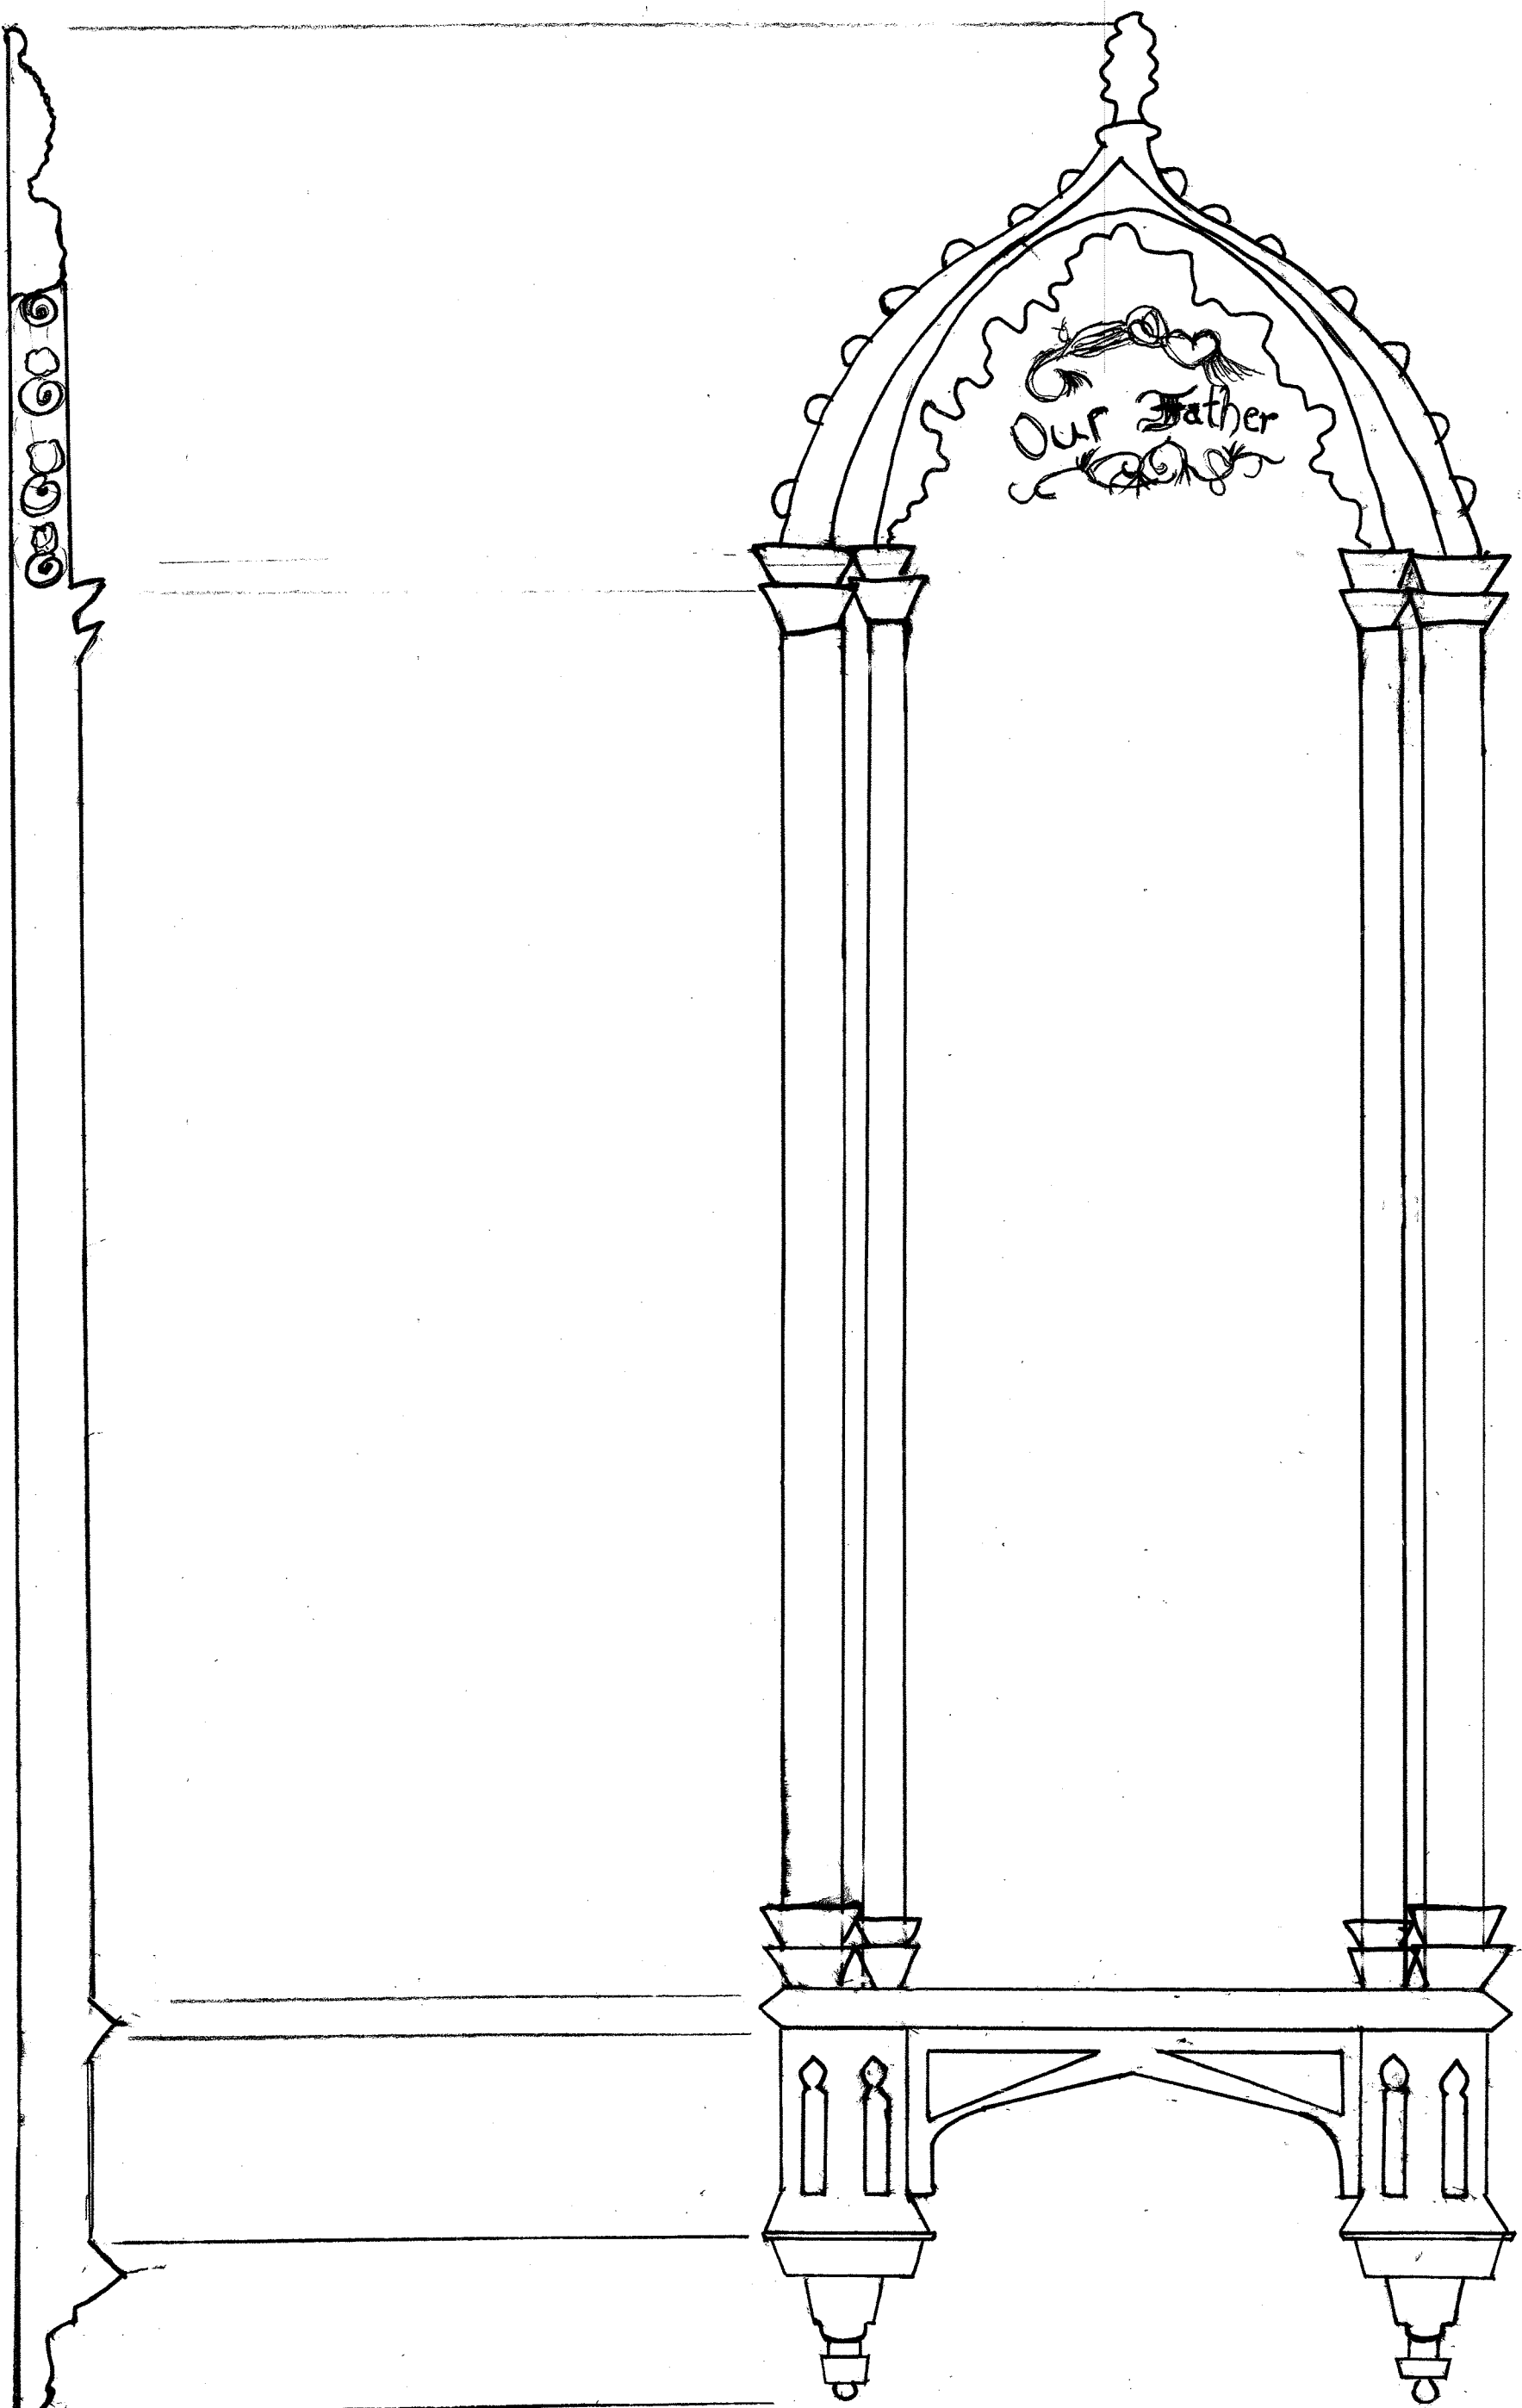
- Repair to the decorative plaster because it has crumbled off.
- Gently washing the black marble background because it has been stained by the white plaster.
- Repainting the white wooden columns and arches.
- Research would include the place the memorial plaques had when it was an Episcopal church.
- Research will also be done on the plaques below that honor prominent church members, mostly on the role they played in the larger Charleston community.

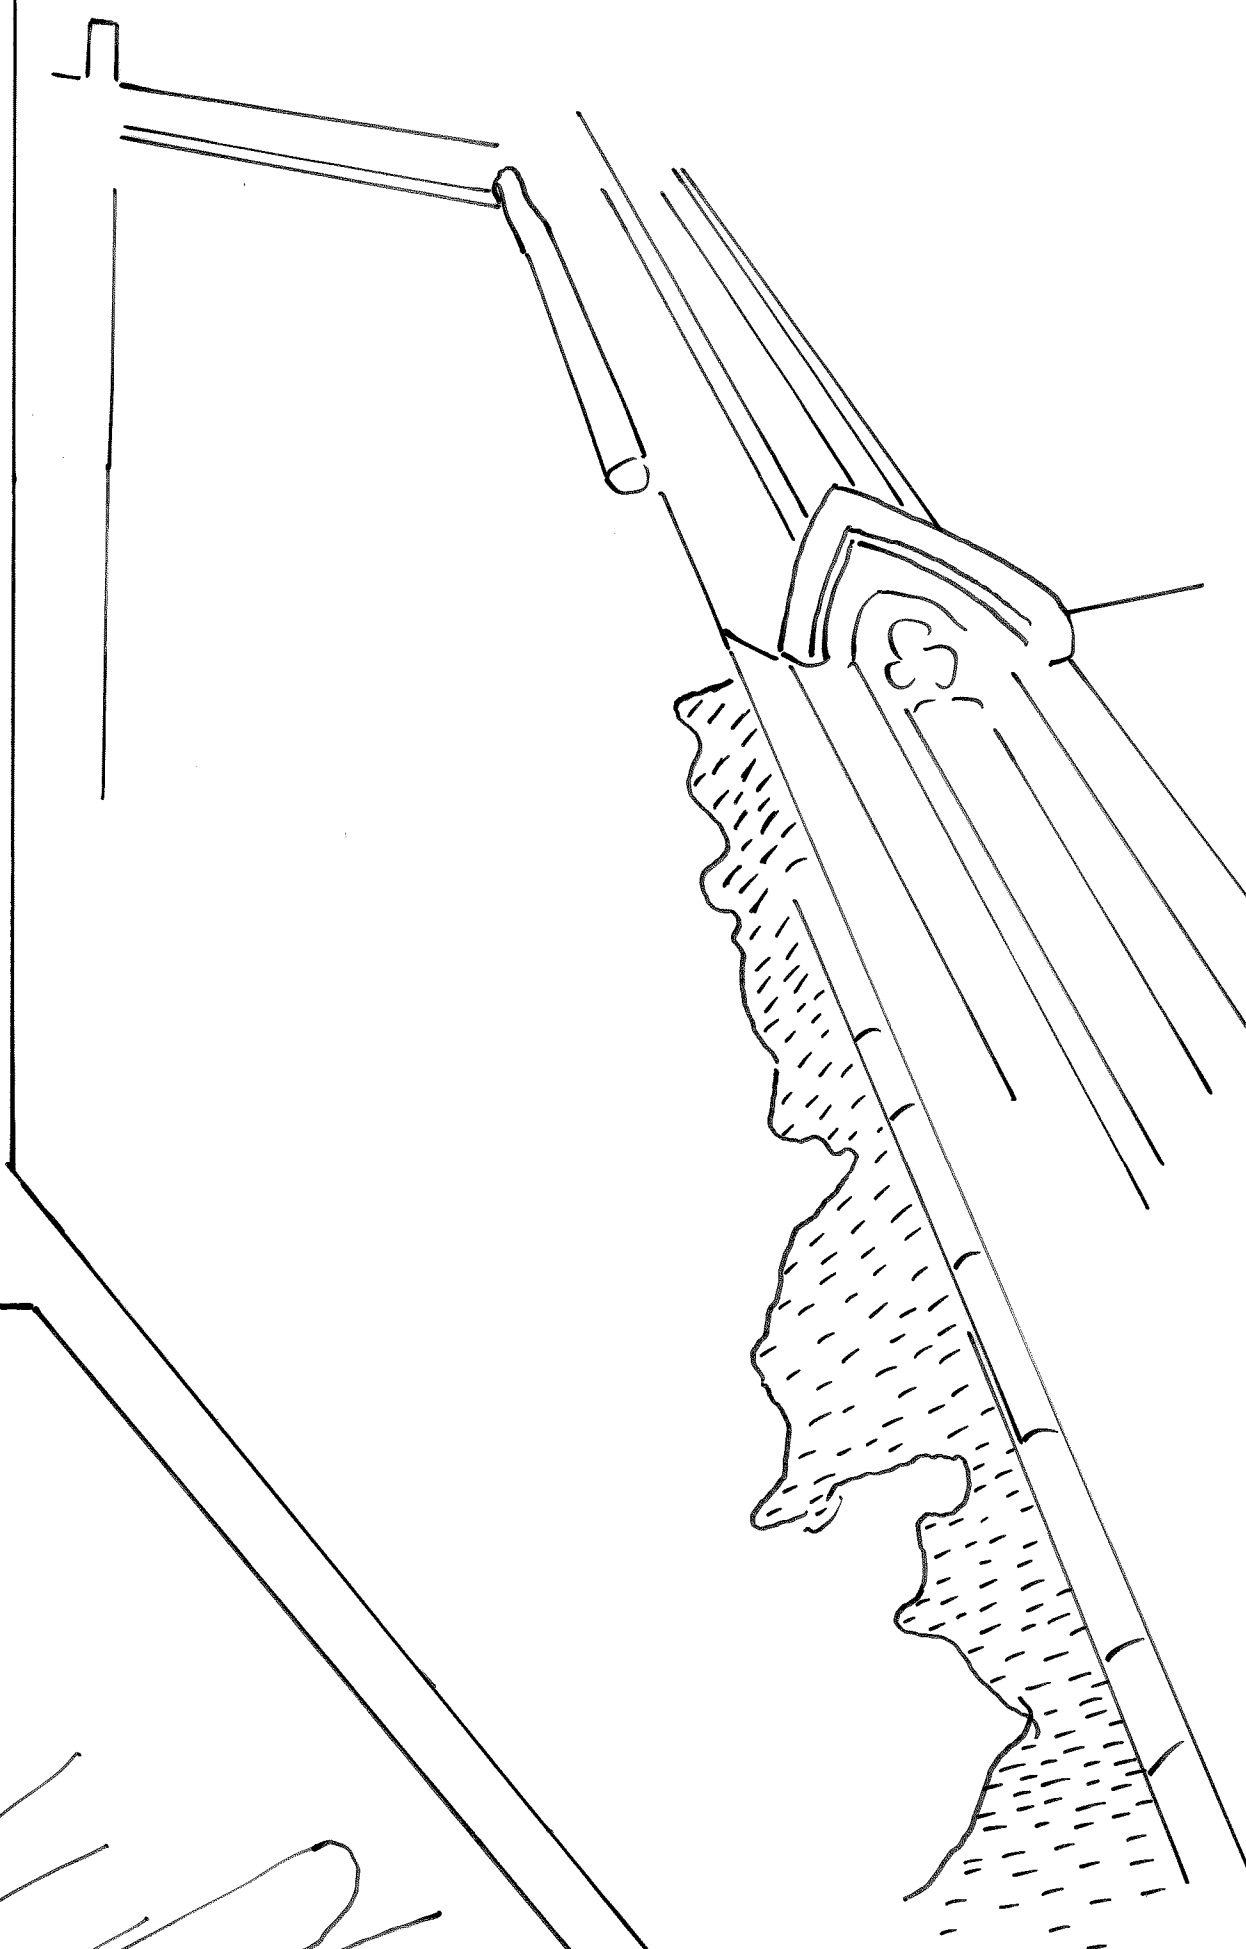
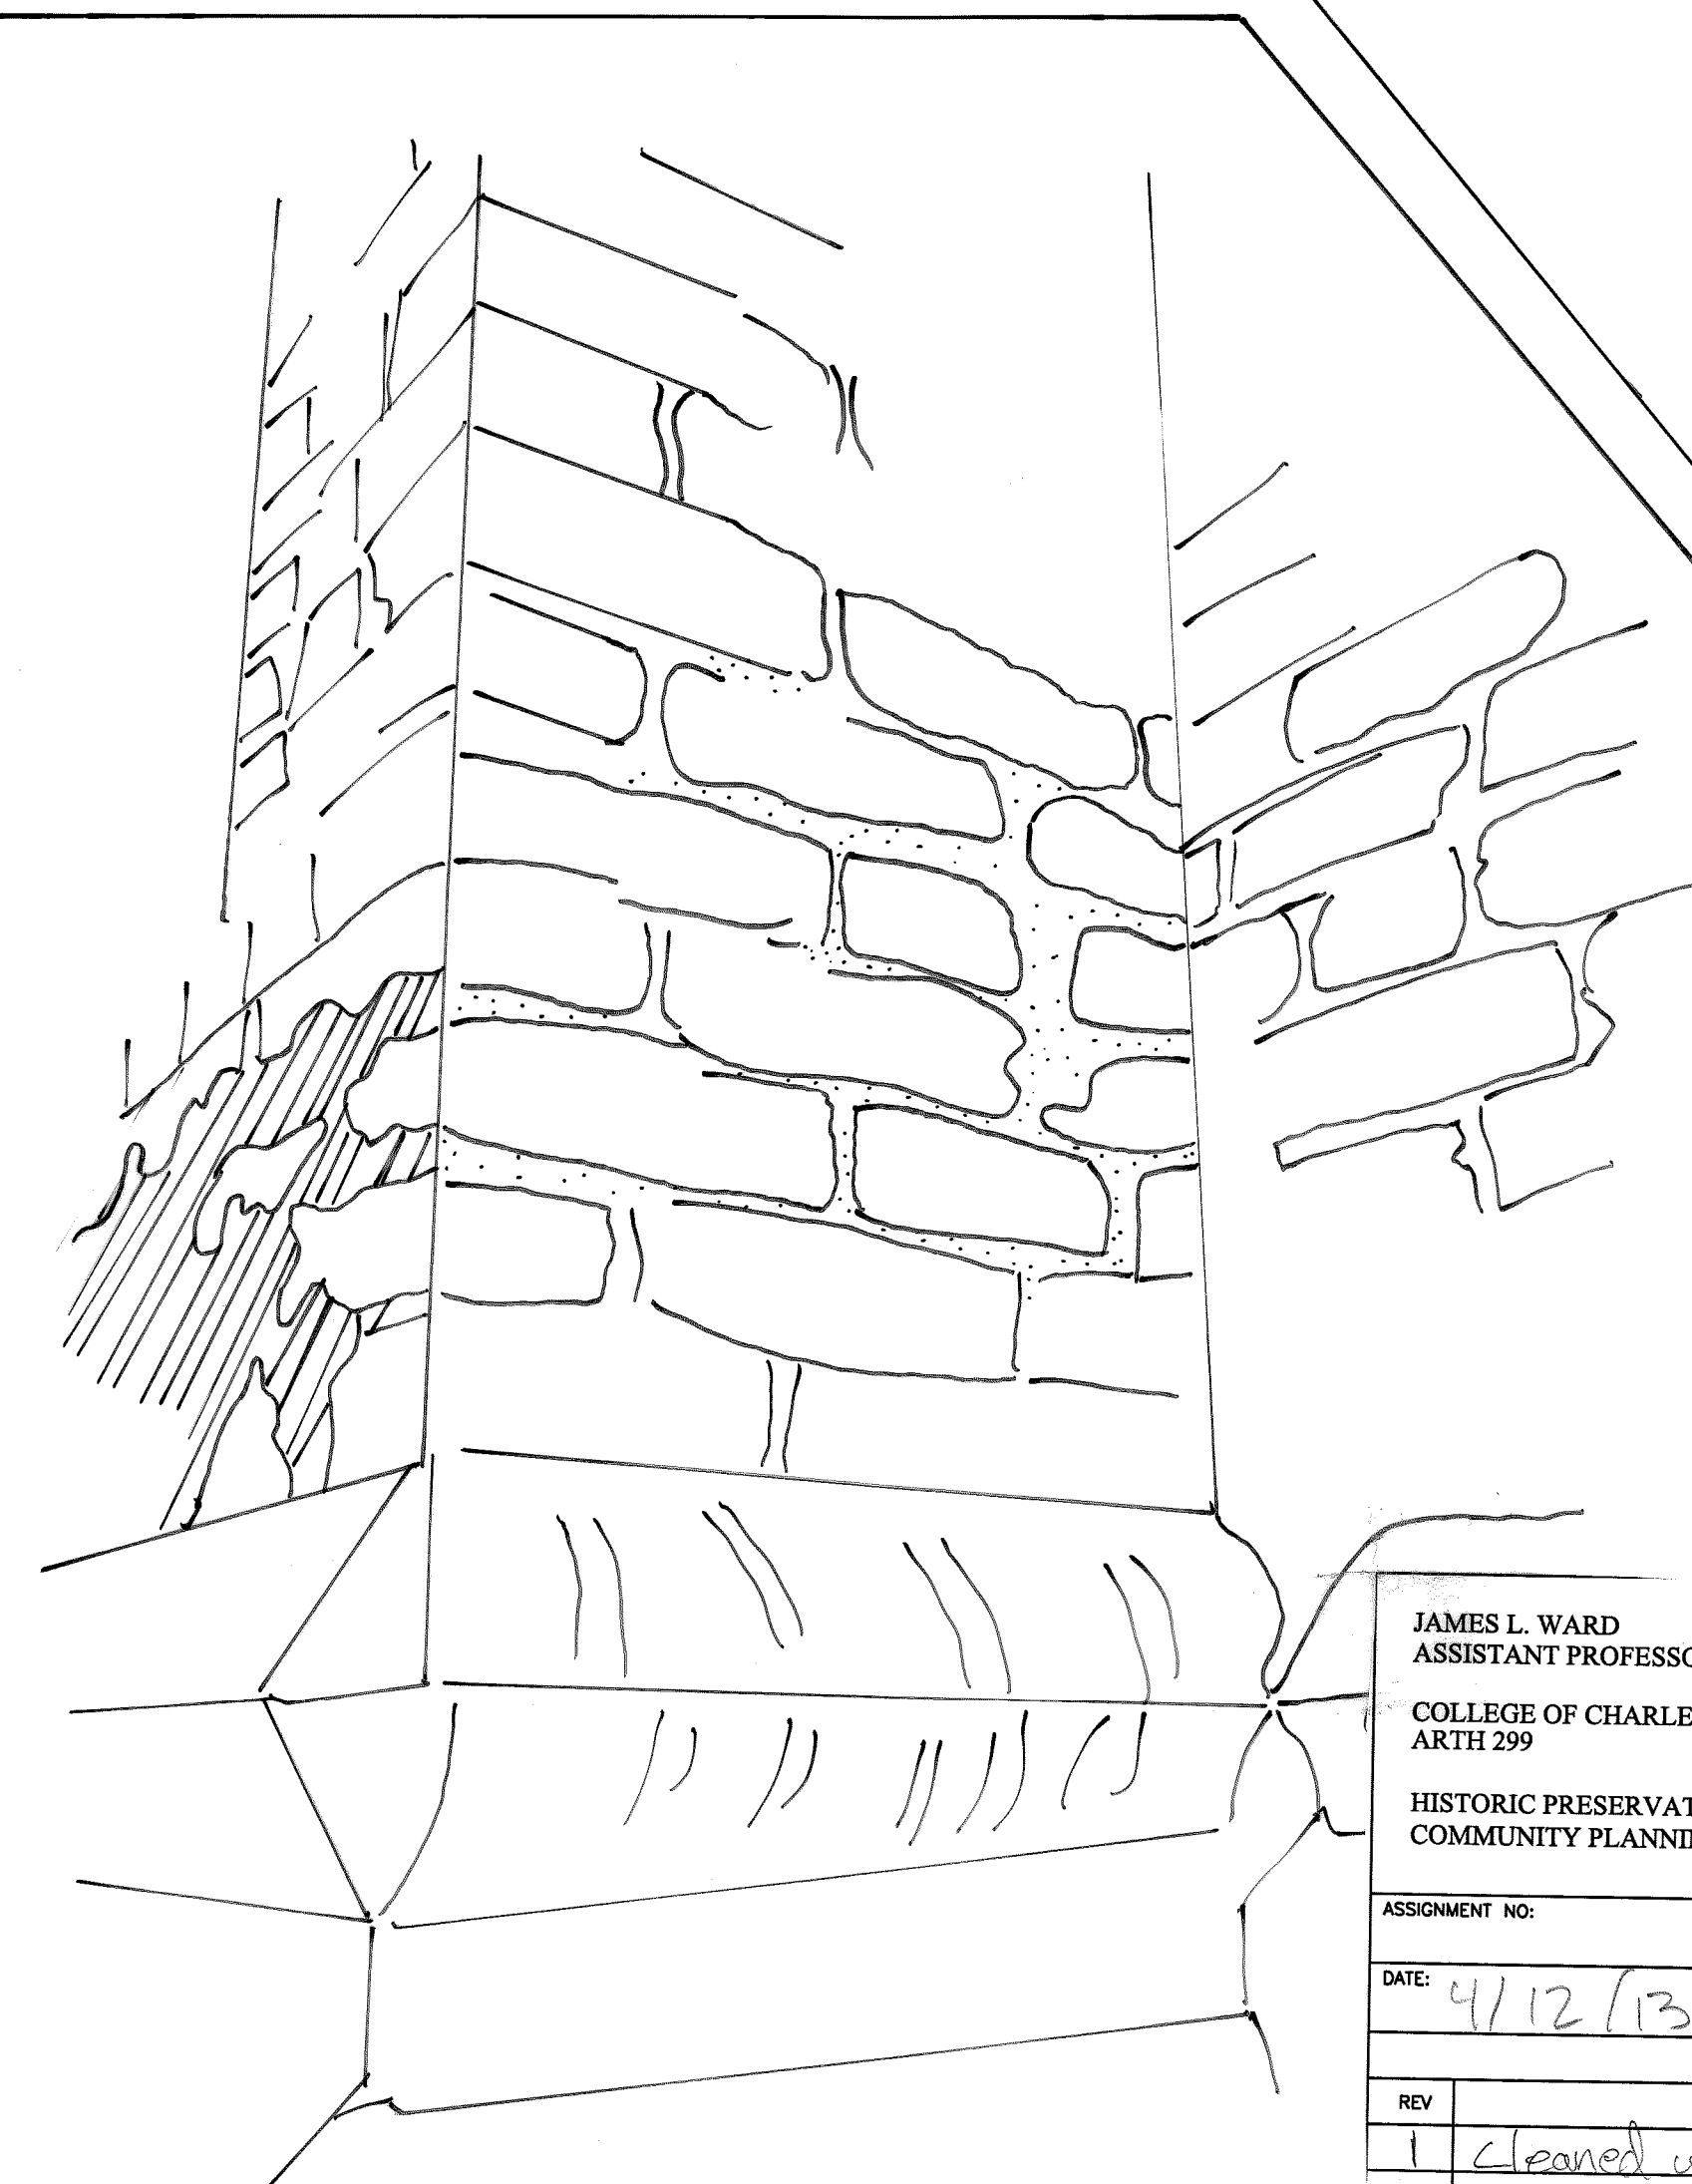
There are many major issues regarding the mortar at St. Luke's Episcopal Church. To cover such a broad range of issues, a narrowing of focus to three main issues was necessary. Falling rain causes several issues, especially when a building is not equipped to cope. Rising damp can have serious repercussions in correlation to the longevity of the foundation. Miscellaneous damage not caused by water can encompass wind erosion, earthquakes, and poor repairs. All of these will be researched and measures to preventing and preserving will be exemplified.

Rising damp seems to have caused an issue, but not in the foundation damage, rather the damage has come with the repairs. Along the base of the north face we see Portland cement spread over cracking brick and diminishing mortar. We see this in places similar to and including detail #1. Detail #1 exemplifies a space not only missing mortar, but also implementing Portland cement for repair. This is a poor solution, as Portland cement does not have the long-term strength to hold the foundation of this large structure together. Rising damp has also brought with it biological life, and with the plant life comes damage to the face of the church. Plant life has been cracking the north face's brick as it grows and forces it roots into the building.

Falling rain on the north face is an especially serious issue. Somewhere from transitioning from a cistern system to a gutter system, the church ended up with neither. In many places there are holes in the wall where gutters previously sat or were intended to sit. But even the existing gutters are often incomplete and still drain down the wall face, causing major water damage to the porous brick, as seen in detail #2. The solving of this situation would be simple and not effect the historic image of the church at all, put in functioning gutters. Just draining the water away from the building properly will cut down on most of the water damage on the north face. This change would also cut down on the plant life growing on all sides of the church.

BY COMBINING BOTH WATER DAMAGE AND RISING DAMP TOGETHER THE CHURCH WILL CONTINUE TO SEE PLANT GROWTH ISSUES. AS SEEN IN BOTH DETAILS, THE CHURCH ACTUALLY HAS VINES AND OTHER GROWTH WITHIN THE STRUCTURE (BRICKS, WALLS, FOUNDATION). THIS CAN BE DETRIMENTAL TO THE CHURCH'S FURTHER USE AND WELL BEING.

IMPROPER DRAINAGE SYSTEMS, SEEN IN BOTH DETAIL DRAWING, HAVE CAUSED DETERIORATION OF THE BRICK AND FOUNDATION. BY LEAVING GUTTERS AND OTHER FORMS OF DRAINAGE IN DISREPAIR THE CHURCH WILL CONTINUE TO DETERIORATE.

ACCURSE WHEN MOISTURE FROM THE OUTSIDE OR CONDENSATION A STRUCTURE DETERIORATES THE BUILDING HSELF. DO TO THE CHURCH'S EXPOSED POROUS BRICK THE STRUCTURE HAS SUFFERED GREATLY. IN ORDER TO CORRECT IS THE CHURCH'S BRICKS WILL HAVE TO BE COVERED BY A SEALANT OR STUCCOED TO PROTECT AGAINST FURTHER EROSION.

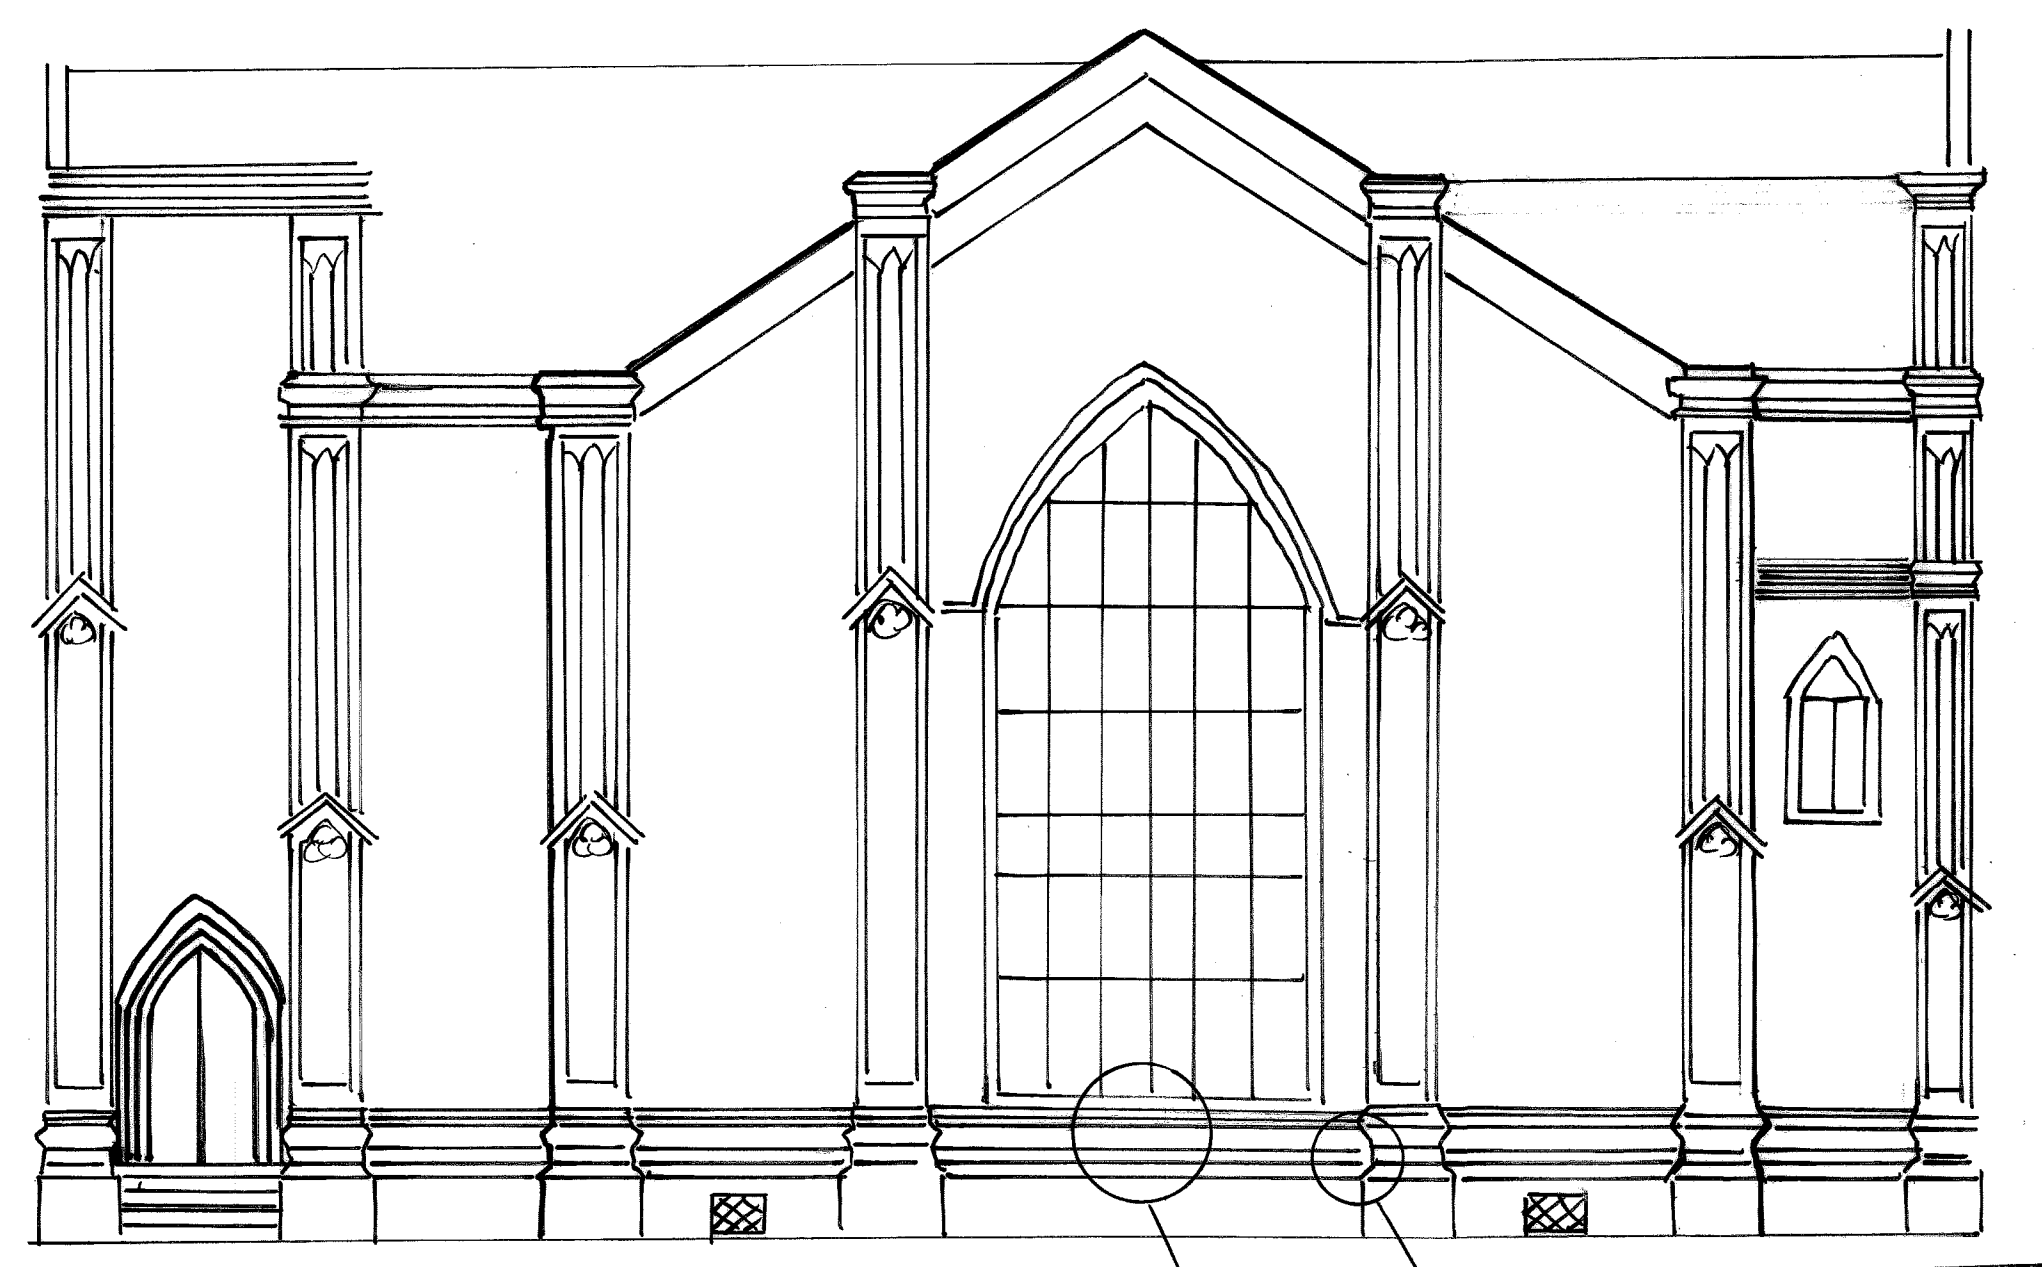
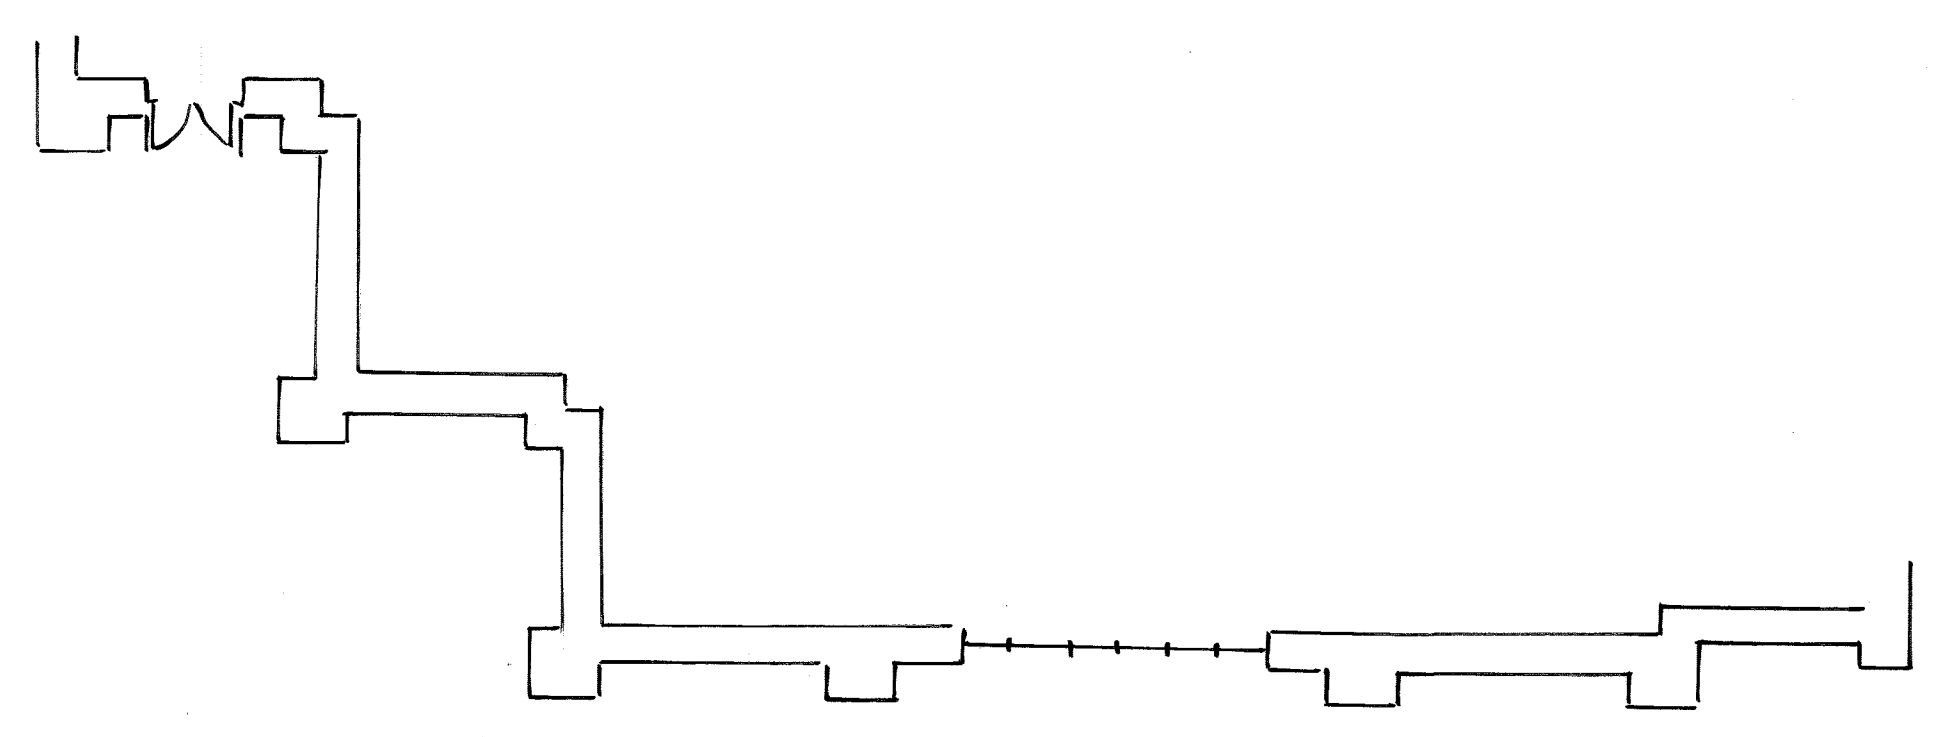
DETAIL B HELPS TO ILLUSTRATE WHAT THE MAJORITY OF THE CHURCH IS FACING. THE EXCESSIVE USE OF PORTLAND CEMENT COMBINE WITH IMPROPER REPAIRS HAS DAMAGED THE CHURCH'S ORIGINAL BRICK. THIS CAN ONLY BE FIXED BY REPOINTING OF THE EXISTING BRICK
