PROFESSOR JAMES WARD		DRAWING TITLE:	
2 BULL STREET		CHARLESTON, SOUTH CAROLINA	
ASSIGNMENT NO.:	DRAWING PREPARED BY: V. KNISELY, K. HILLOCK, M. LAVAGHINA	SCALE: SEE NOTES	SHEET:
DATE: 4-14-07	REVISIONS		
REV.	DESCRIPTION	DATE	APPROVED
4-14-07	ELEVATIONS WEST & SOUTH

2 BULL STREET BACK PORCH DETAIL

JAMES L. WARD ASSISTANT PROFESSOR		BULL & COMING STREET RESIDENCE HALLS	
COLLEGE OF CHARLESTON ARTH 299-SPRING 2007		DRAWING TITLE: #2 BULL ST. BACK PORCH DETAIL	
HISTORIC PRESERVATION & COMMUNITY PLANNING		DRAWING PREPARED BY (TEAM/INDIVIDUAL): MORGAN LAUGHLIN	
ASSIGNMENT NO:		DATE:	04-13-07
SCALE:	3/4"=1'	SHEET:	
REVISIONS			
REV	DESCRIPTION	DATE	APPROVED

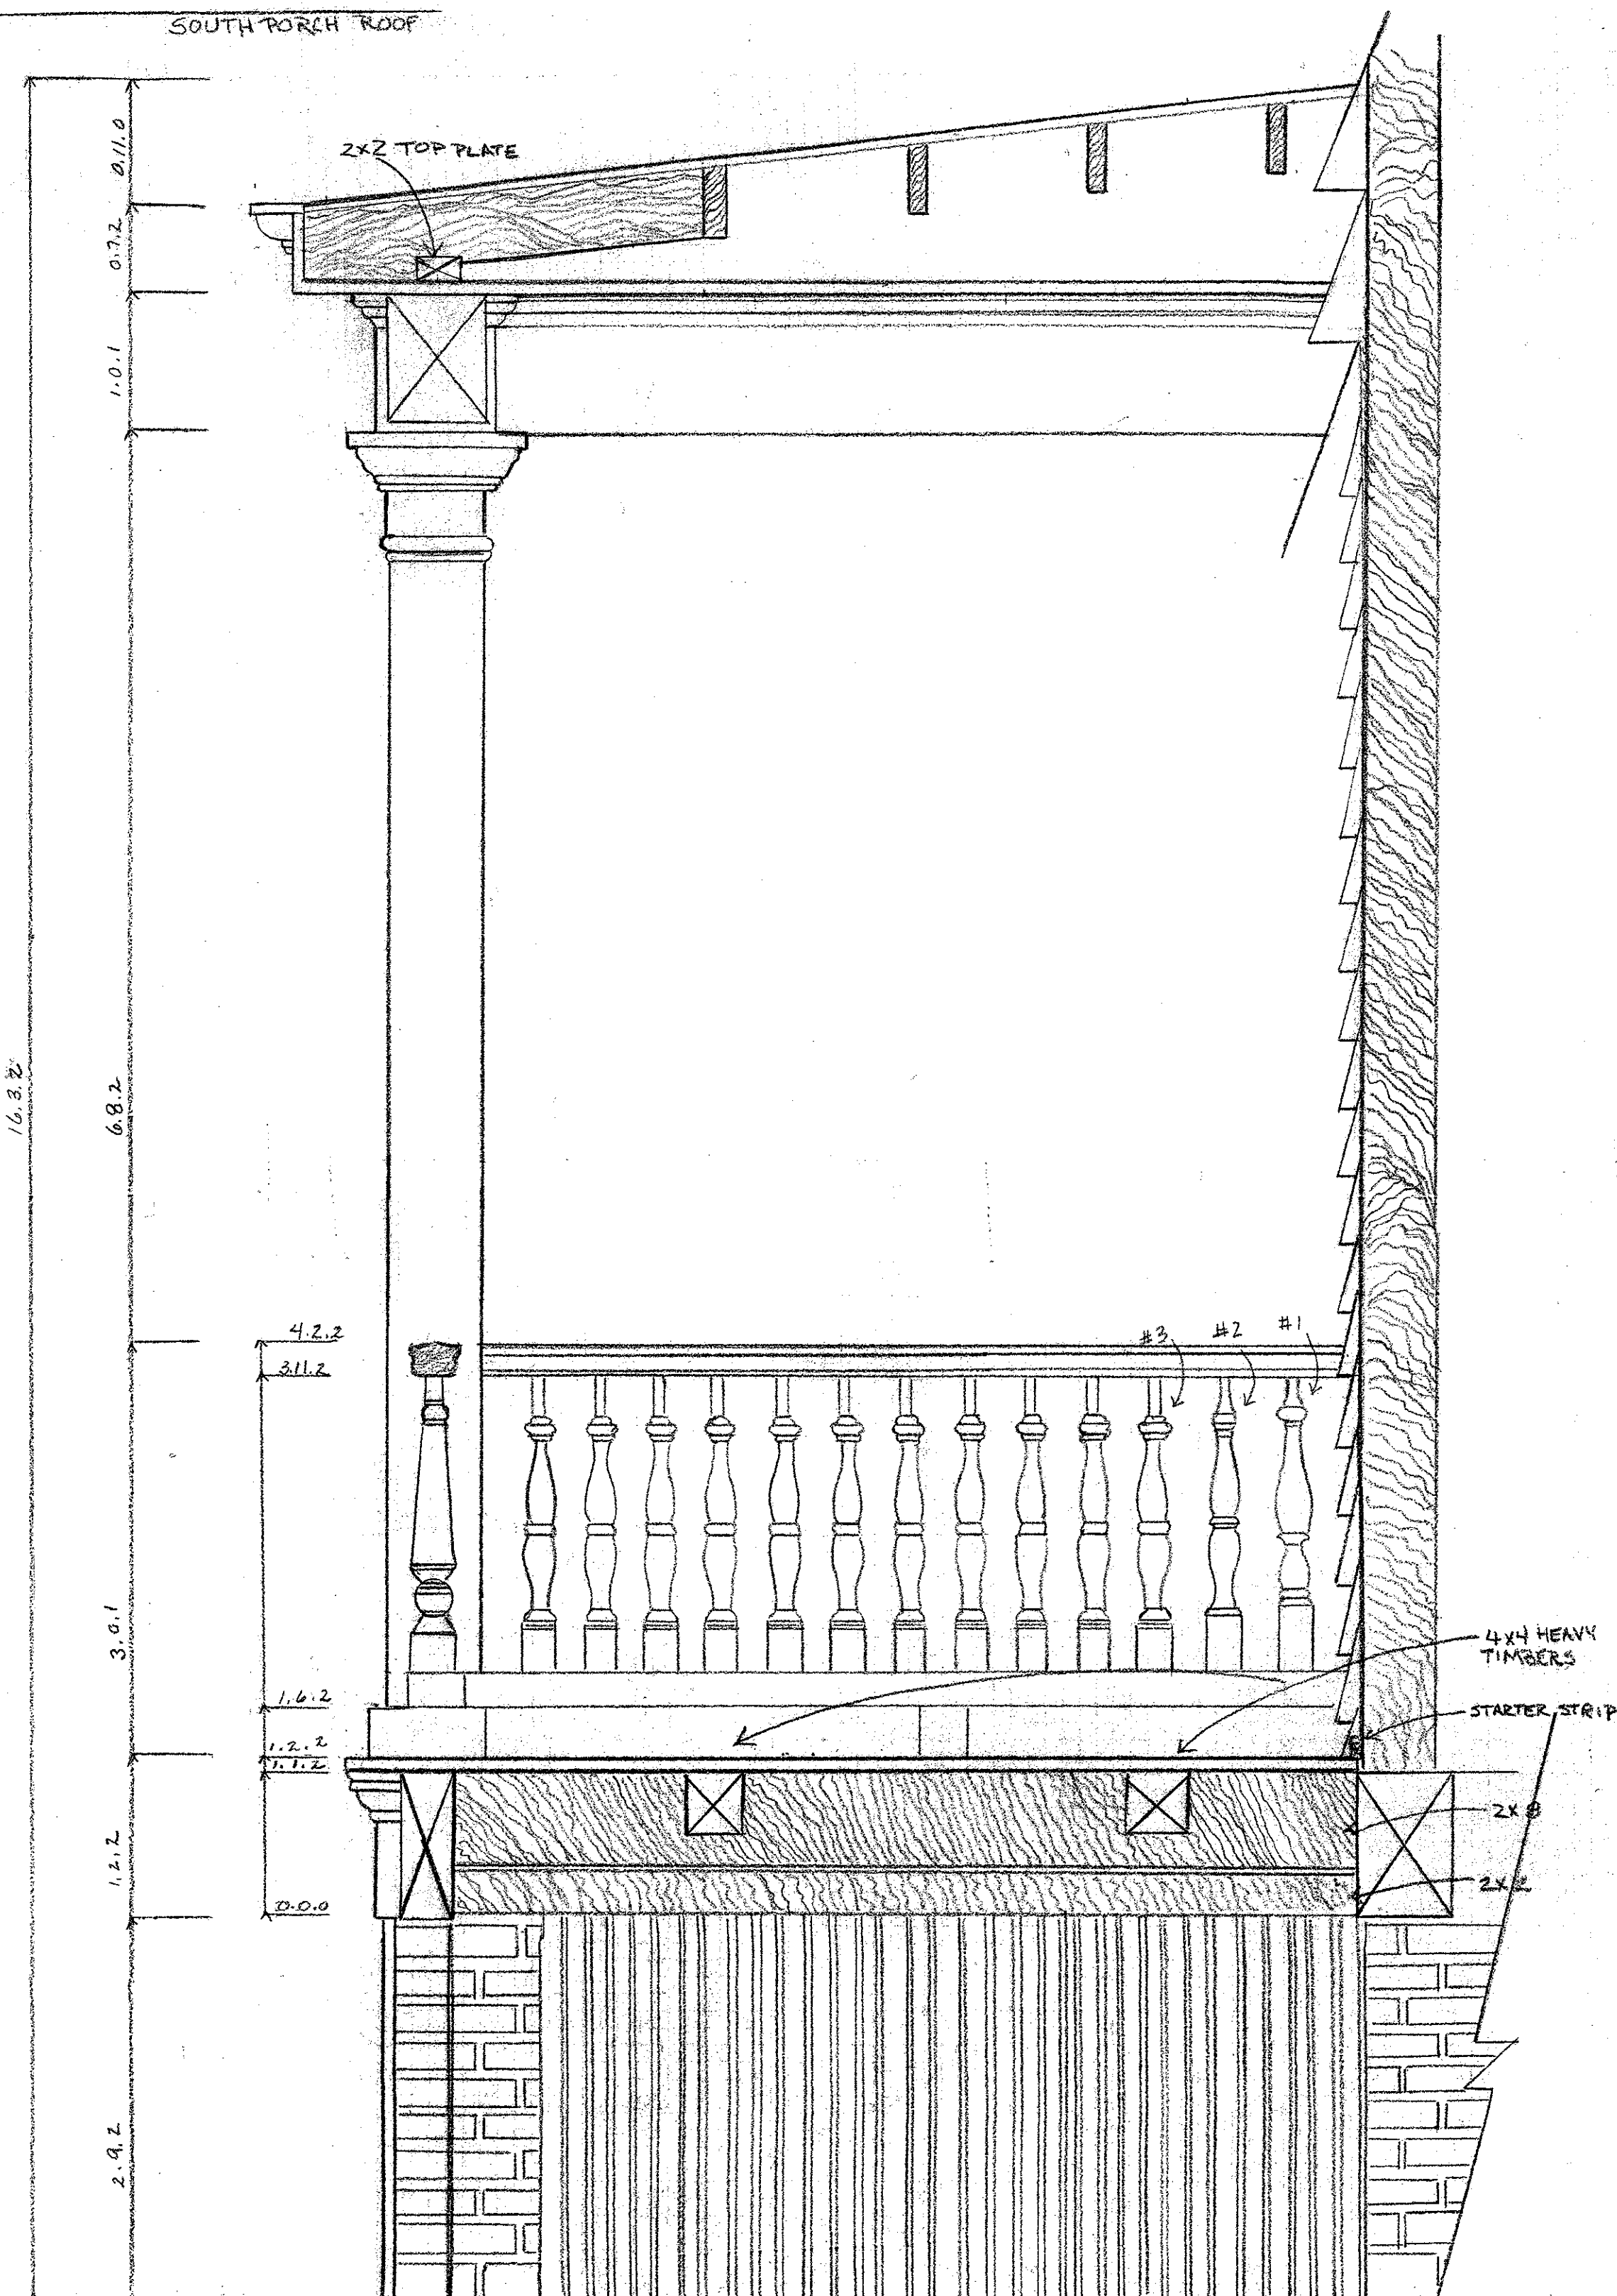
1 SECTION
SCALE: 1" = 1'
WEST SIDE SOUTH PORCH

1. THE BRICK PIERS IN THE FOUNDATION APPEAR TO BE STABLE, HOWEVER, REPOINTING OF THE PIERS ALONG THE EDGE OF THE PORCH IS NECESSARY. THE MORTAR IS DISINTEGRATING AND NOT FUNCTIONING PROPERLY CAUSING LOOSE, DAMP BRICKS. IF THE PIERS ARE NOT REPOINTED SOON, THE BRICKS WILL BECOME DAMAGED FROM INCREASING WETNESS. A MORTAR ANALYSIS IS RECOMMENDED TO DETERMINE THE CORRECT MORTAR TO USE IN REPOINTING.

2. THE STAIRCASE IS NOT SECURE. IT IS VERY NARROW AND "WOBBLES" A BIT. THE WOOD MAY BE OF POOR QUALITY AND/OR BE BEGINNING TO ROT. THE WOOD NEEDS TO BE EXAMINED TO DETERMINE THE CAUSE OF THE PROBLEM. THE WOOD WILL HAVE TO BE EITHER REPLACED, OR THE STAIRCASE SUPPORTED WITH MORE SUPPORTIVE BEAMS.

3. THE WOOD FLOOR BEAMS ARE IN BAD CONDITION. THEY ARE WARPED, SPLITTING, AND SEPARATING FROM THE BASE BOARDS. THIS COULD BE DUE TO POOR WOOD QUALITY IN COMBINATION WITH ABRASION AND WEAR FROM HIGH FOOT TRAFFIC. THESE BOARDS MUST BE REPLACED SOON WITH MORE DURABLE BOARDS.
